## **Town of Boston Wohlhueter Tank Improvements**

**February 2020**

**EVALUATION OF THE  
672,000 GALLON STEEL STANDPIPE  
“WOHLHUETER TANK”  
COLDEN, NEW YORK  
FOR  
ERIE COUNTY WATER AUTHORITY  
BUFFALO, NEW YORK**

October 25, 2017

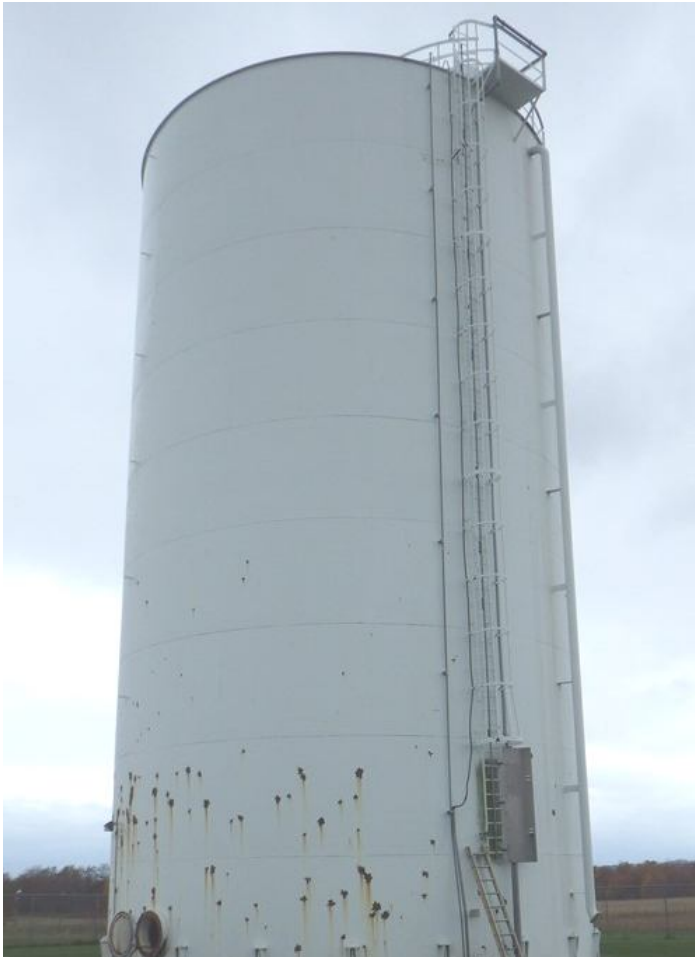
1. **Exterior Coating Condition:** The coating on the exterior of the tank appeared to be in poor condition on the two bottom shell rings with widespread peeled coating and corrosion. The exterior coating exhibited very poor adhesion to the steel.

1. Tank. Note coating failures and rust on lower shell.

1. **Life of the Exterior Coating:** The exterior coating system appeared to be in poor condition with numerous areas of peeled coating and corrosion. Tank Industry Consultants believes that the exterior of the tank should be painted within the next 1 to 2 years from a corrosion standpoint. Due to the very poor adhesion of the existing exterior coating, topcoating does not appear to be an option.

b. **Coating Application:** The entire tank exterior should be cleaned to the equivalent of an SSPC-SP 6, Commercial Blast Cleaning and have an epoxy-primed, epoxy intermediate and polyurethane finish coating system applied. However, care must be taken during the application of this particular coating system because this coating does have poor dry-fall characteristics, and potential damage to the surrounding property must be taken into consideration. The polyurethane coatings also require close monitoring of temperature and humidity during application.

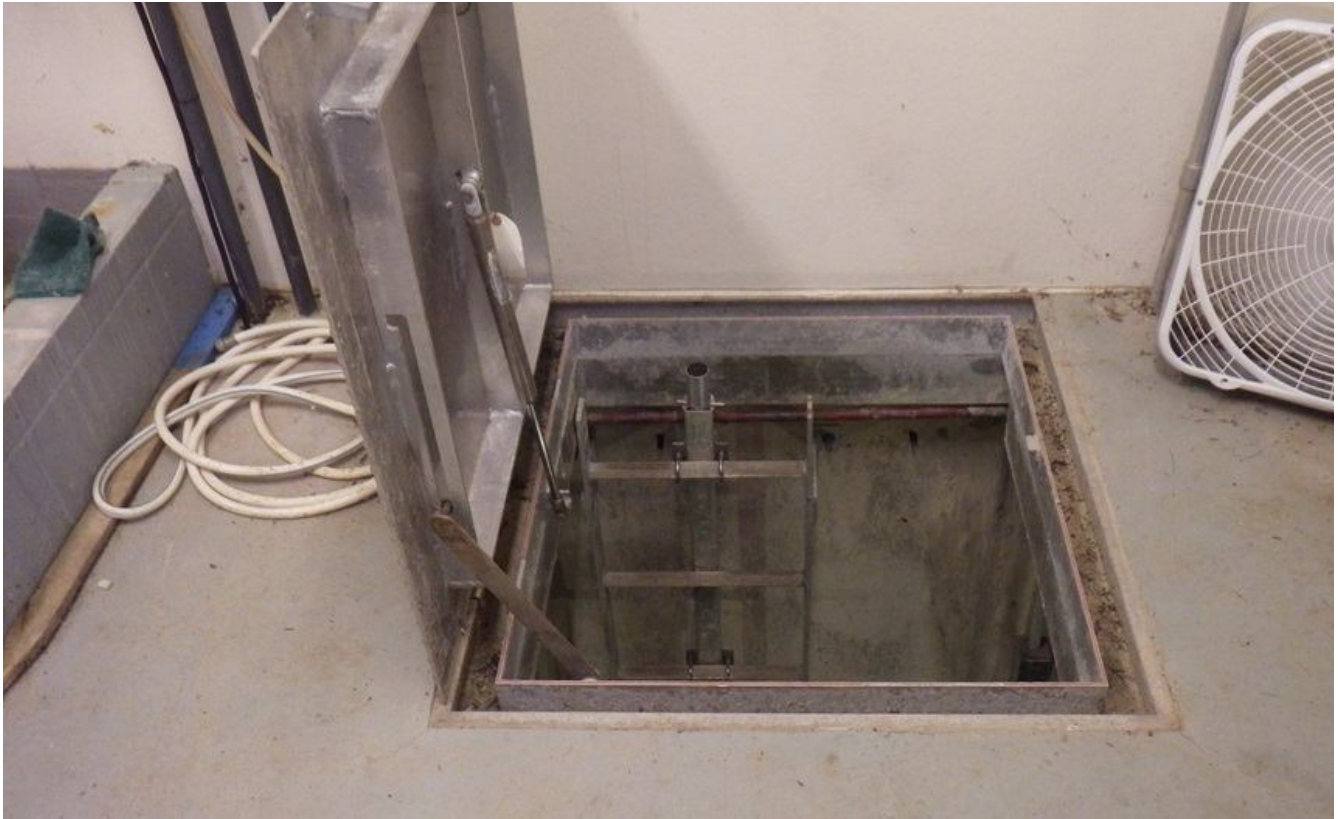
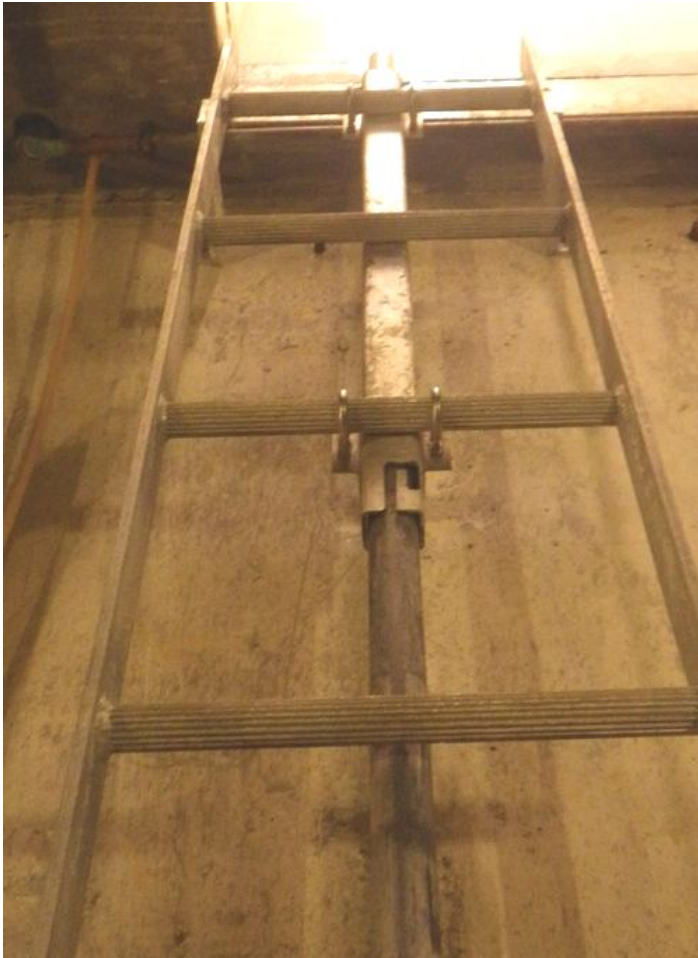
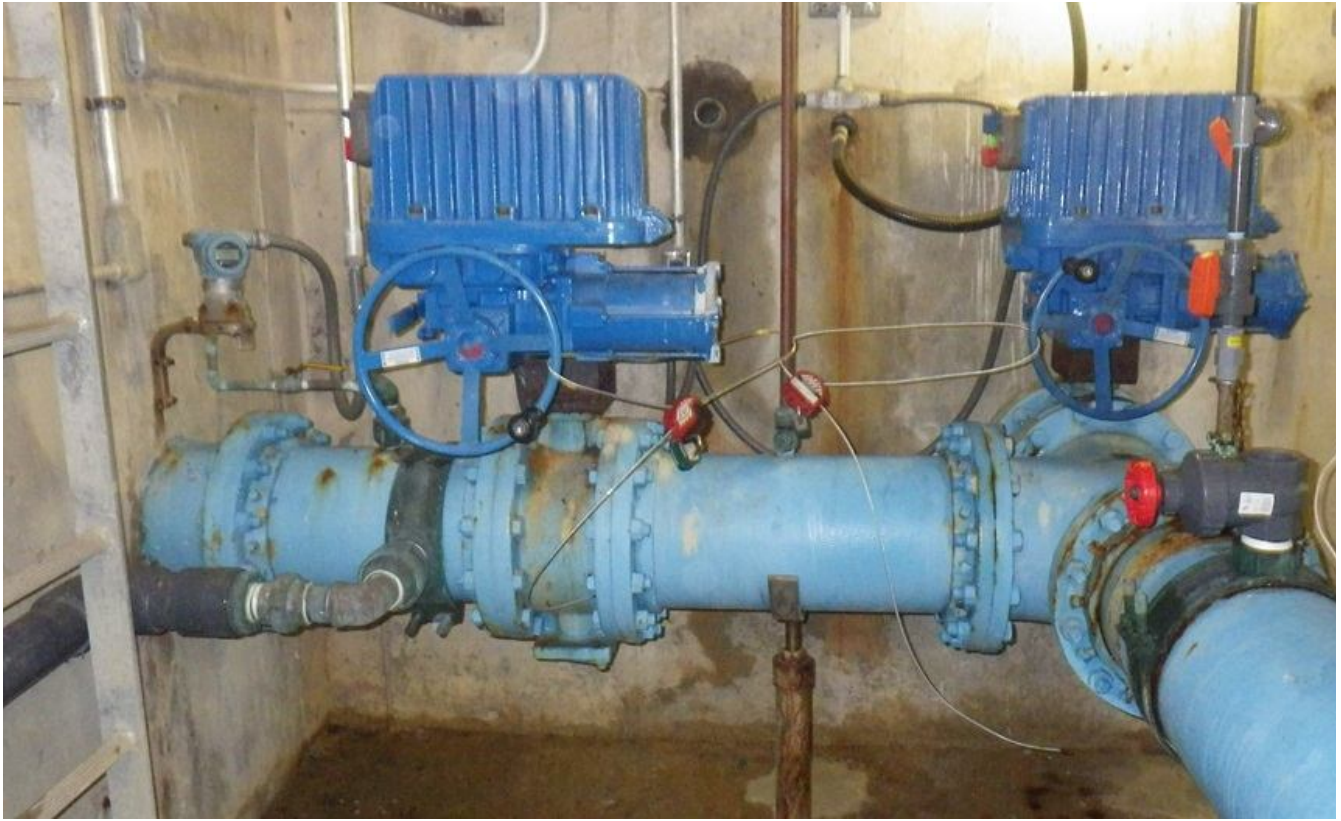
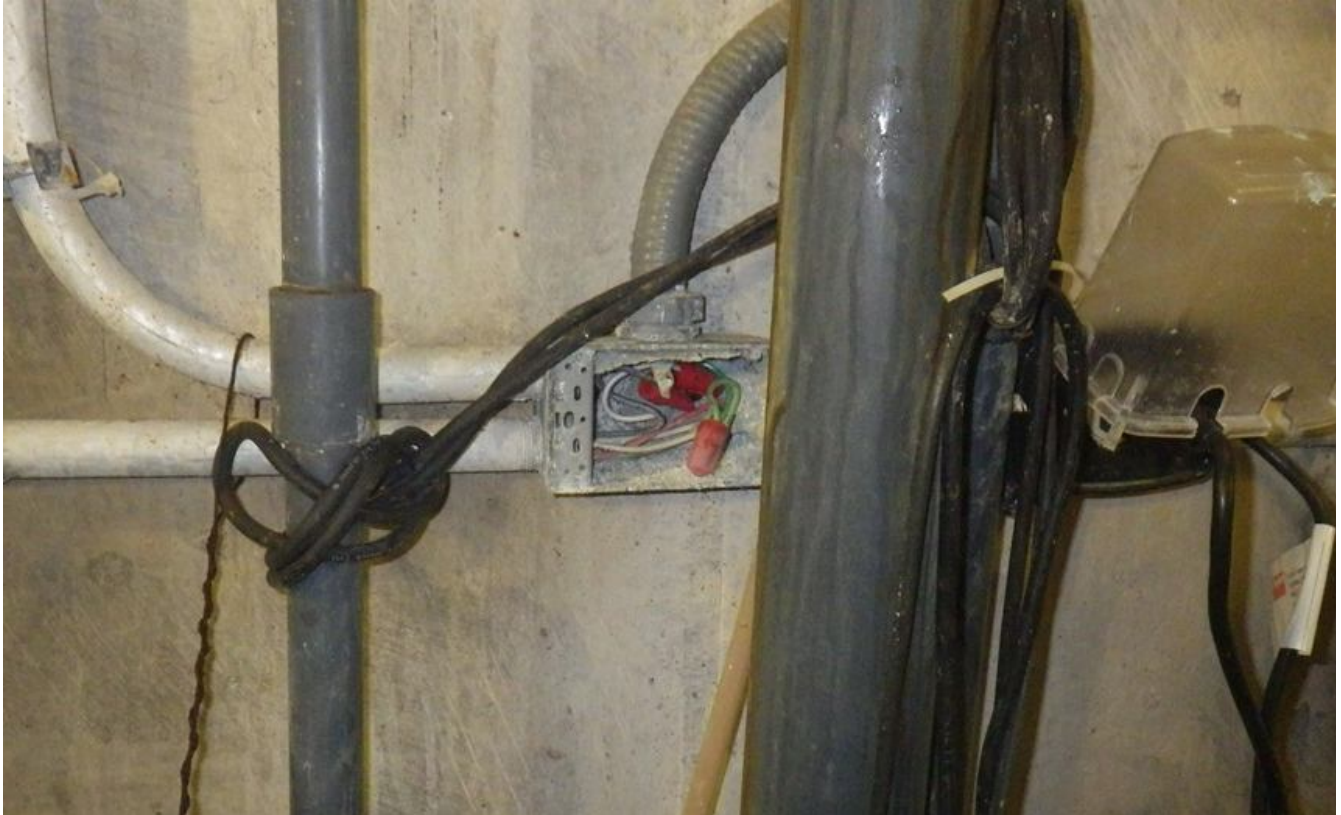
5. **Valve Vault:** There were safety and OSHA deficiencies noted: (1) the 5-1/2 in. minimum toe room did not meet the required 7 in. minimum, (2) one of the electrical receptacles was not equipped with ground fault interrupt circuits, and (3) an uncovered conduit junction box with exposed wiring was located in the valve vault. A valve vault was located beneath the pump building on the site. The vault access was equipped with an aluminum ladder. Minor spots of corrosion were observed on the piping in the valve vault at the time of the field evaluation. The vault was equipped with a sump and pump. Electrical equipment and four operational lights were located in the vault. A conduit junction in the vault was missing a cover. (See photos 7-10)

7. Valve vault access inside building on site.

8. Valve vault access ladder.

9. Piping and valves in vault.

10. Conduit junction with missing cover.

6. **Valve Vault:** If compliance with OSHA dimensional and safety standards is desired, the access ladder should be modified to allow adequate toe room. The piping and valves located in the valve vault should be cleaned and painted in accordance with the interior coating recommendations at the time of the tank cleaning and coating. The exterior concrete surfaces should be cleaned to the equivalent of a brush-off blast cleaning and painted with a concrete sealer. Freeze protection should be provided for on all control piping and static water lines. The electrical outlet should be equipped with ground fault interrupt circuits, and the missing cover for the conduit junction replaced.

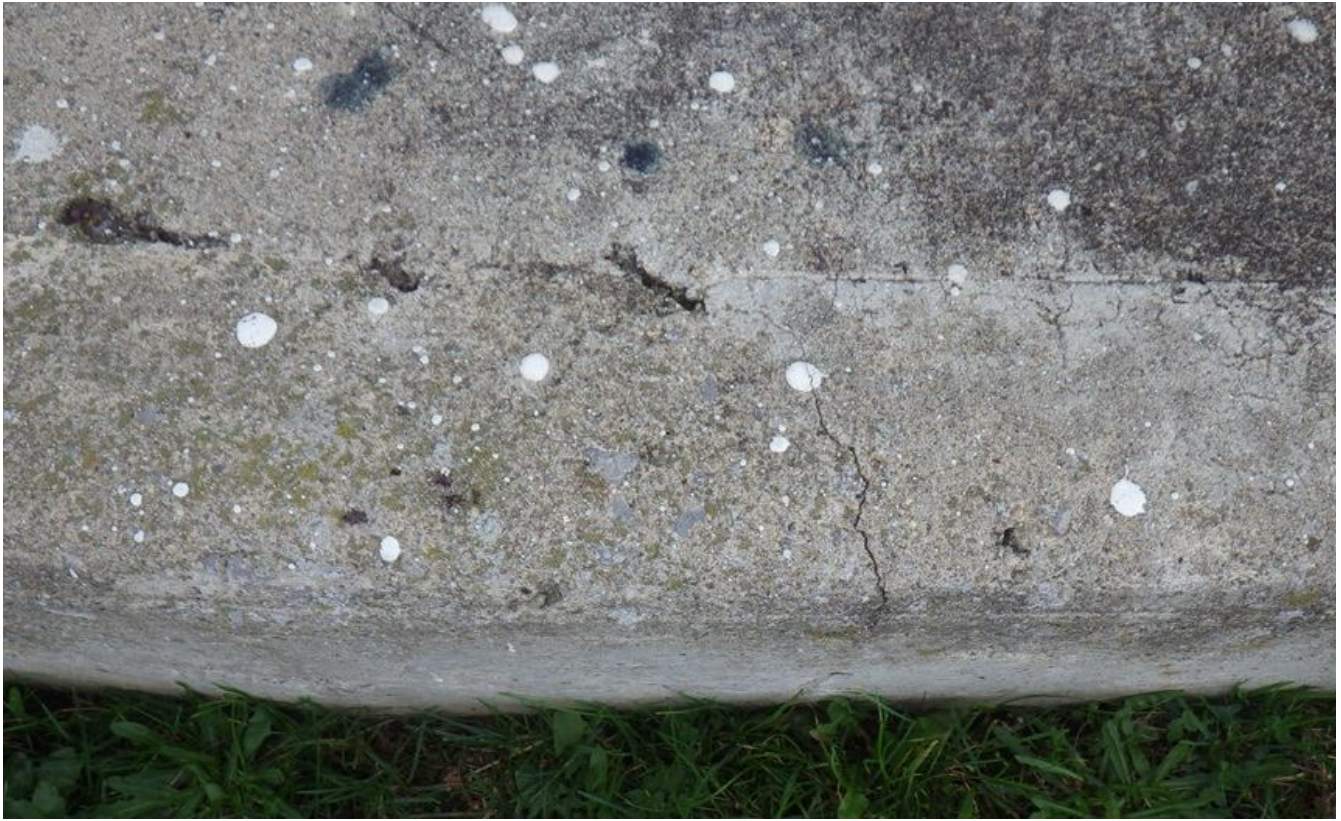
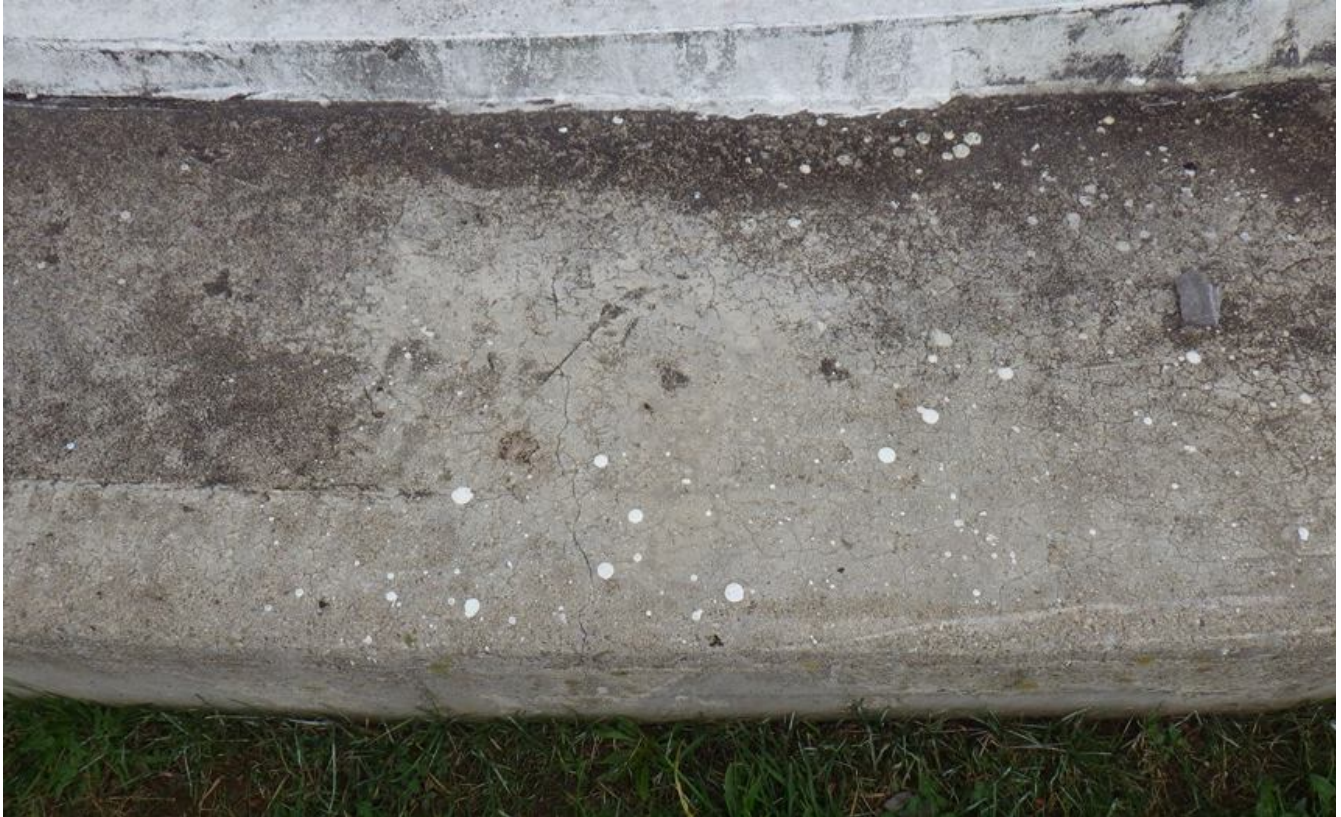
3. **Foundation:** The concrete tank foundation appeared to be in fair condition as hairline cracks and areas of exposed aggregate were observed. The foundation had the AWWA recommended projection of 6 in. to 12 in. above grade. No coating was visible on the exposed concrete surfaces at the time of this field evaluation except for drips from the tank coating. A large rock had been placed on the foundation. (See photos 11-13)

11. Crack in tank foundation.

12. Tank foundation.

3. **Foundation:** When the tank exterior is repainted, any unsound concrete should be chipped to sound material and the concrete should be brush-off blasted. Any deteriorated areas or voids found should have a bonding agent and a vinyl emollient modified concrete patching mortar applied to build up the surface to its original contour. The concrete should then be painted with a concrete sealer.

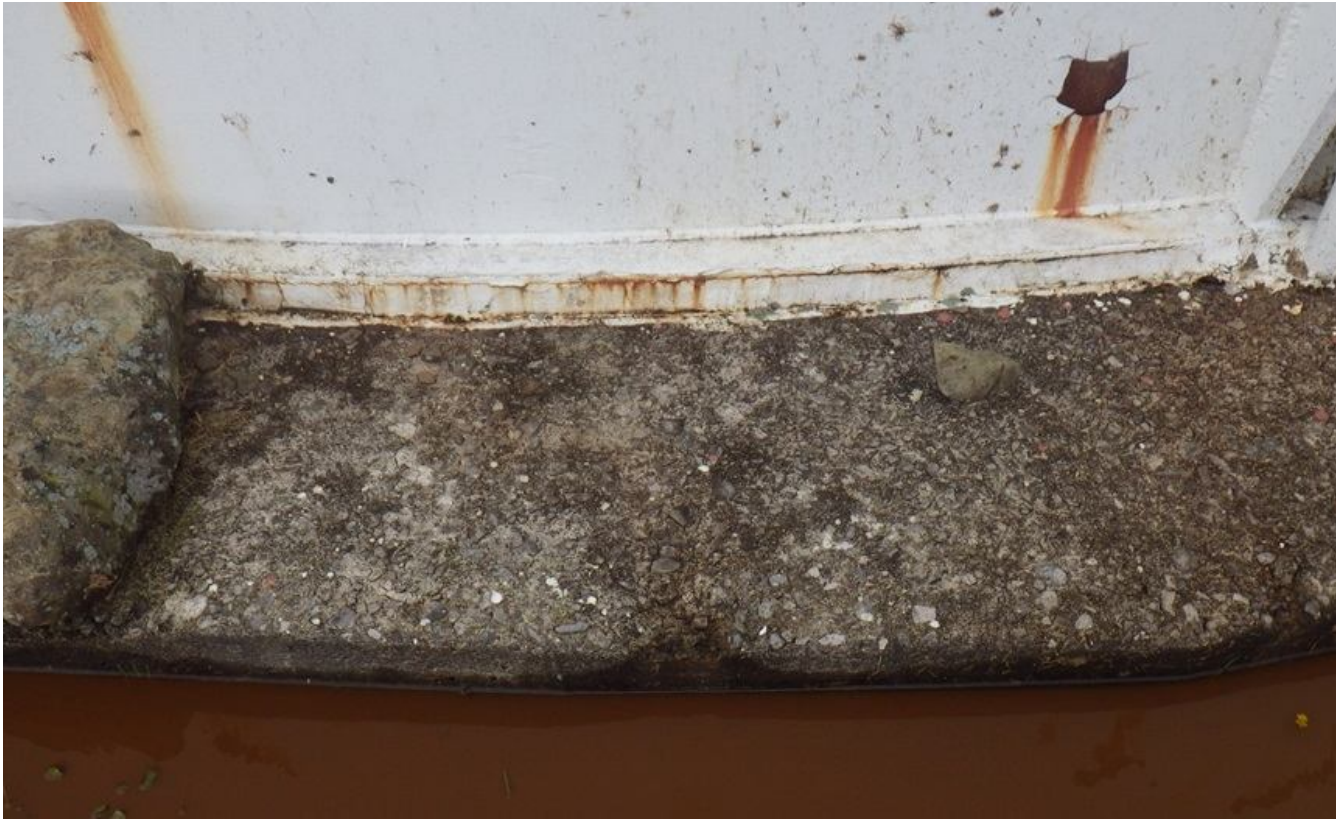
4. **Grout and Sealant:** There was a pad of grout between the tank bottom plate and the concrete foundation. Cracks were noted in the grout. Most of the grout was not visible due to the presence of a flexible sealant located around it. The sealant was loose in areas, and vegetation was noted at an area along the grout-to-bottom plate interface. (See photos 13-15)

2. **Bottom Plate:** The tank bottom plate extension appeared to be in nearly its original condition at the time of the field evaluation. Isolated spots of corrosion but no significant metal loss were observed along the edge of the bottom plate projection. (See photos 13-15)

13. Tank foundation.

4. **Grout Maintenance:** All loose grout should be chipped away to solid material when the tank is empty. Any shim plates which can be easily removed should be taken out. Any voids in the grout should be filled with a nonshrinking, nonstaining, structural grout material. The grout should be placed as far back under the bottom plate as possible and squared off vertically with the edge of the bottom plate. Any gap between the steel bottom plate and the grout should be filled with a flexible sealant.

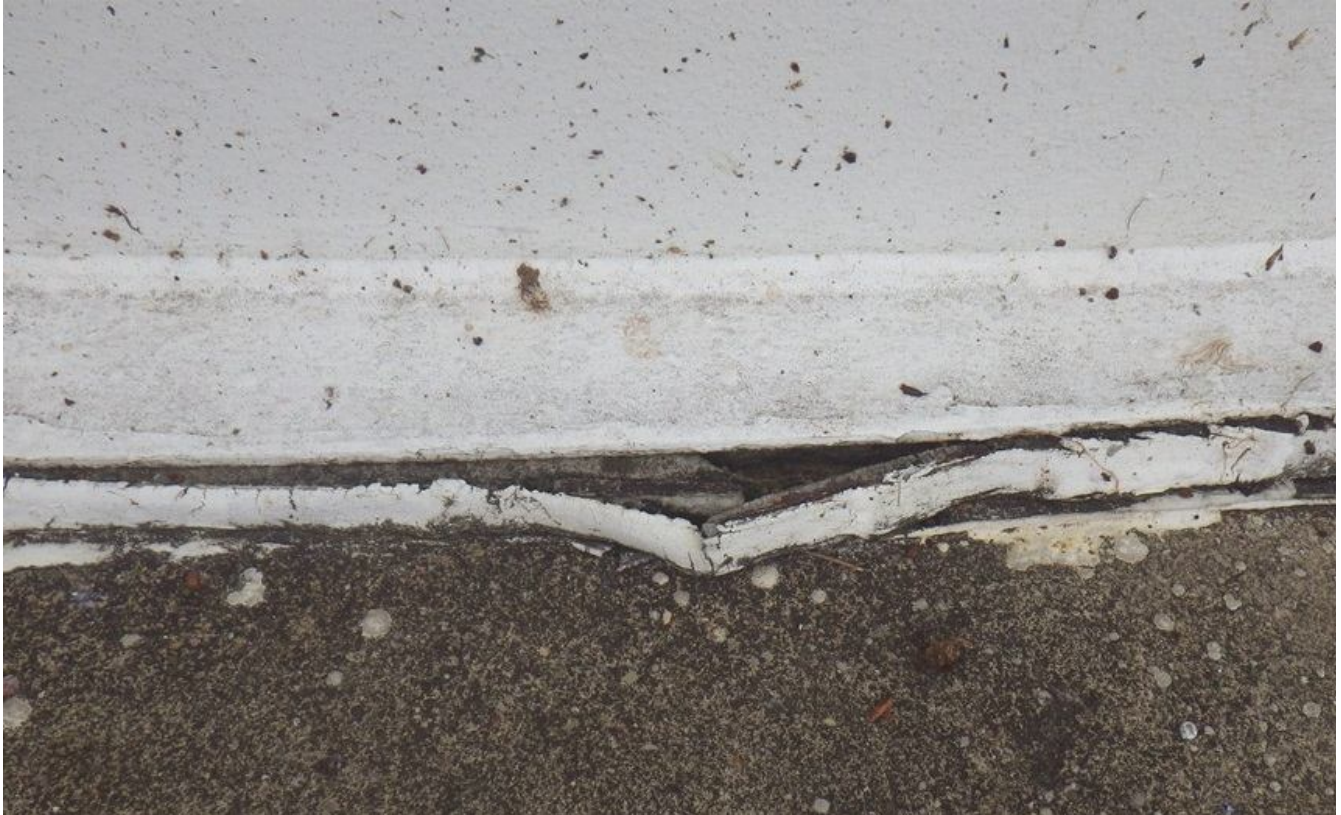
14. Peeled sealant along grout and bottom plate.

5. **Sealant Maintenance:** When the exterior repainting is performed, the existing sealant located between the bottom plate and the foundation should be removed and replaced with a flexible polyurethane sealant.

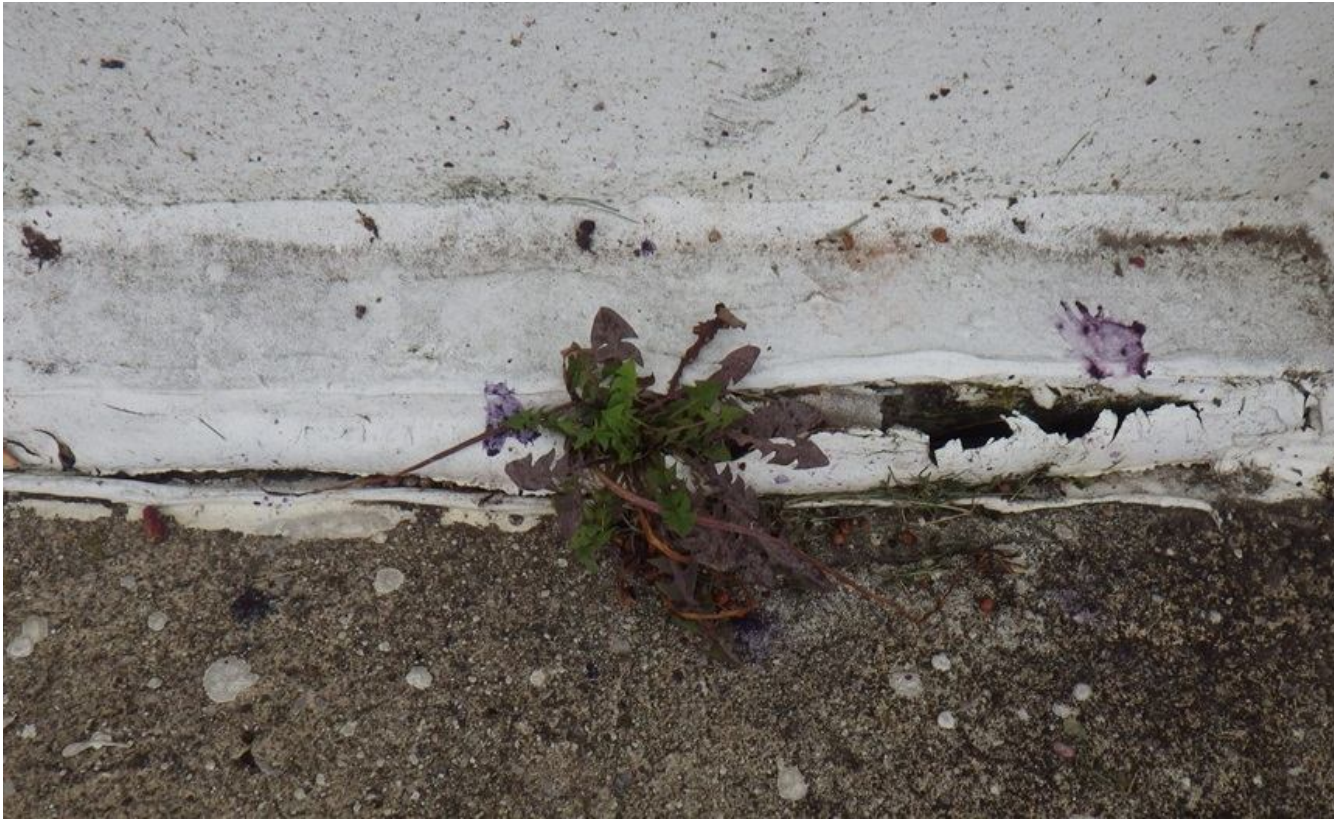
15. Vegetation at bottom plate.

1. **Site Maintenance:** The site should be maintained so that the top of the foundation projects a minimum of 6 in. to a maximum of 12 in. above grade and so that proper drainage away from the foundation occurs. Site maintenance should be performed with the mower discharge directed away from the base of the tank to prevent rock chips in the coating and the accumulation of debris on the foundation and within the anchor bolt chairs. Precautions should be taken when working around the propane tank on site.

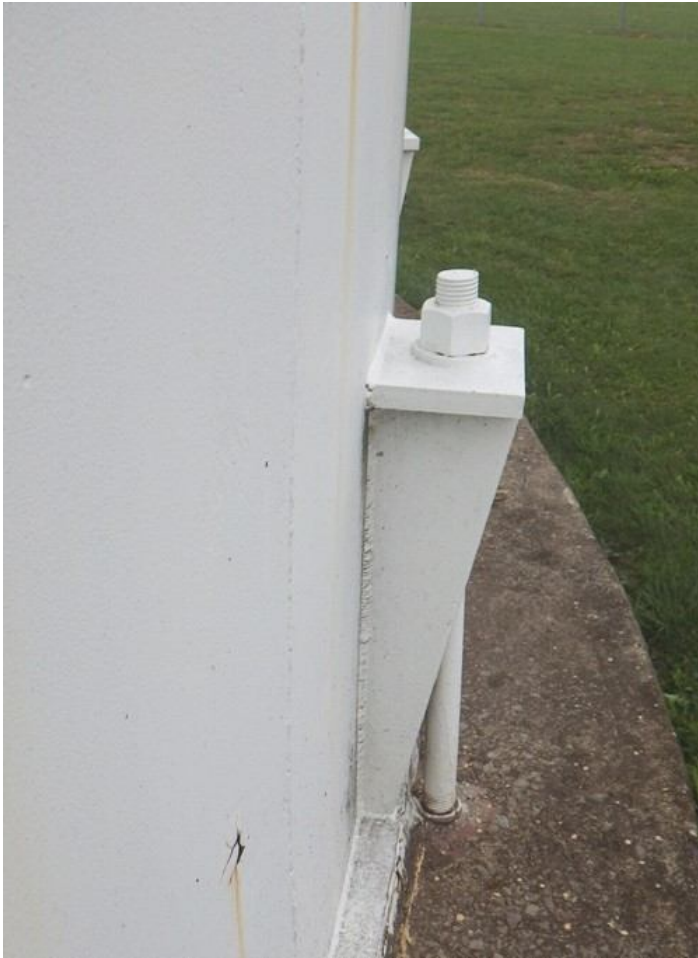
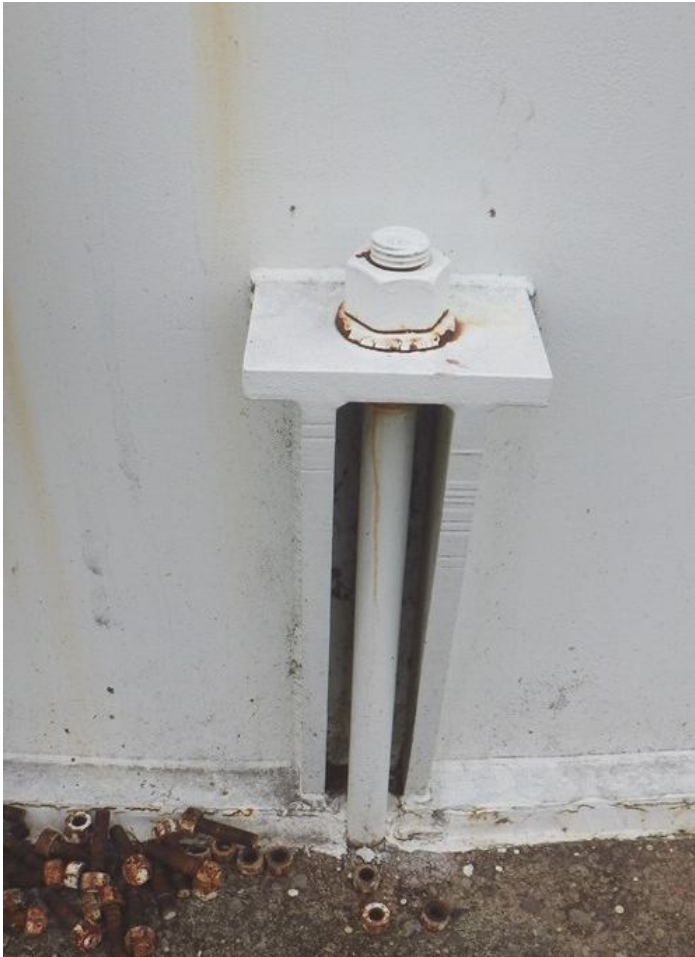
3. **Anchor Bolts and Chairs:** The tank was equipped with 20 anchor bolts and chairs. Some spots of peeled coating and rust were observed on the anchor bolt washers, and rust staining was noted on some of the anchor bolts. (See photos 16-17)

16. Anchor bolt and chair.

17. Anchor bolt and chair.

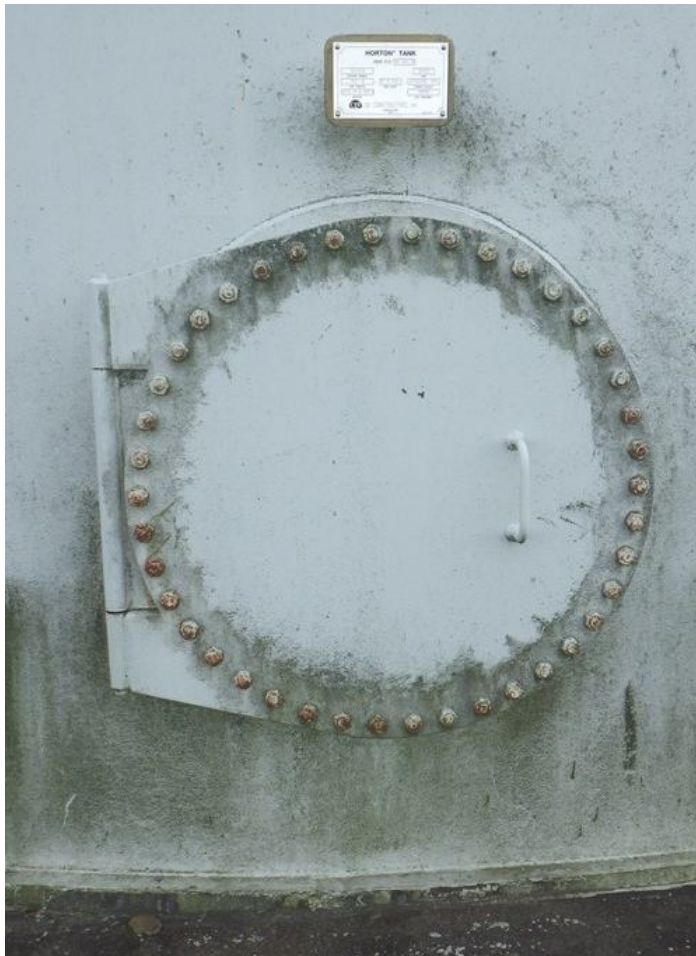
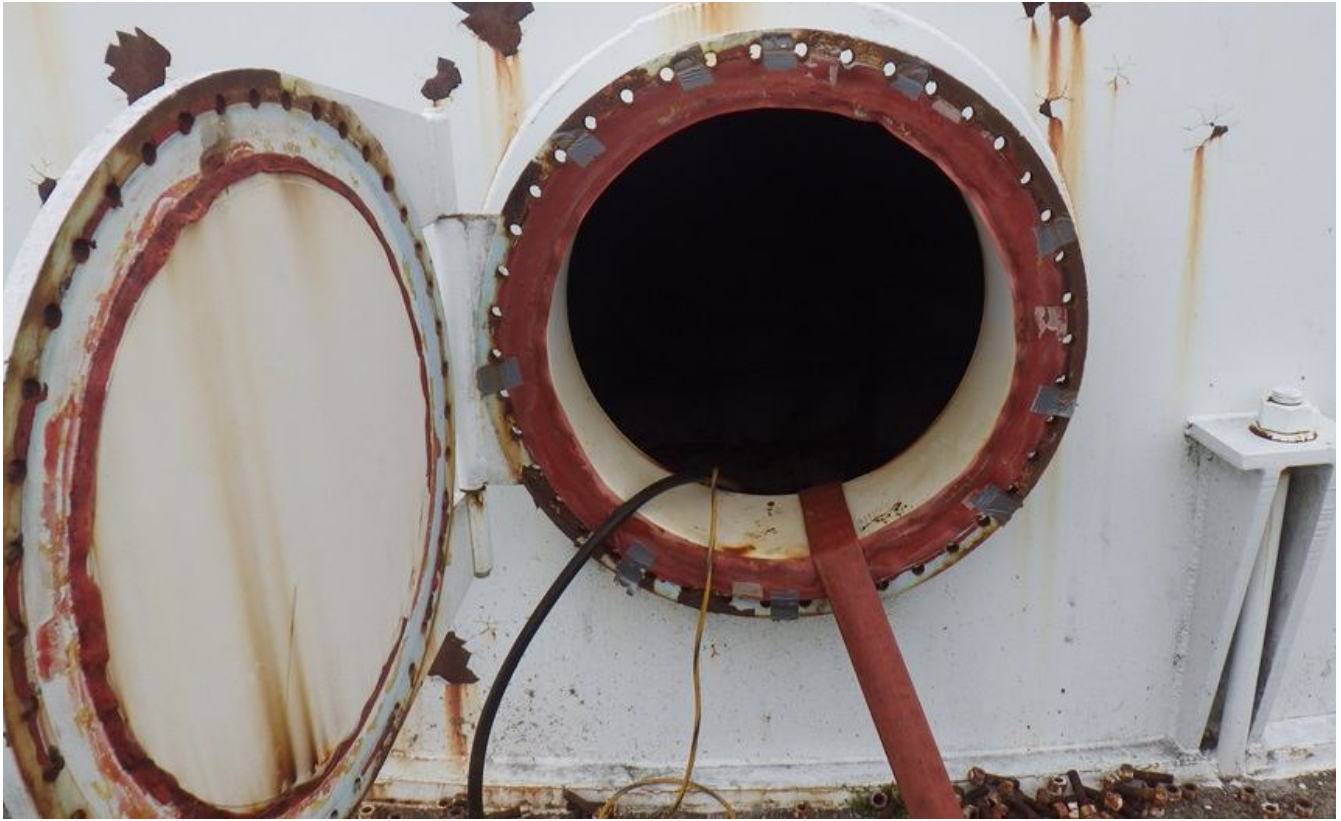
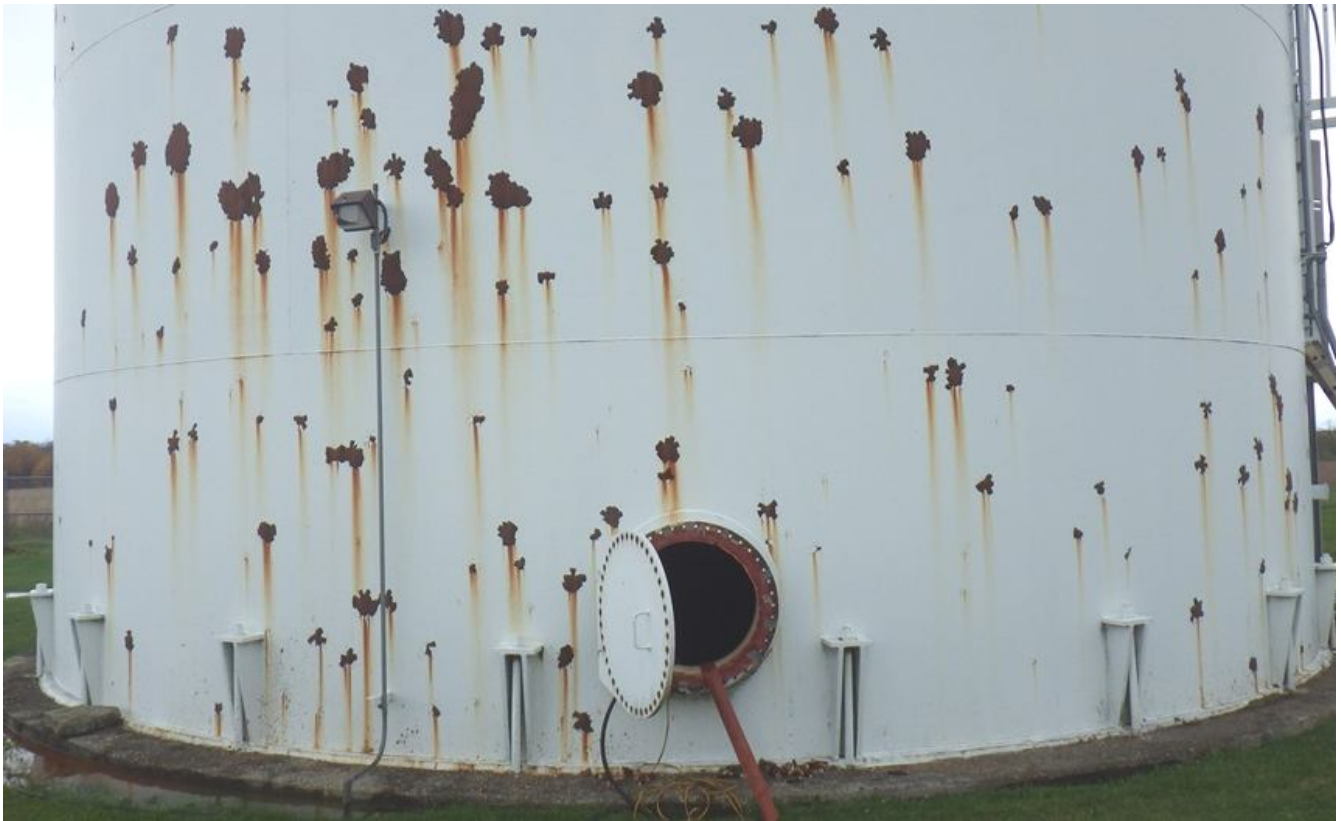
5. **Shell Manholes:** The tank was equipped with two flanged and bolted circular manholes located on the north and south sides of the tank. The shell plate around each of the manholes was equipped with a circular reinforcing plate. The shell manhole covers were equipped with hinged support arms located on the exterior of the tank. Corrosion was observed on the flanges and bolts. (See photos 20-22)

20. Shell manhole and tank nameplate.

21. Shell manhole.

22. Shell manhole and light fixture. Note coating failures and rust on shell.

13. **Existing Shell Manholes:** At the time of recoating and repairs, the gaskets for the shell manholes should be replaced, and the bolts should be replaced with galvanized bolts.

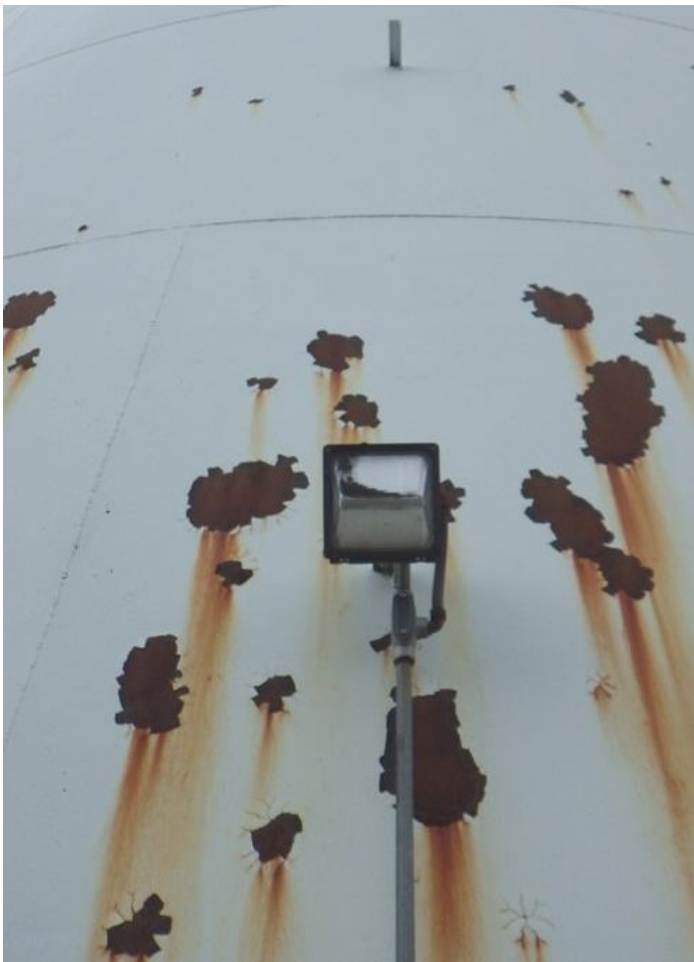
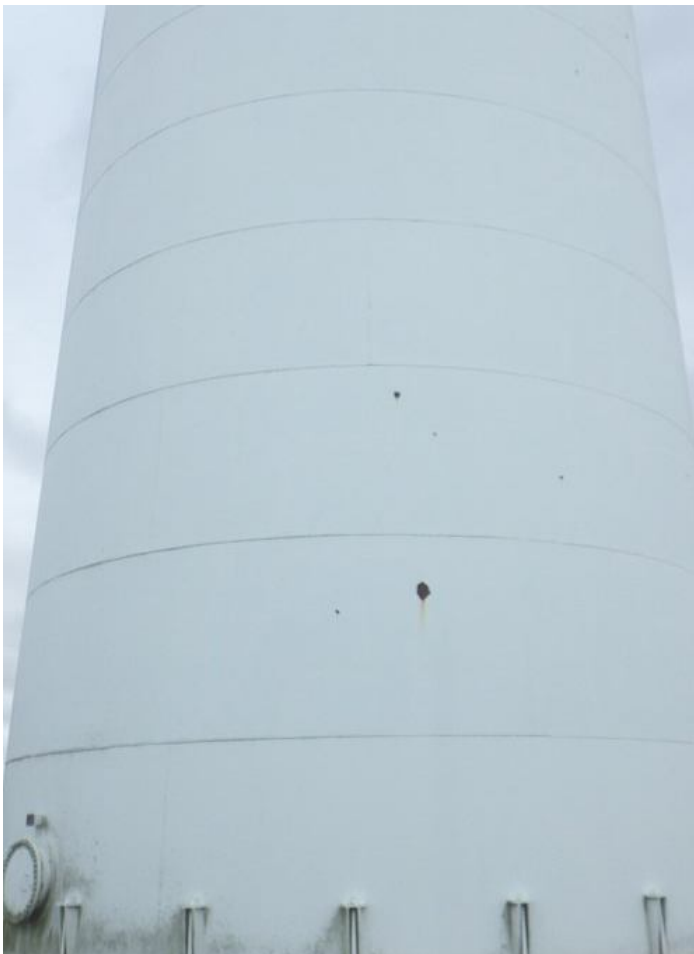
4. **Shell Condition:** The contour of the tank shell appeared adequate as no significant irregularities were observed at the time of this field evaluation. The coating appeared to be in very poor condition as numerous areas of peeled coating and corrosion were noted, primarily on the two bottom shell rings. The coating exhibited very poor adhesion to the steel. A conduit extended up a set of brackets located adjacent to the ladder. A security light was mounted near the base of the shell. The

23. Light fixture. Note coating failures and rust on shell.

24. Coating failures and rust on shell.

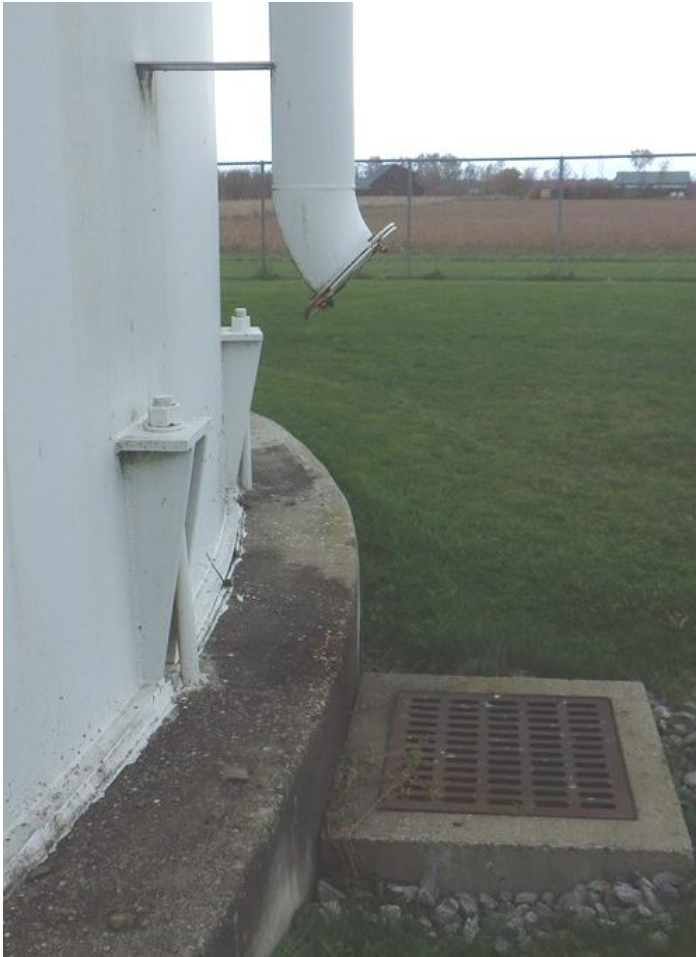
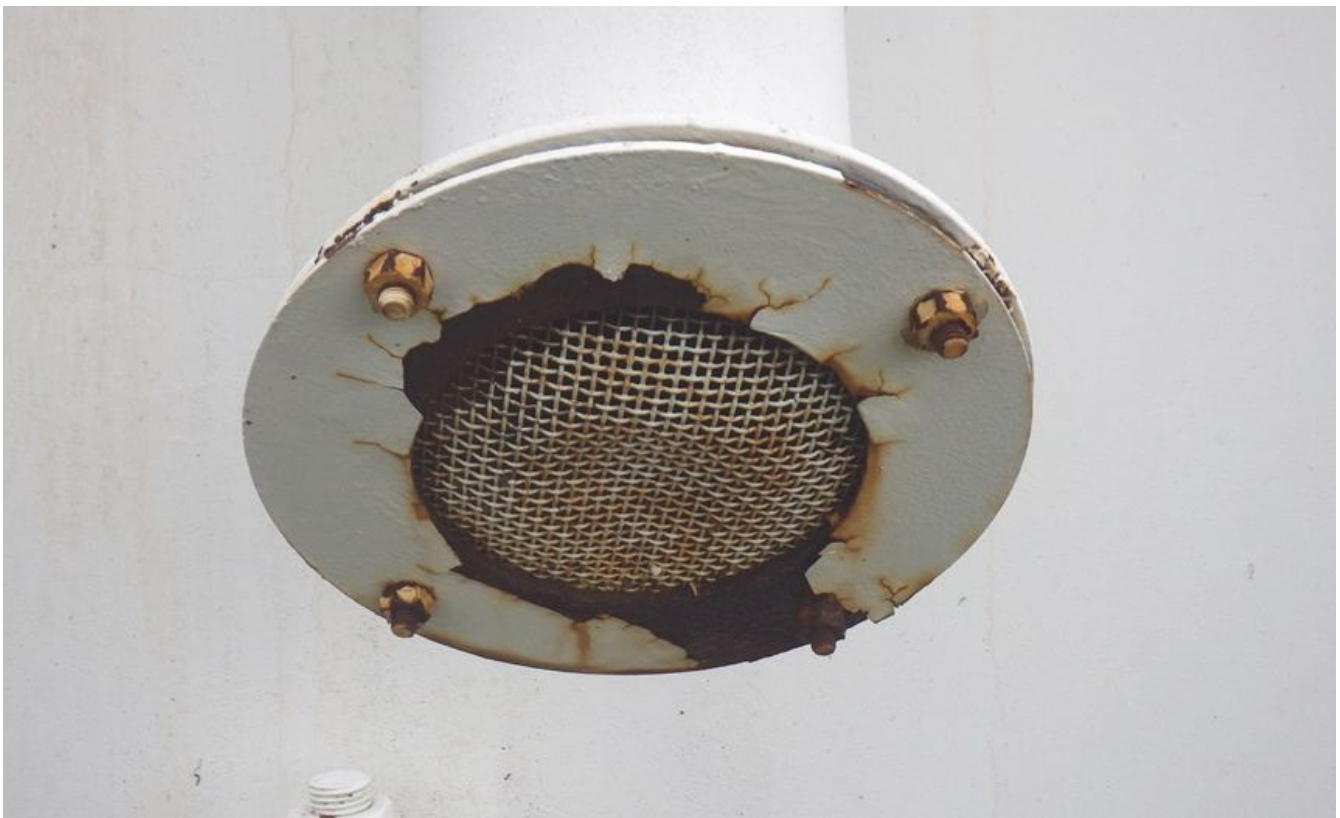
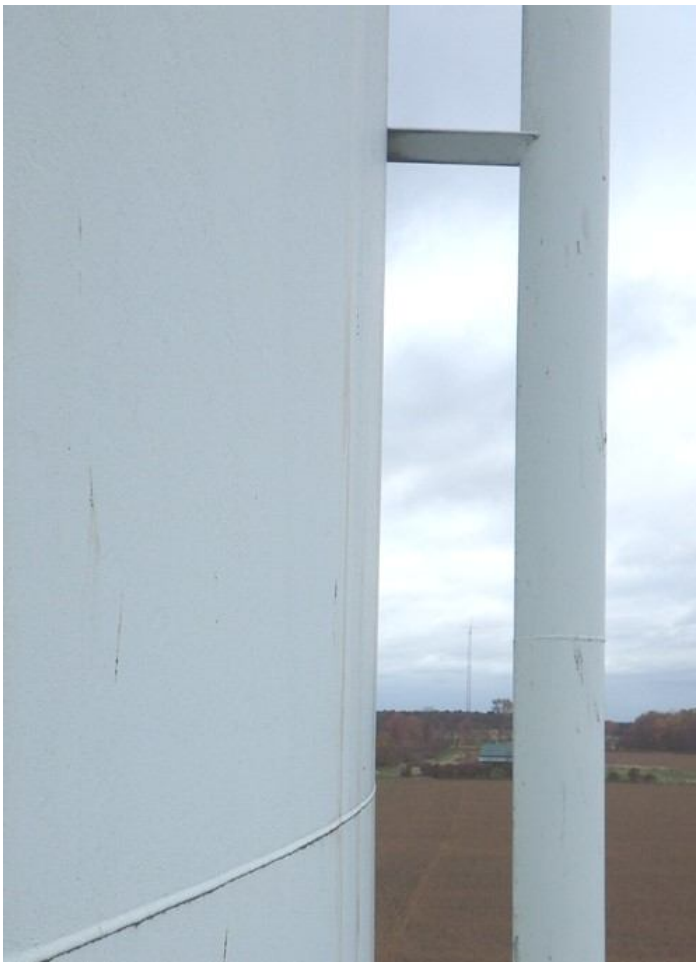
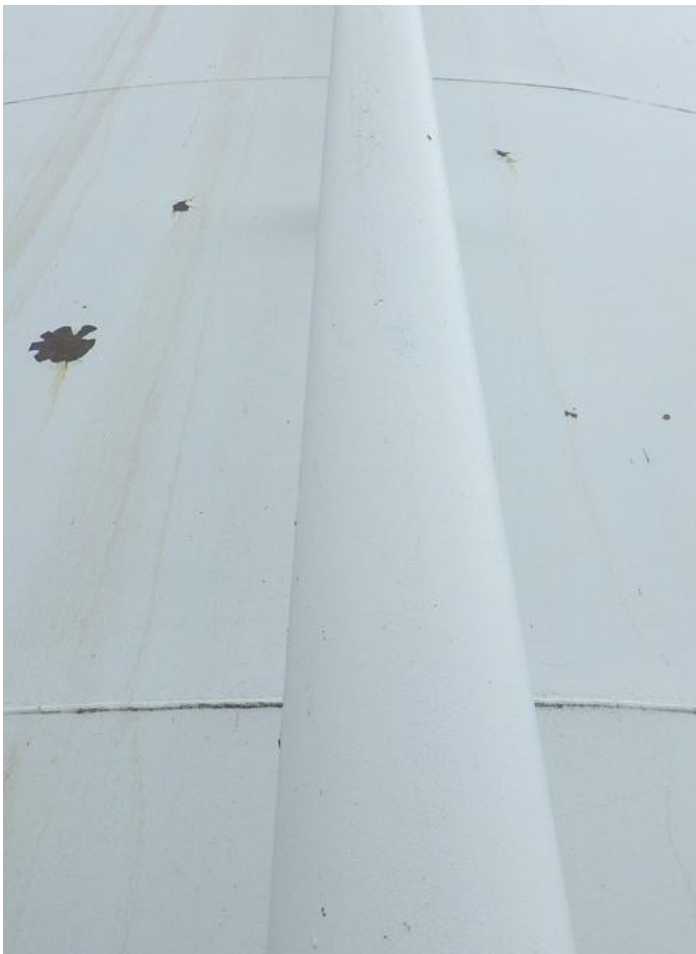
6. **Overflow Pipe:** The overflow pipe exited through the top shell ring and extended down the shell before discharging above a grate-covered drain basin. The discharge end was screened, and rust was observed on the flange for the screen. The pipe was equipped with welded steel brackets which appeared to be in their original structural condition at the time of this field evaluation. (See photos 25-28)

25. Overflow pipe discharge above drain basin.

26. Screen at discharge end of overflow pipe. Note rust on flange.

27. Overflow pipe.

28. Overflow pipe.
