## **Town of Boston Wohlhueter Tank Improvements**

**February 2020**

**EVALUATION OF THE  
672,000 GALLON STEEL STANDPIPE  
“WOHLHUETER TANK”  
COLDEN, NEW YORK  
FOR  
ERIE COUNTY WATER AUTHORITY  
BUFFALO, NEW YORK**

October 25, 2017

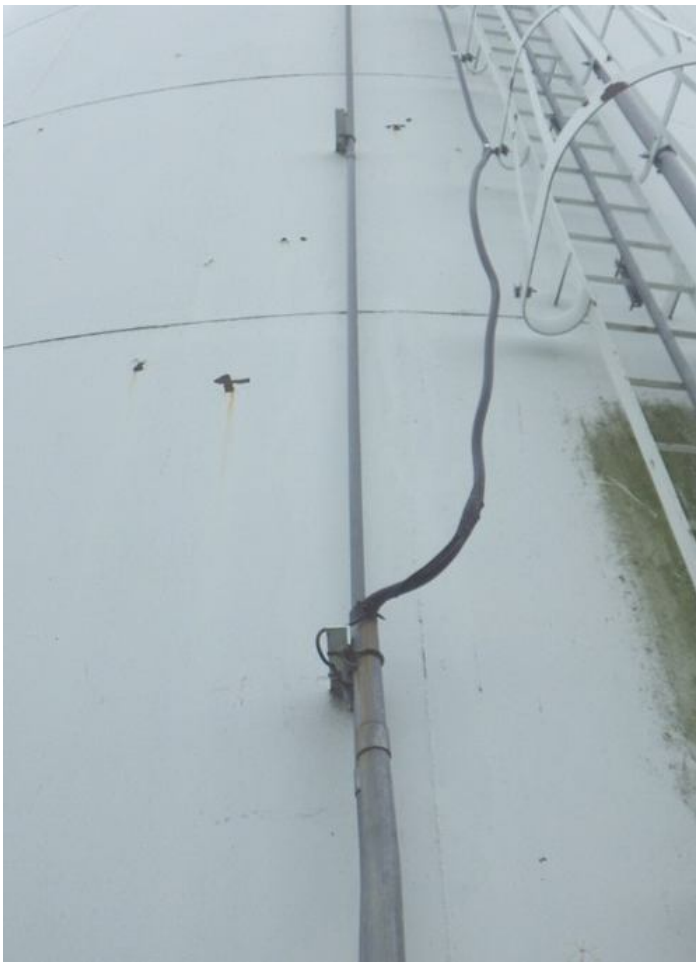
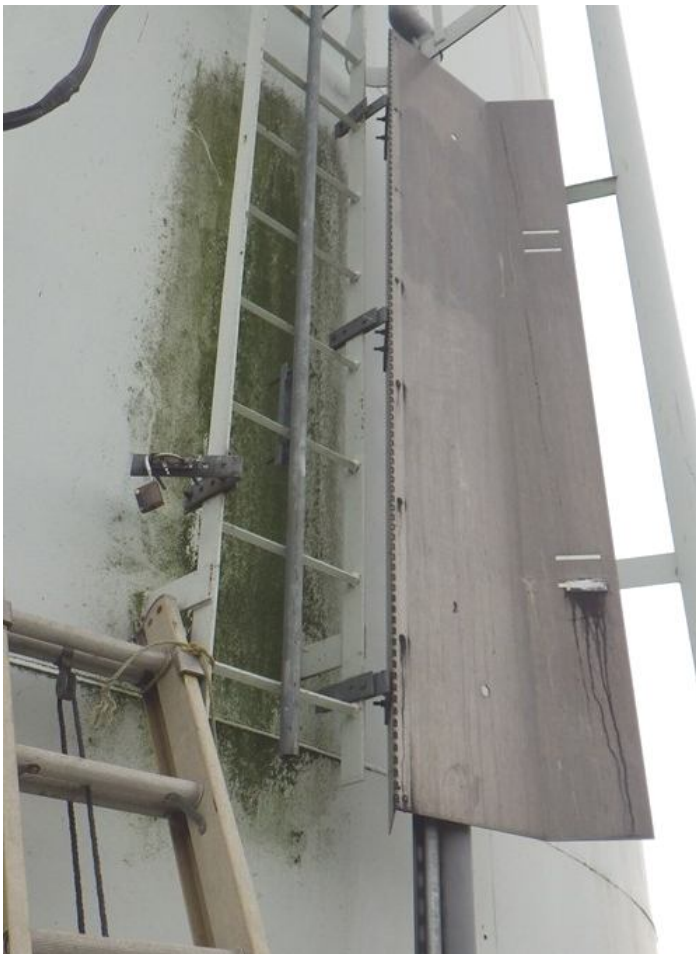
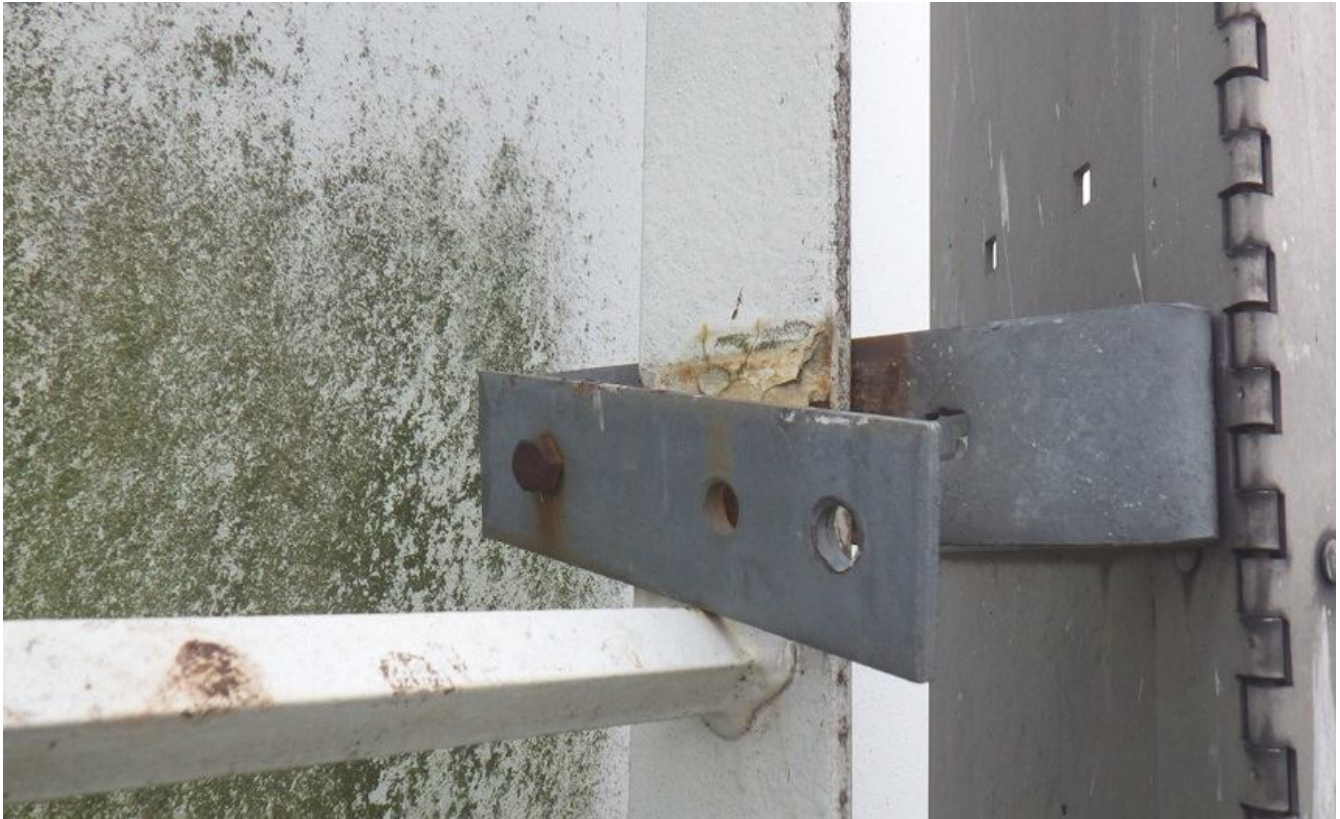
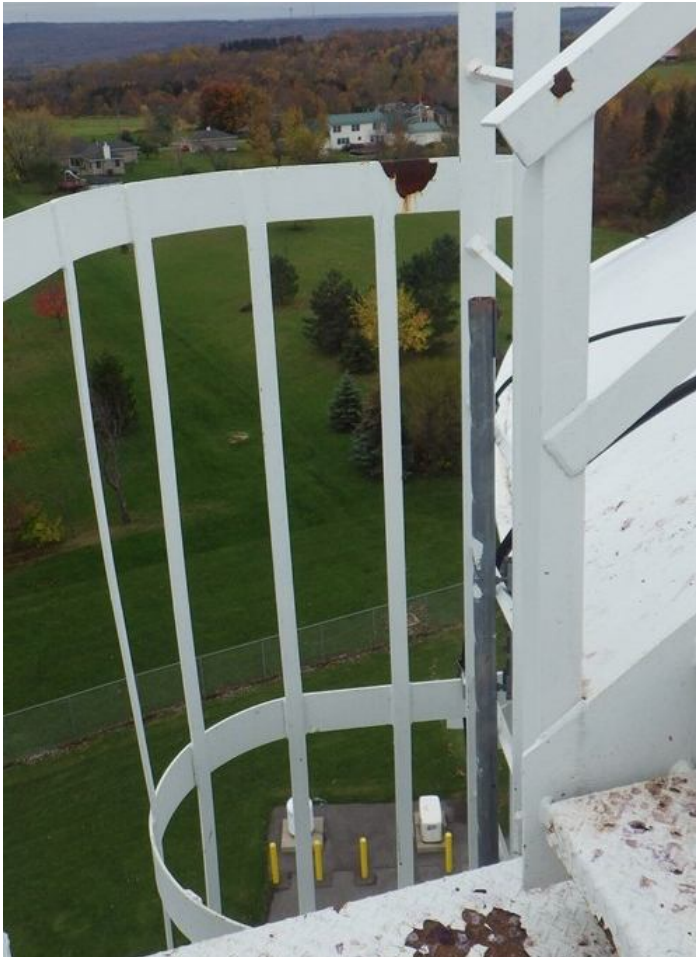
7. **Exterior Ladder:** **There was a safety and OSHA deficiency noted: the 26 in. depth of the ladder safety cage did not precisely meet the required 27 in. minimum.** The exterior ladder was welded to brackets which were welded to the shell. The ladder and brackets appeared to be in nearly their original structural condition at the time of this field evaluation. The ladder was equipped with a notched-tubular safe-climbing device and a safety cage which was constructed of welded flat bar members. Spots of corrosion were observed on the ladder safety cage, and a coaxial cable was clamped to the cage. The bottom of the ladder was equipped with a locked aluminum ladder gate-type vandal deterrent. The top bracket for the vandal deterrent was missing a bolt and was loose. No side plates were present along the ladder adjacent to the vandal deterrent. (See photos 19-31, 33)

29. Conduit and coaxial cable adjacent to shell ladder.

30. Shell ladder with vandal deterrent.

31. Unattached bracket for shell ladder vandal deterrent.

33. Shell ladder access to platform.

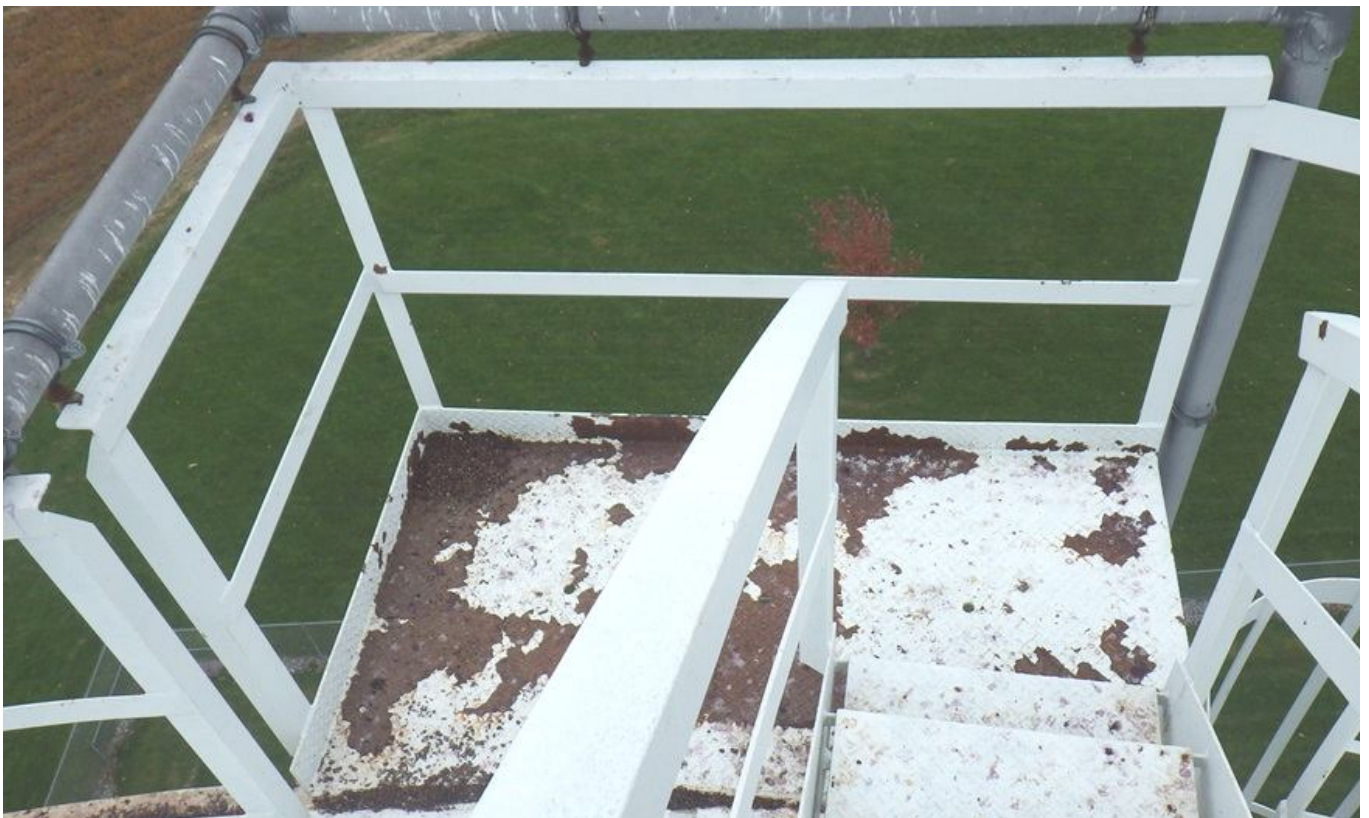
8. **Platform:** **There was a safety-related and OSHA deficiency noted: the access opening to the platform was not equipped with a self-closing gate to deter personnel from inadvertently falling from the platform.** A platform was located at the top of the exterior ladder and adjacent to the roof access. The platform was constructed of a diamond plate floor, and corrosion and debris were observed on the topside of the platform floor. Rust staining was observed on the underside of the platform floor. The platform was equipped with a safety railing which was constructed from welded and bolted angle and flat bar members. Spots of corrosion were noted on the safety railing. A PVC pipe extended along the top of the platform safety railing to the roof manhole. (See photos 33-34, 36)

34. Platform at roof.

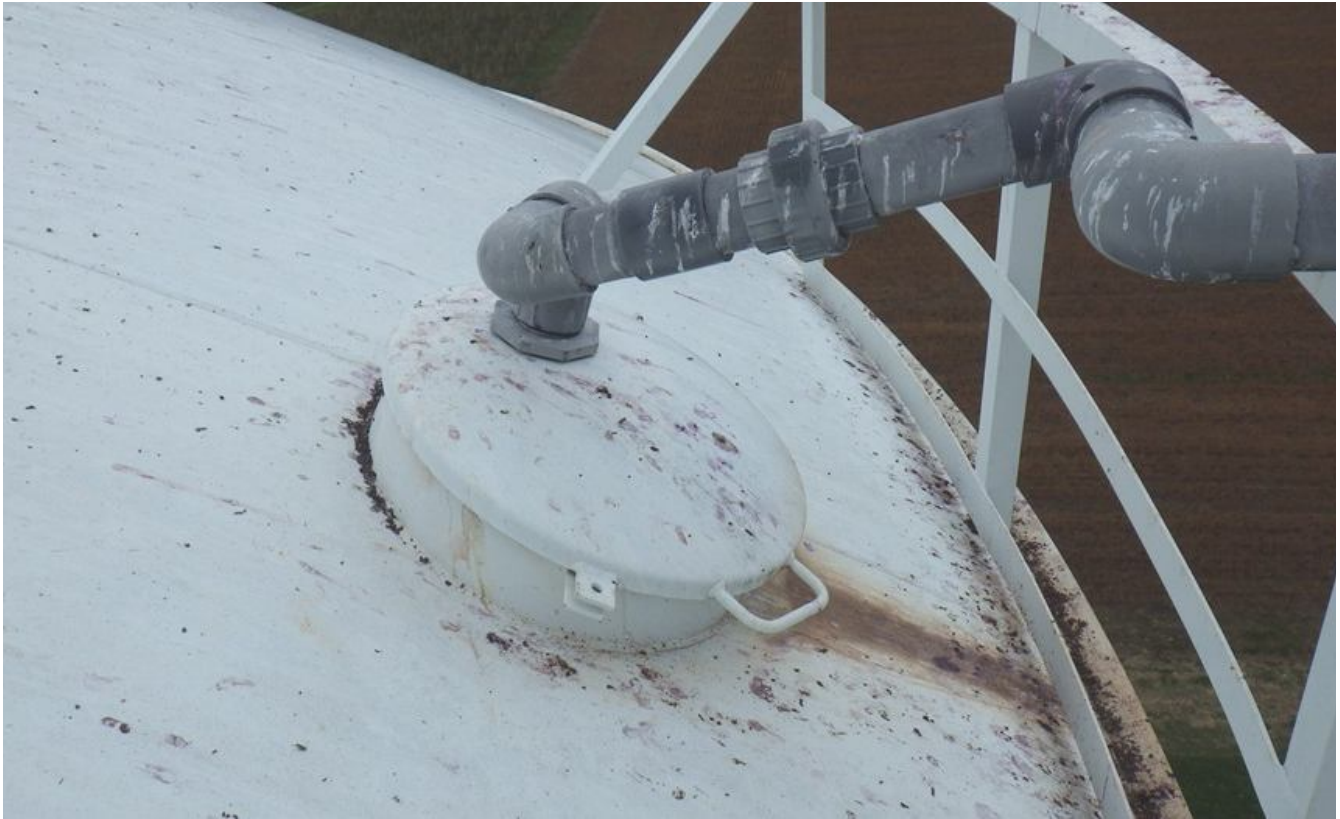
12. **Roof Manhole:** There were sanitary and AWWA deficiencies noted: (1) the cover overlap of 1-1/4 in. did not meet the required minimum of 2 in., and (2) the roof manhole was not locked. The roof was equipped with one manhole which had a hinged cover. The roof manhole was not locked prior to and after this evaluation. A 3 in. diameter PVC pipe penetrated the roof manhole cover which prevented personnel from accessing the manhole at the time of the field evaluation. (See photos 35-36)

35. Pipe attached to hinged roof manhole cover.

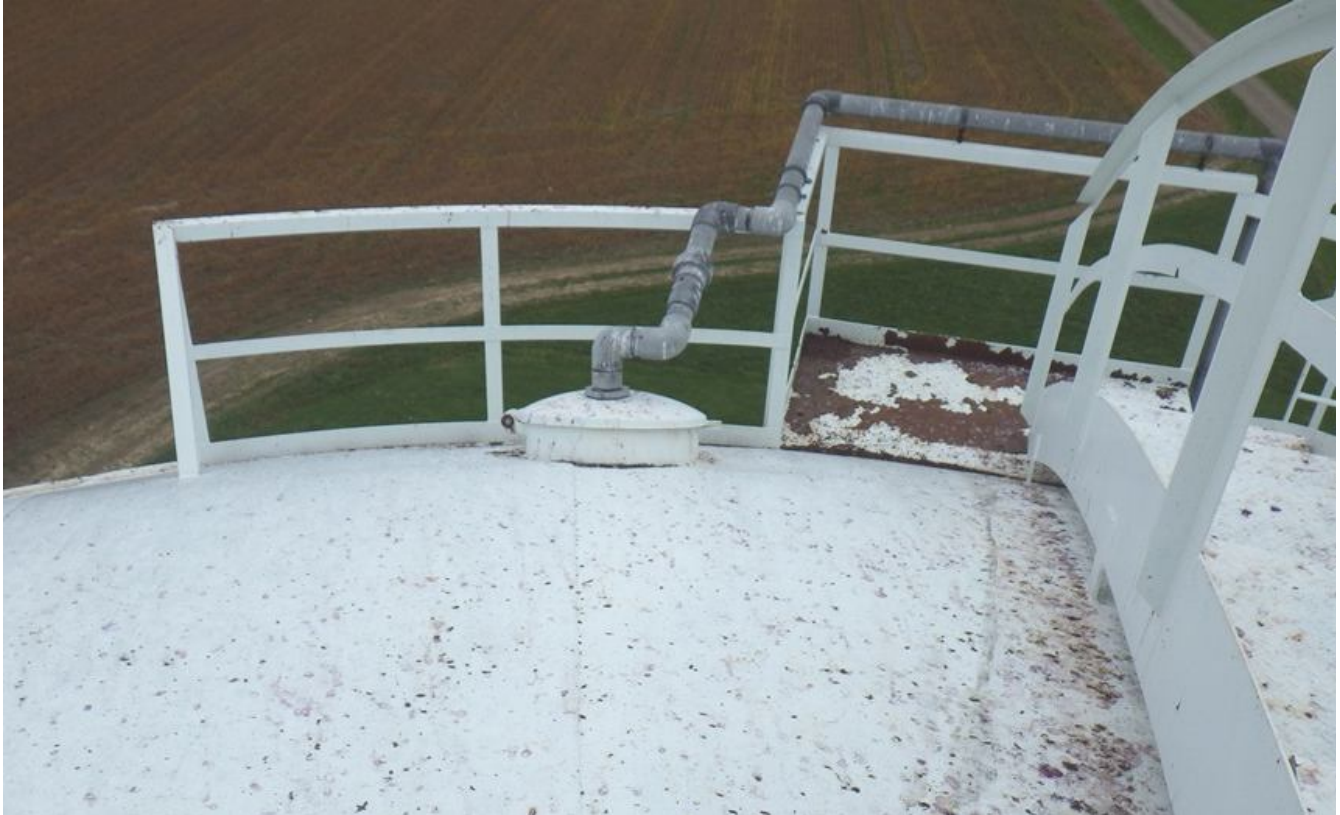
9. **Roof Safety Railings:** The roof was equipped with safety railings which extended along the edge of the roof adjacent to the roof manhole and around the roof vent at the center of the roof. The safety railings were constructed from welded angle and flat bar members. Spots of corrosion were noted on the safety railing members. An antenna was mounted on the safety railing adjacent to the roof vent, and a cable extended along the roof to the antenna. A lightning rod was attached to the antenna. A PVC pipe extended along the top of the safety railing located along the roof's edge to the roof manhole. (See photos 36, 42-45)

11. **Roof Stairs:** Stairs extended from the roof access to near the roof vent at the center of the roof. The stairs were equipped with safety railing which were constructed of welded angle and flat bar members. Minor rust and debris were observed on the stairs. A coaxial cable extended up the roof along the stairs. (See photos 36, 40-43)

36. Roof safety railing, platform, stairs, and pipe attached to hinged roof manhole cover.

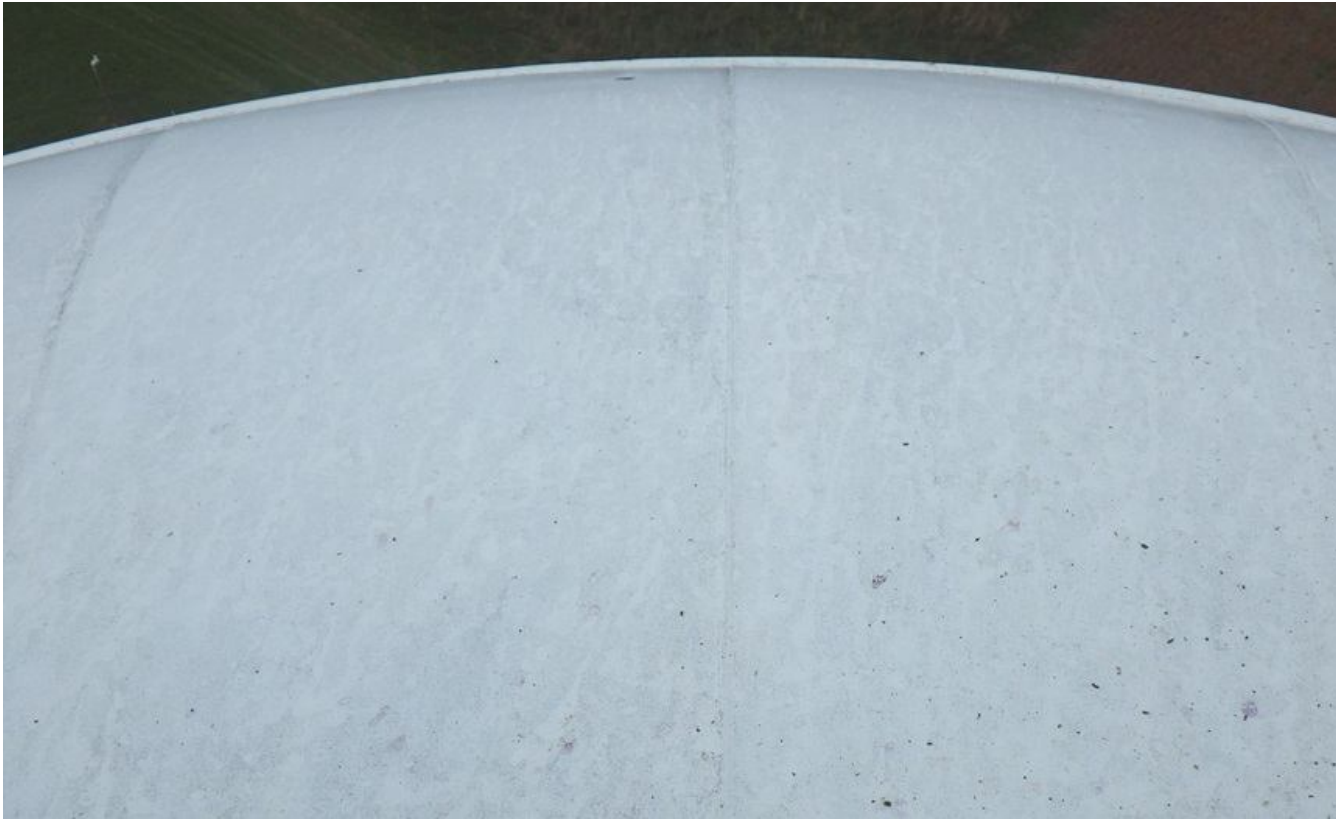
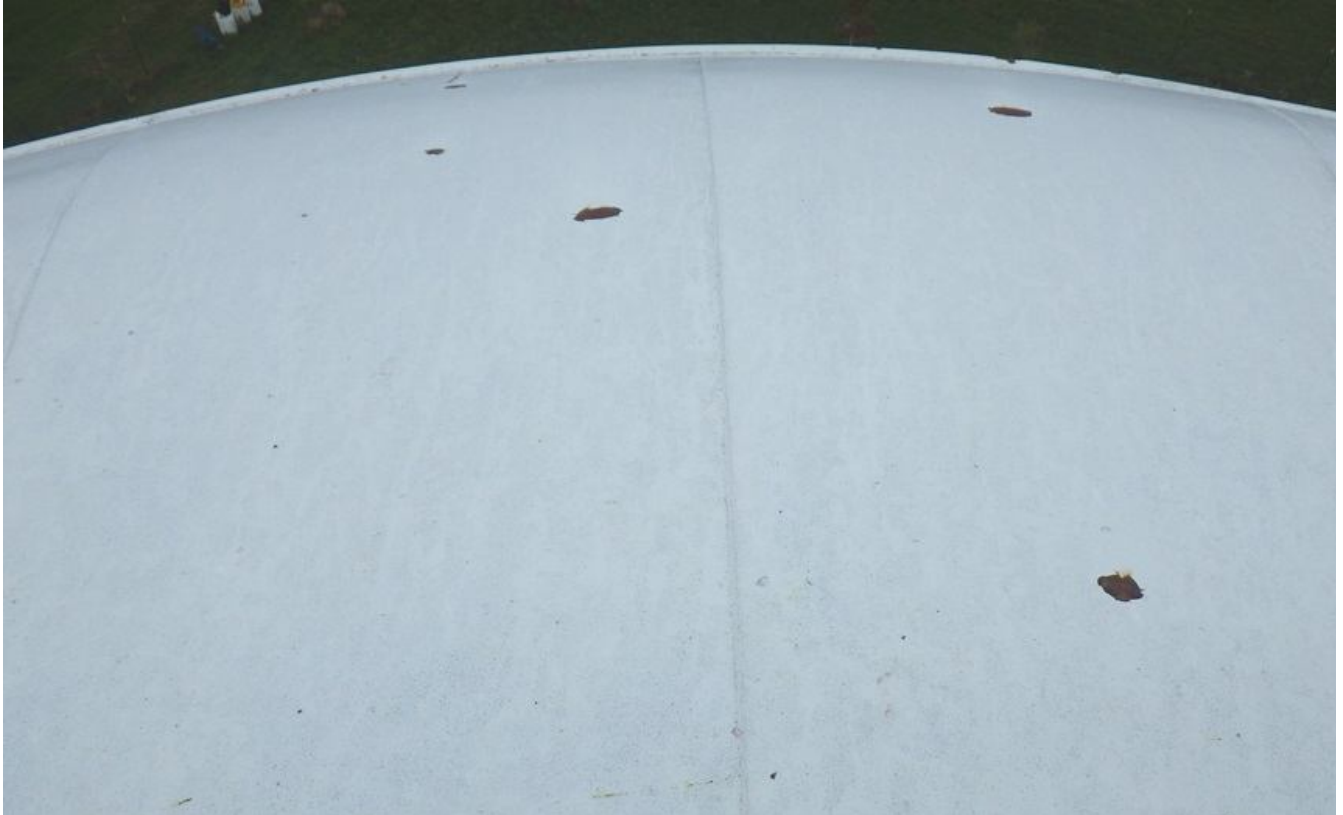
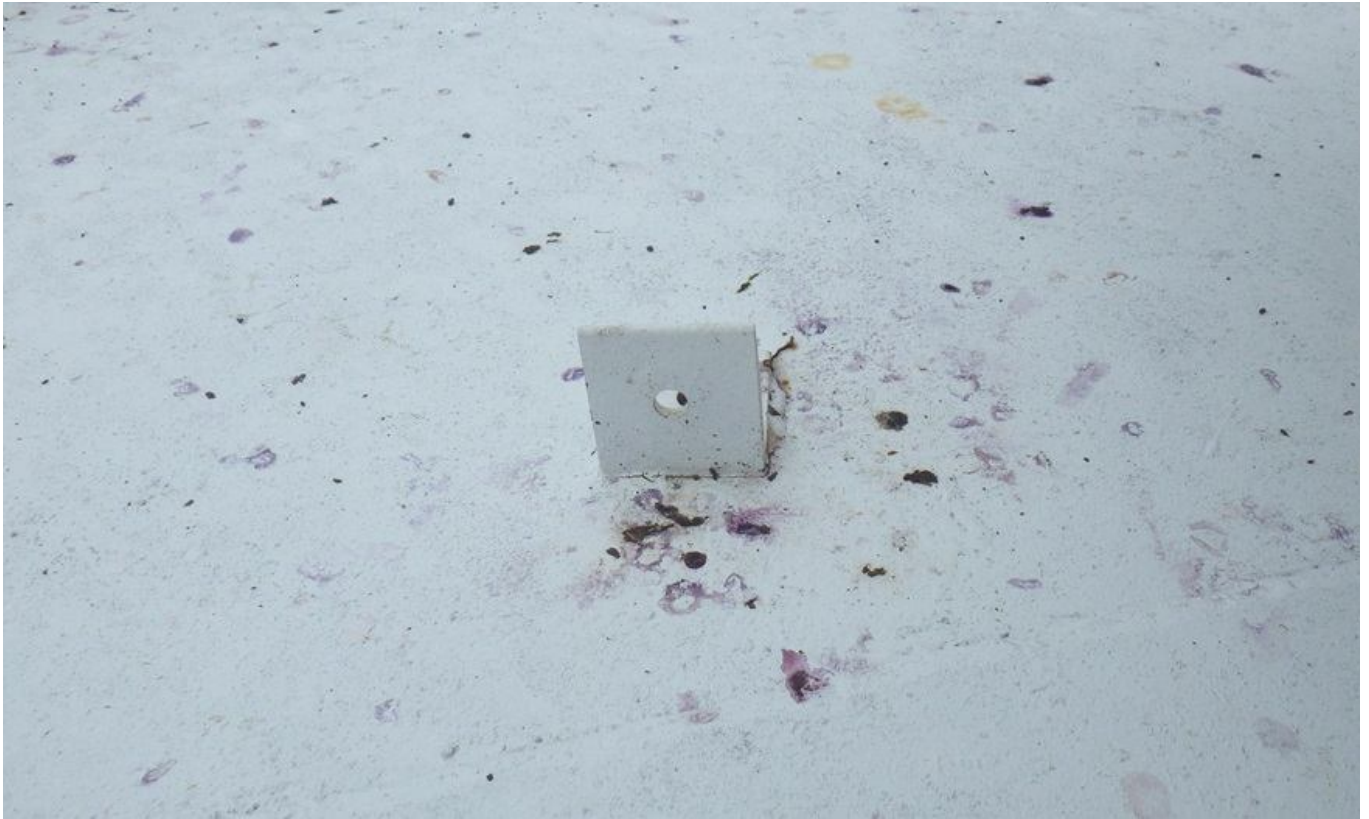
10. **Roof Condition:** The contour of the roof appeared adequate at the time of this evaluation. The roof coating appeared to be in fair to poor condition. Spots of peeled coating and rust were observed on the roof. The roof coating exhibited very poor adhesion to the steel. Two lugs were located on the roof cap on opposite sides of the roof vent. **It is the opinion of Tank Industry Consultants that the lugs should not be used for rigging purposes.** (See photos 37-39)

37. Exterior roof.

38. Coating failures and rust on exterior roof.

39. Lug on roof.

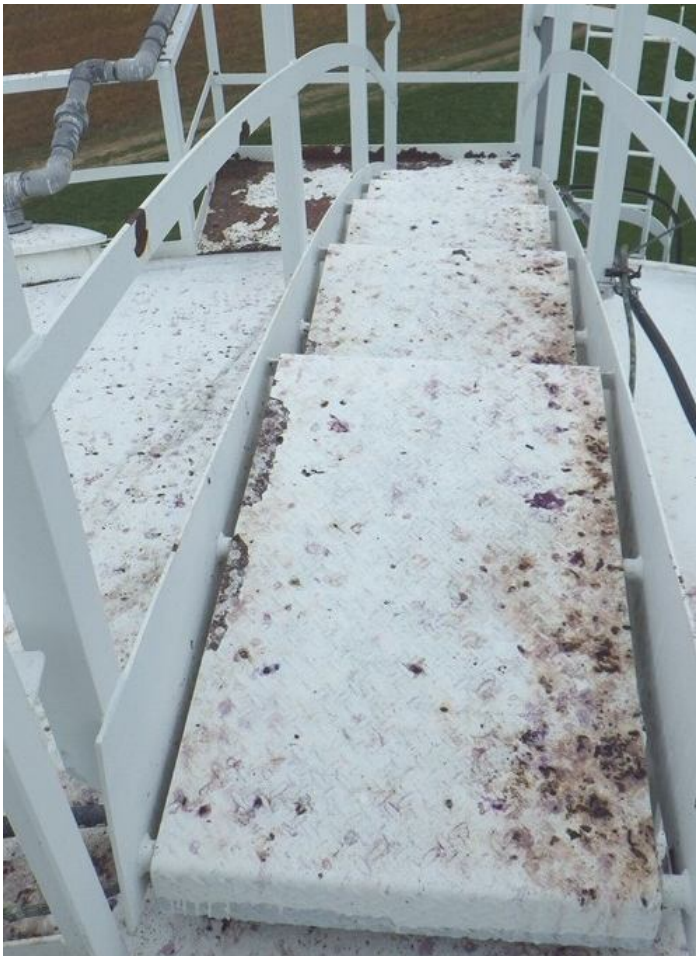
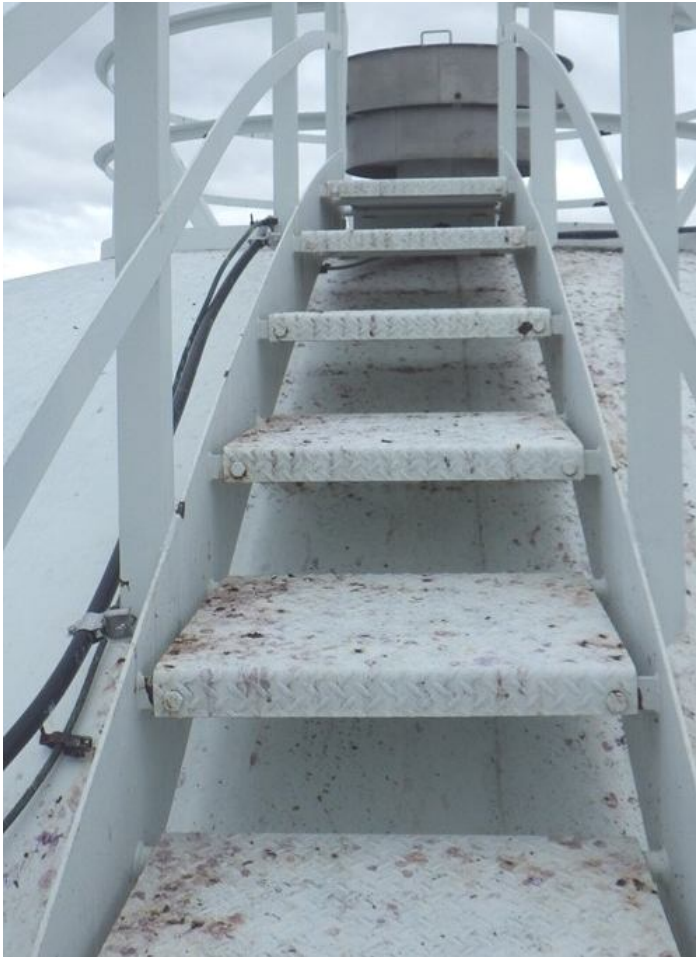
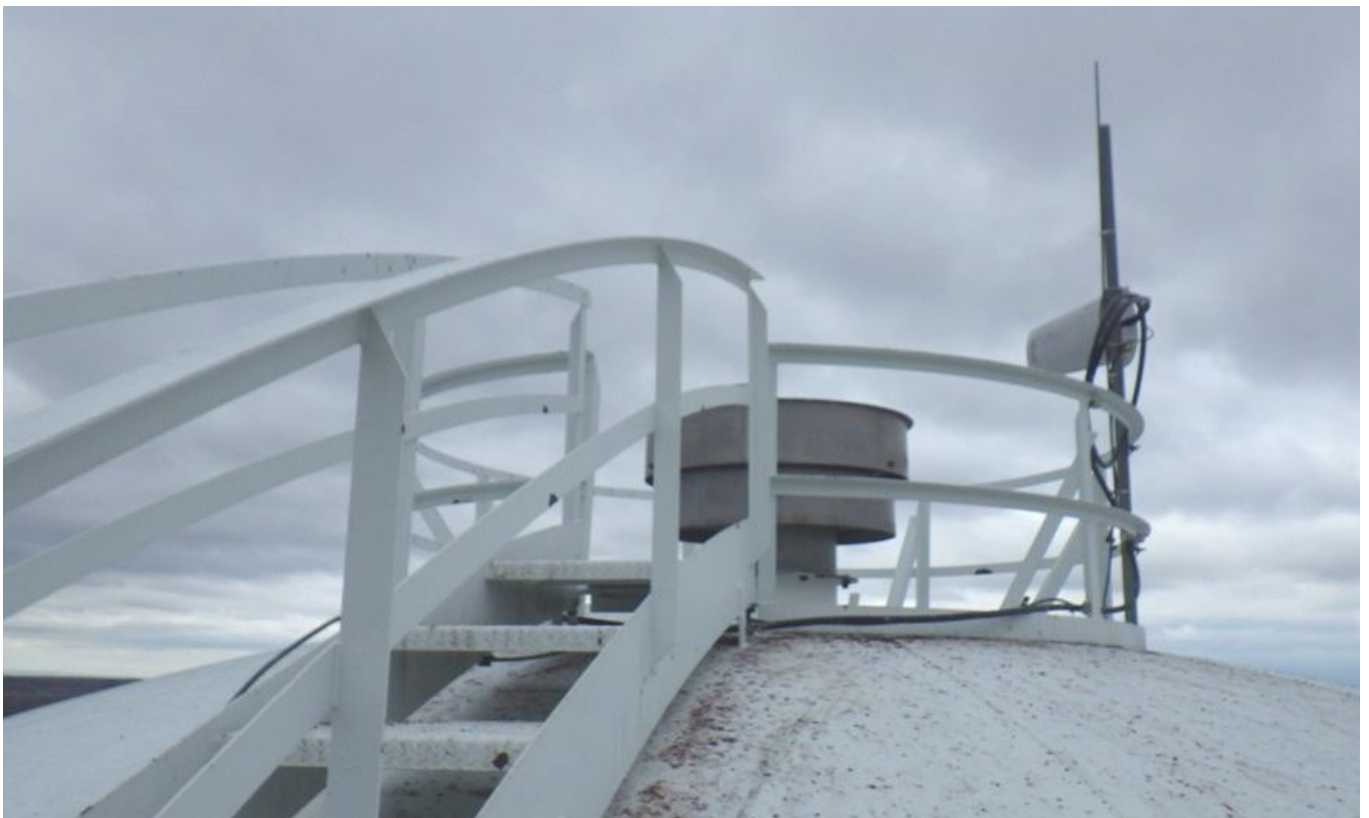
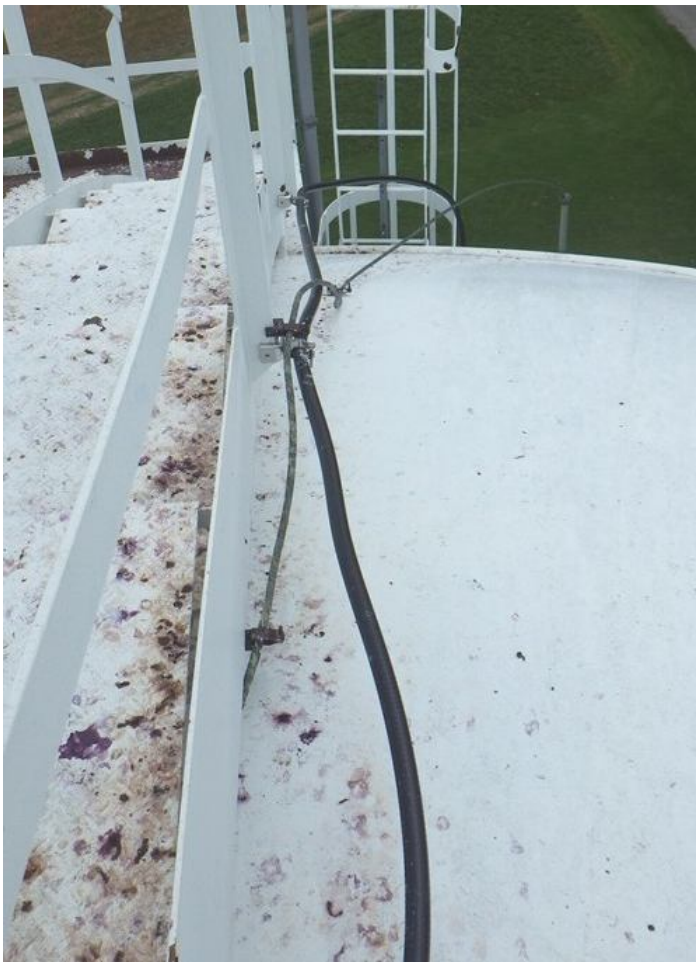
40. Roof stairs.

41. Stairs to roof vent.

42. Stairs, railing, roof vent, and antenna.

43. Coaxial cable along roof stairs.

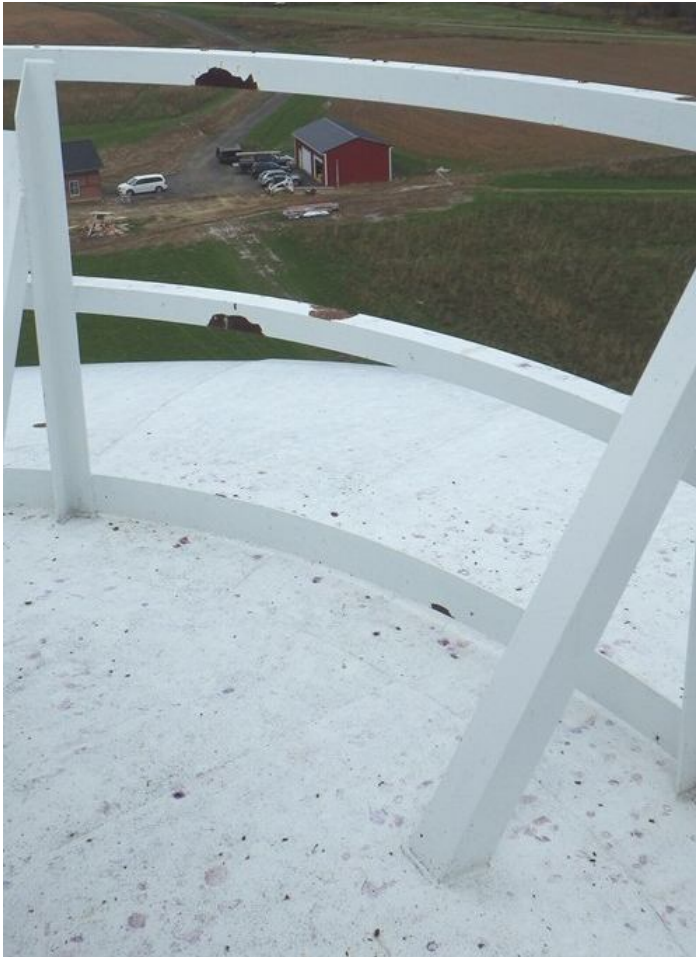
45. Rust on roof safety railing.

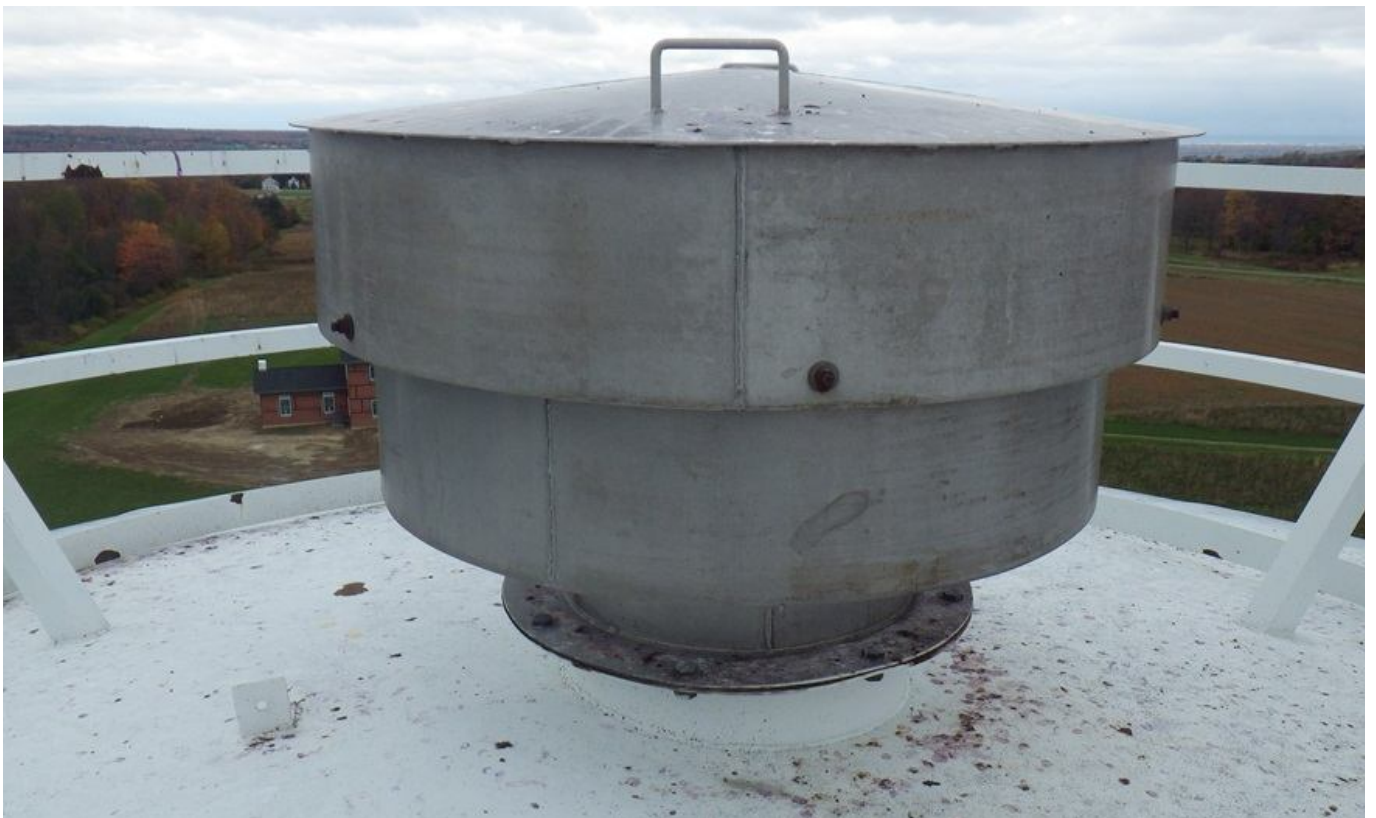
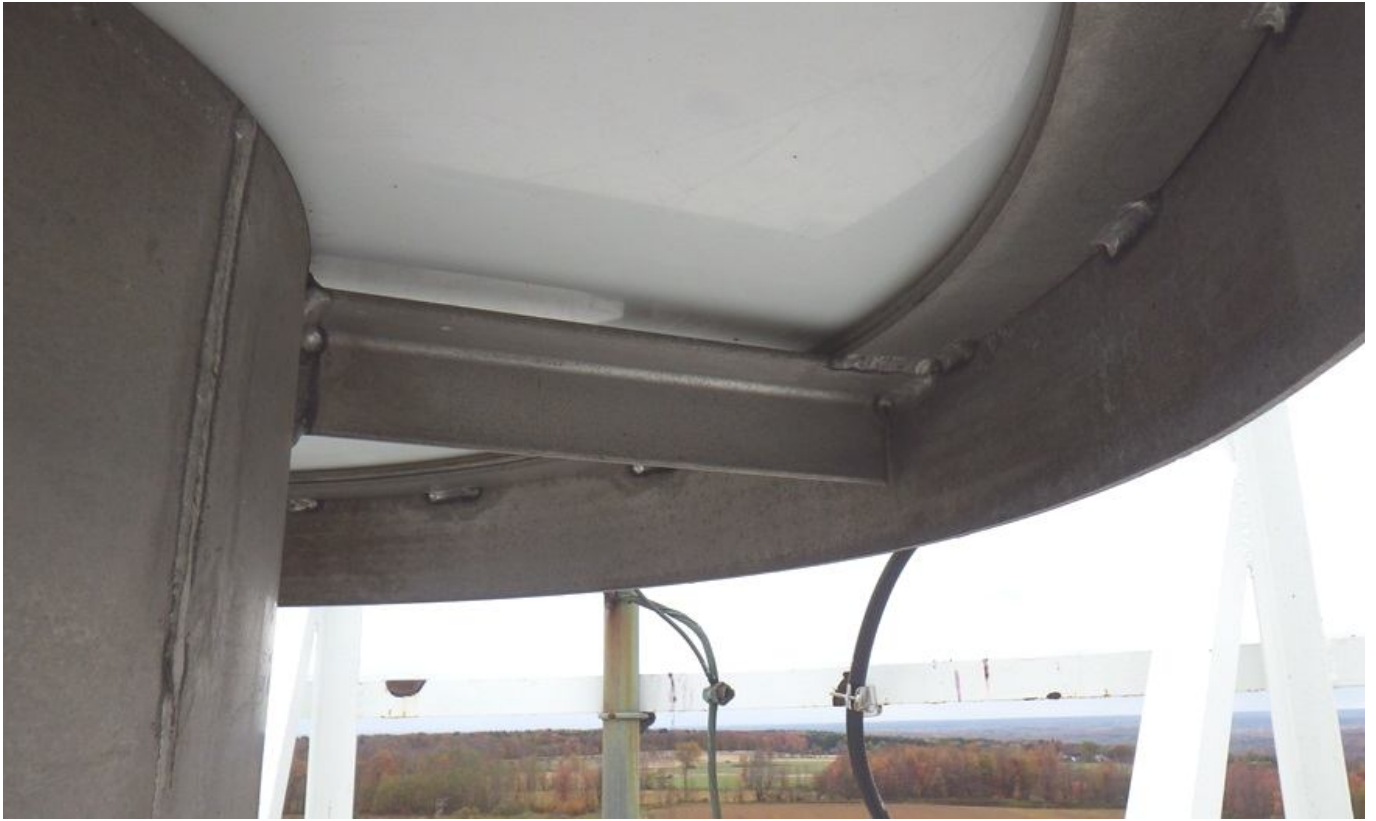
13. **Roof Vent:** There was a sanitary deficiency noted: gaps were located between the flanges for roof vent where a flange was bent. What appeared to be a clog-resistant vent was mounted to a flanged opening located in the approximate center of the roof. The aluminum vent appeared to be equipped with pallets which would facilitate ventilation during filling or draining of the tank. The proper operation or design of the pallets was not verified during this evaluation. Handles were located on the roof vent cover. **It is the opinion of Tank Industry Consultants that the handles should not be used for rigging purposes.** (See photos 46-47)

46. Roof vent.

47. Roof vent pallet.

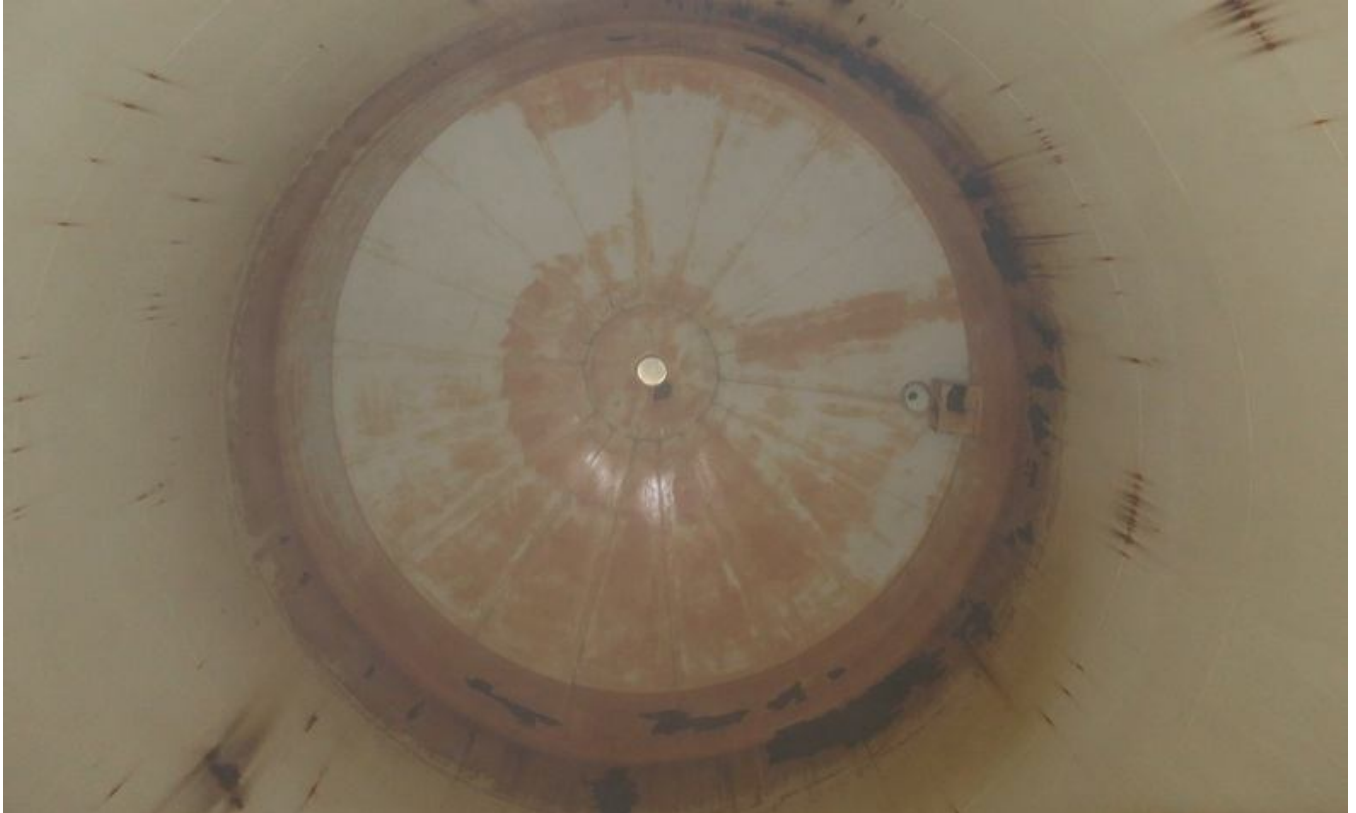
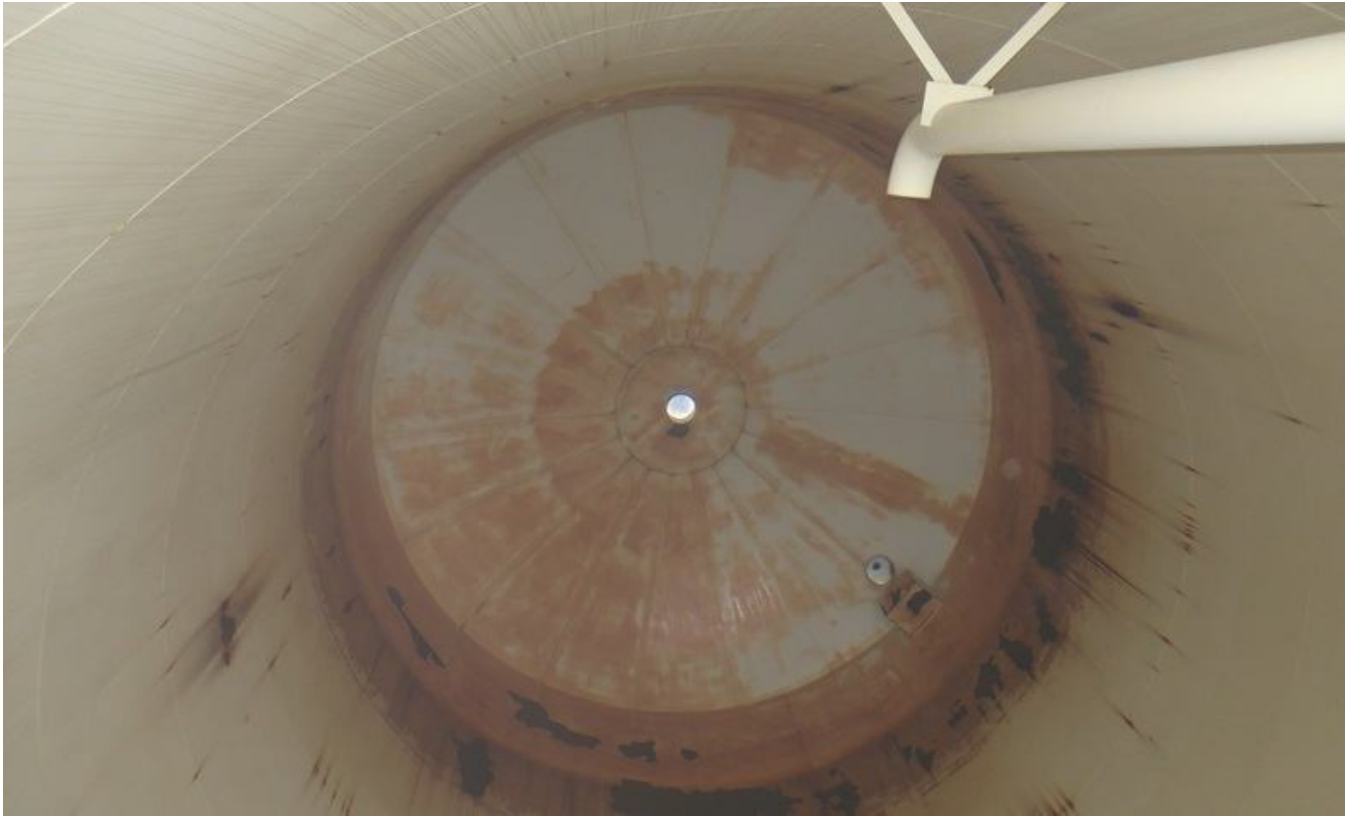
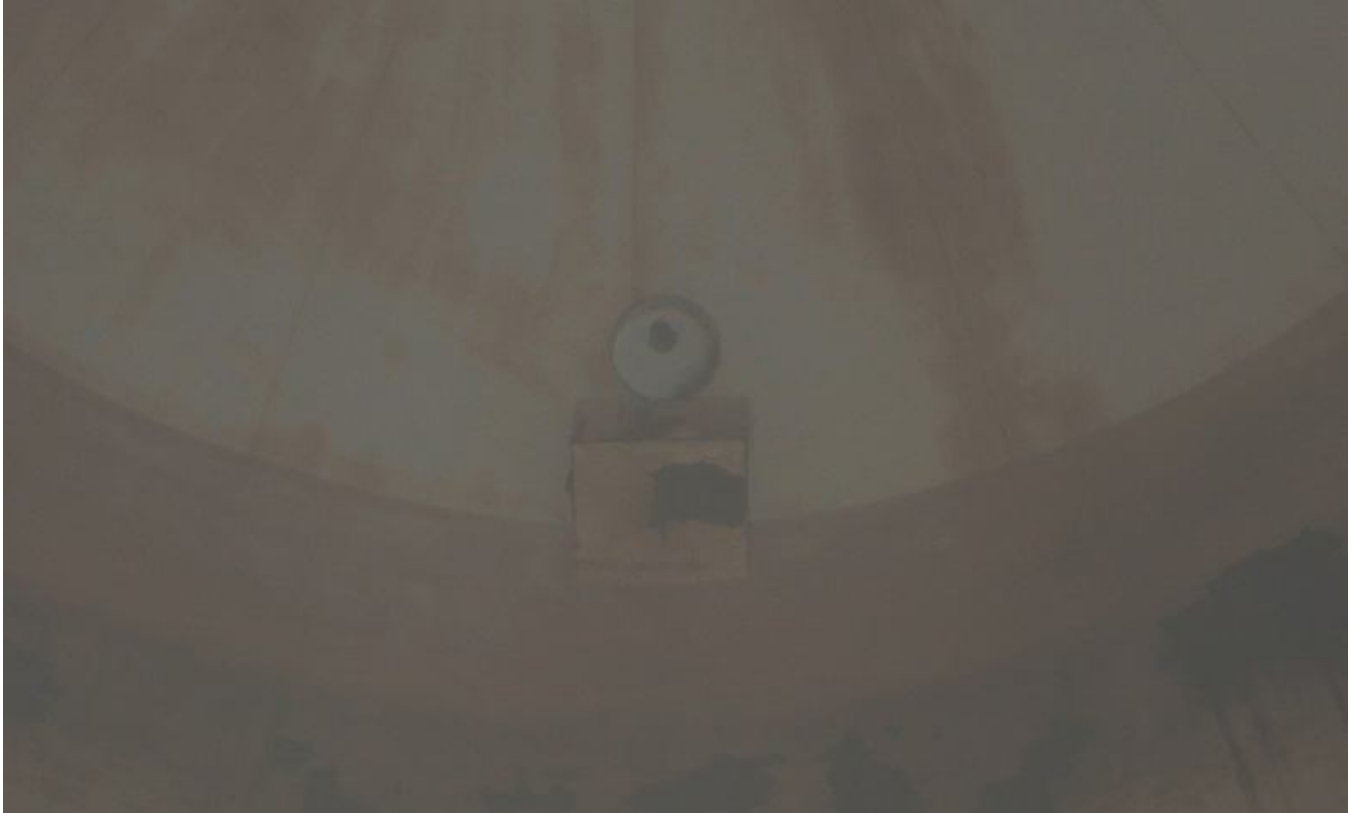
2. **Roof Condition:** The coating on the roof plates appeared to be in poor condition. Widespread rust staining was observed on the roof plates. (See photos 48-50)

48. Interior roof and shell. Note corrosion.

49. Interior roof, shell, and inlet pipe. Note corrosion.

50. Overflow weir box below roof manhole.
