## **Town of Boston Wohlhueter Tank Improvements**

**February 2020**

**EVALUATION OF THE  
672,000 GALLON STEEL STANDPIPE  
“WOHLHUETER TANK”  
COLDEN, NEW YORK  
FOR  
ERIE COUNTY WATER AUTHORITY  
BUFFALO, NEW YORK**

October 25, 2017

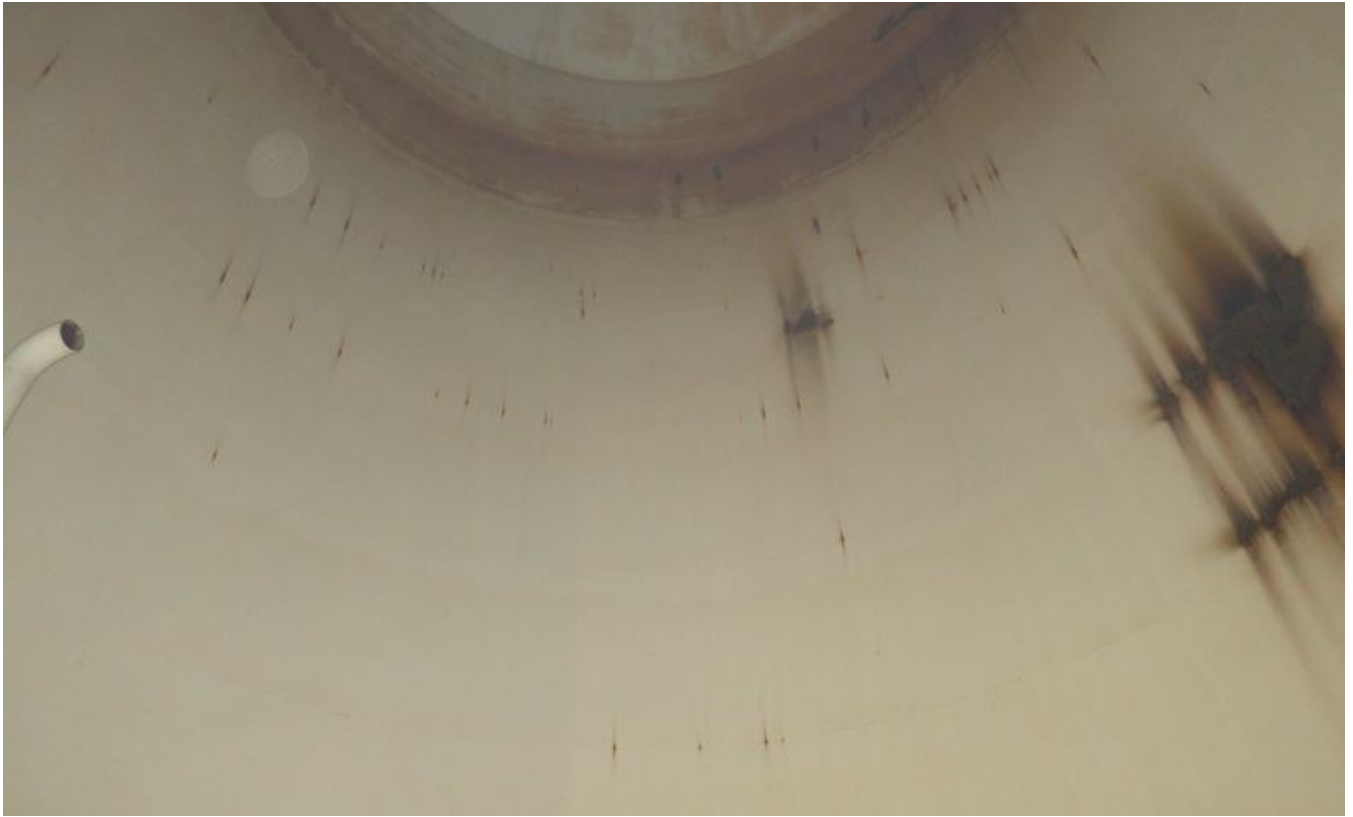
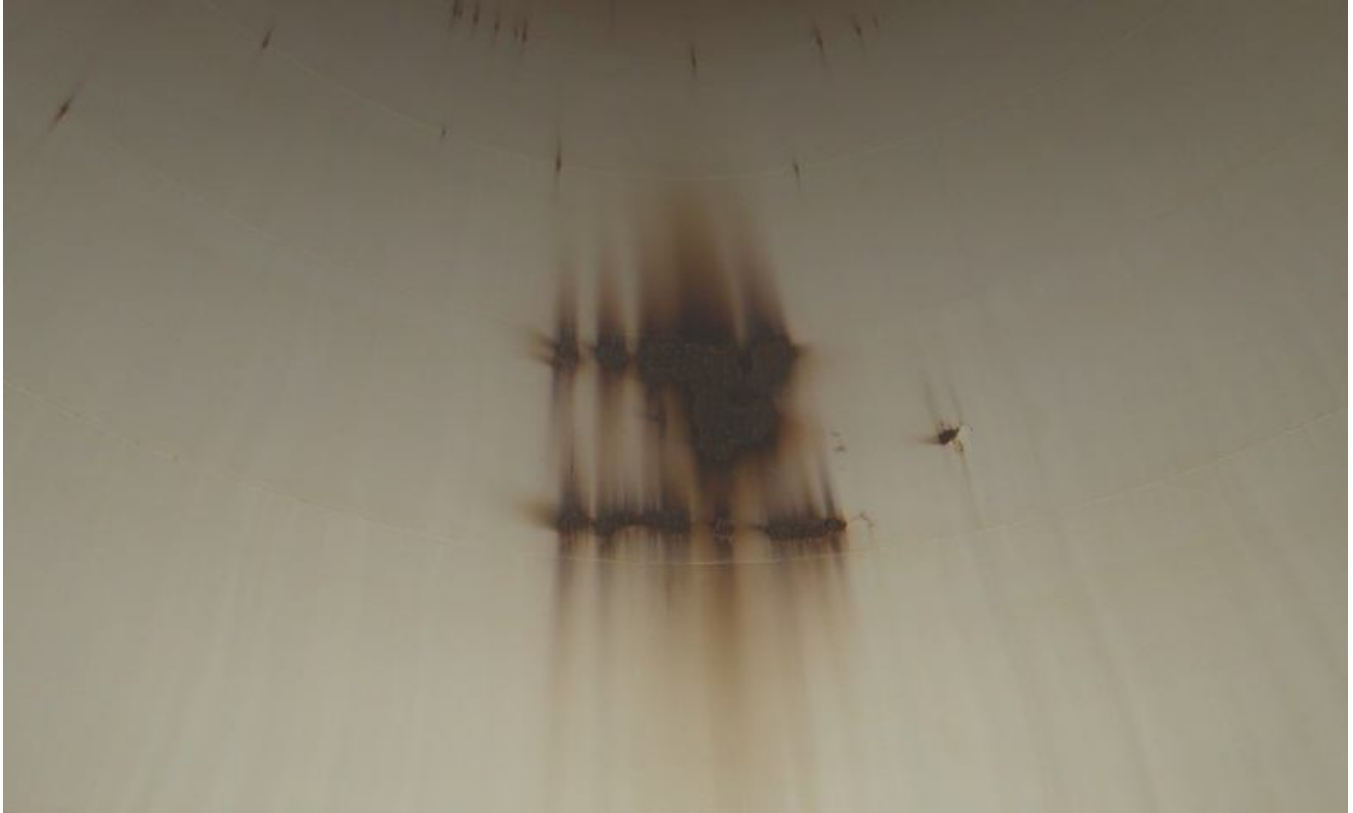
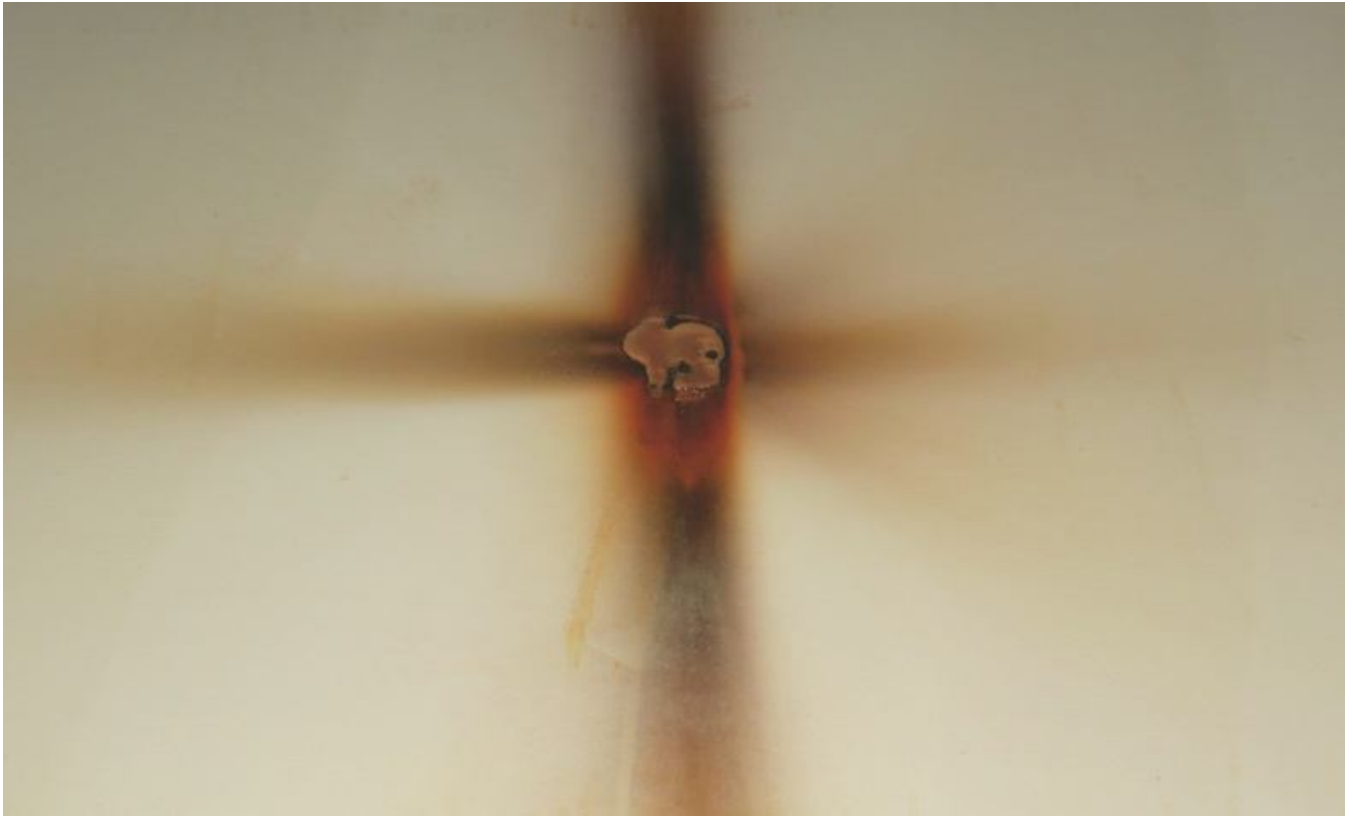
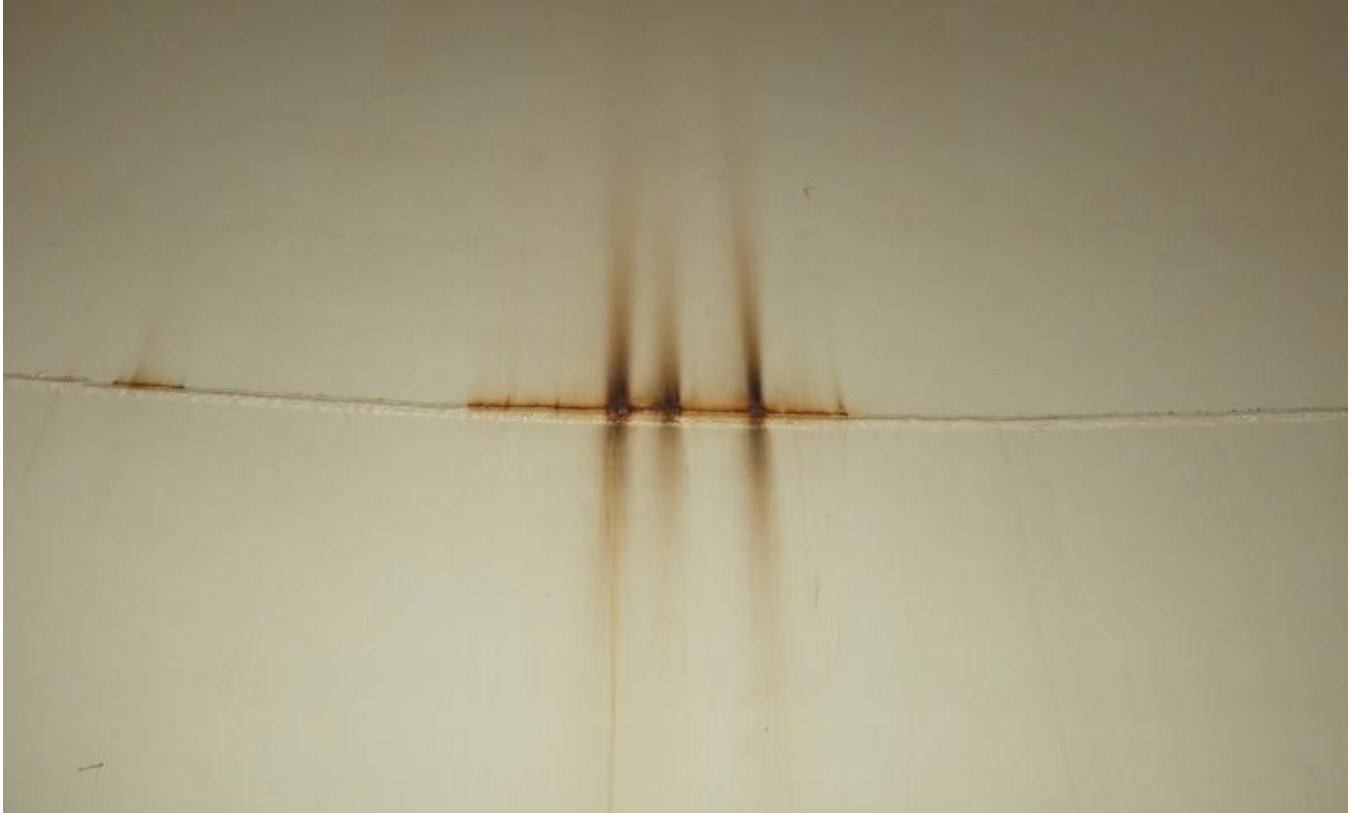
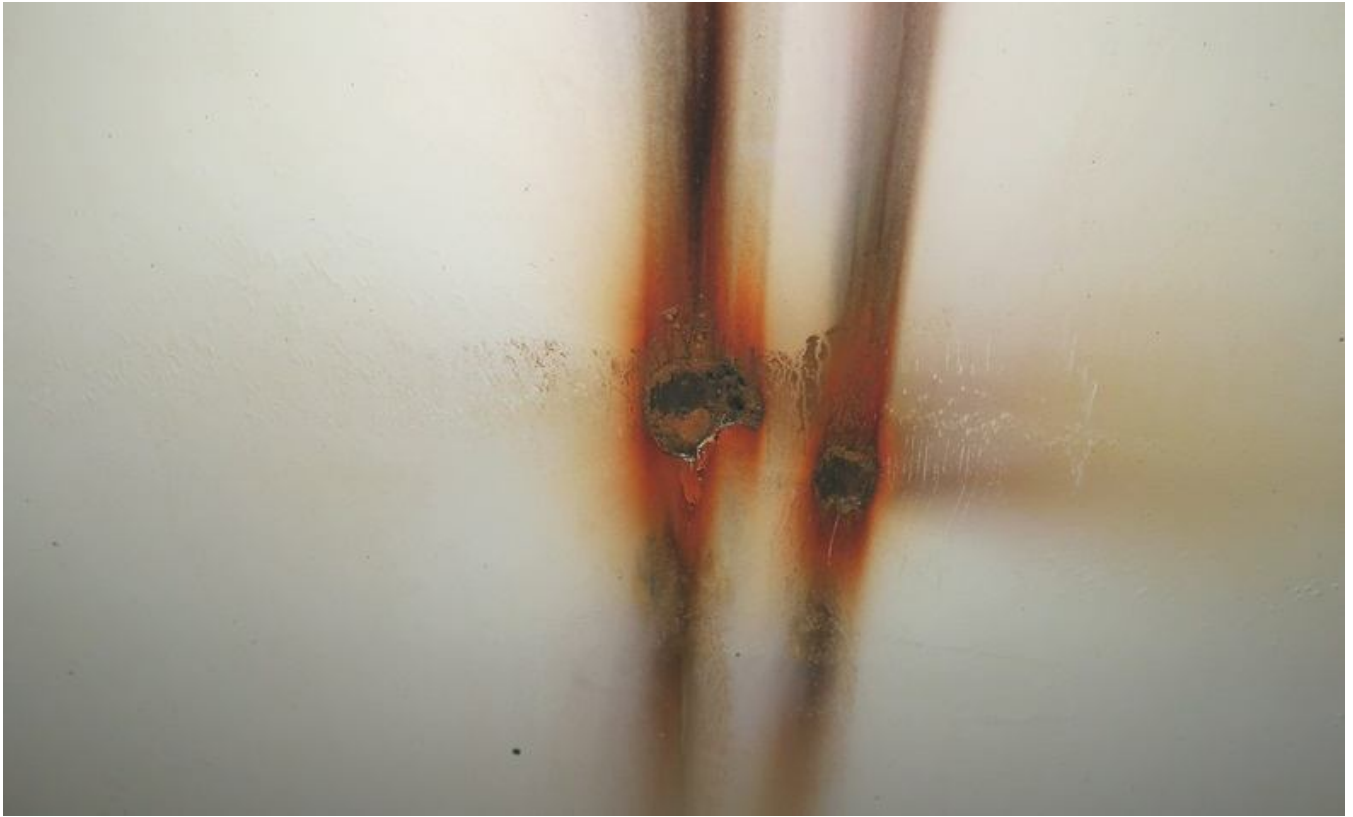
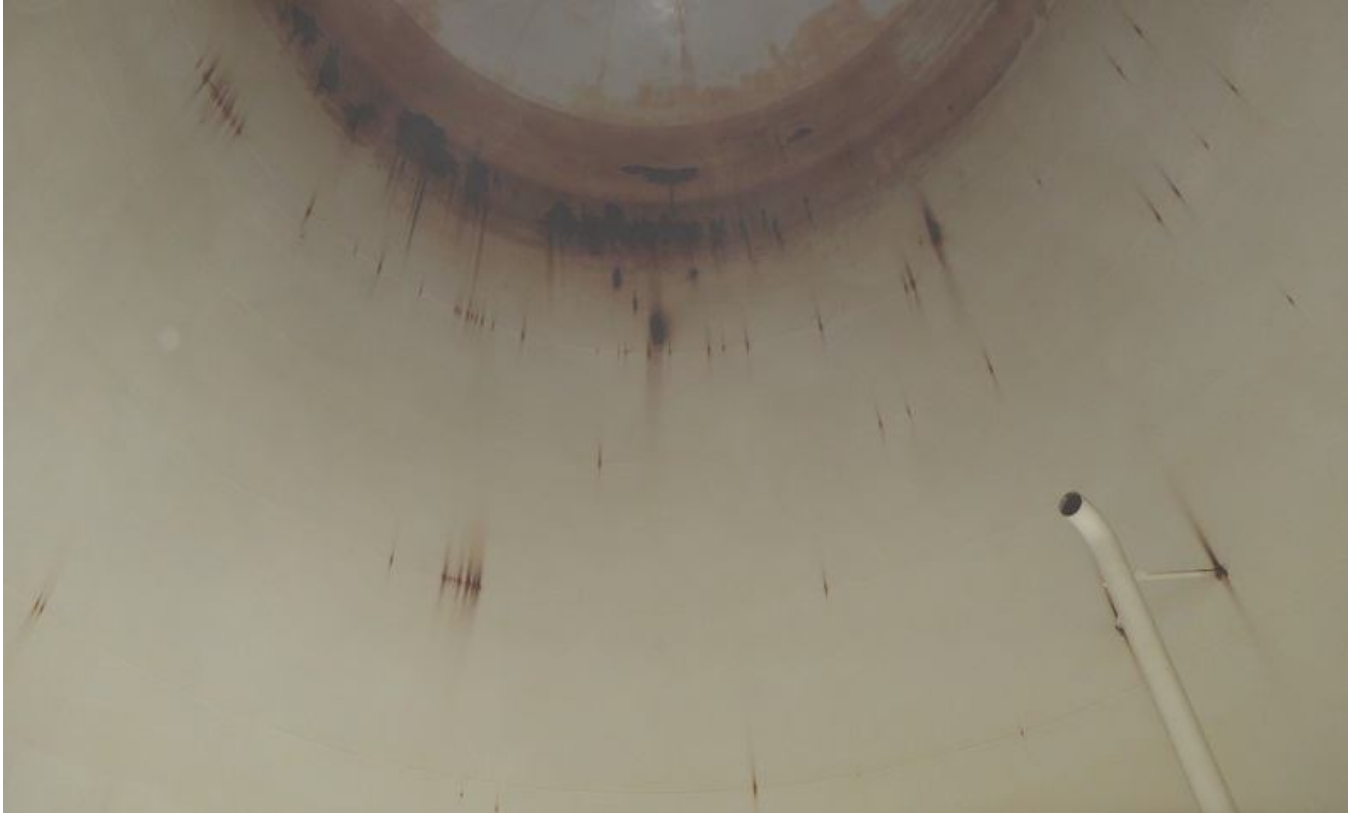
3. **Shell Condition:** The coating on the shell interior appeared to be in poor condition with areas of corrosion noted. The largest area of corrosion noted measured approximately 3 ft wide x 10 ft tall. Coating failures and corrosion were worse in the upper shell. Metal loss measurements taken during this evaluation indicated a typical pit depth of less than 1/16 in., and the deepest pit found measured less than 1/8 in. deep. A top shell angle was located along the roof-to-shell connection. (See photos 51-58)

51. Corrosion on interior shell.

52. Corrosion on interior shell.

53. Corrosion on interior shell.

54. Corrosion along interior shell weld seam.

55. Corrosion on interior shell.

56. Corrosion on interior shell.

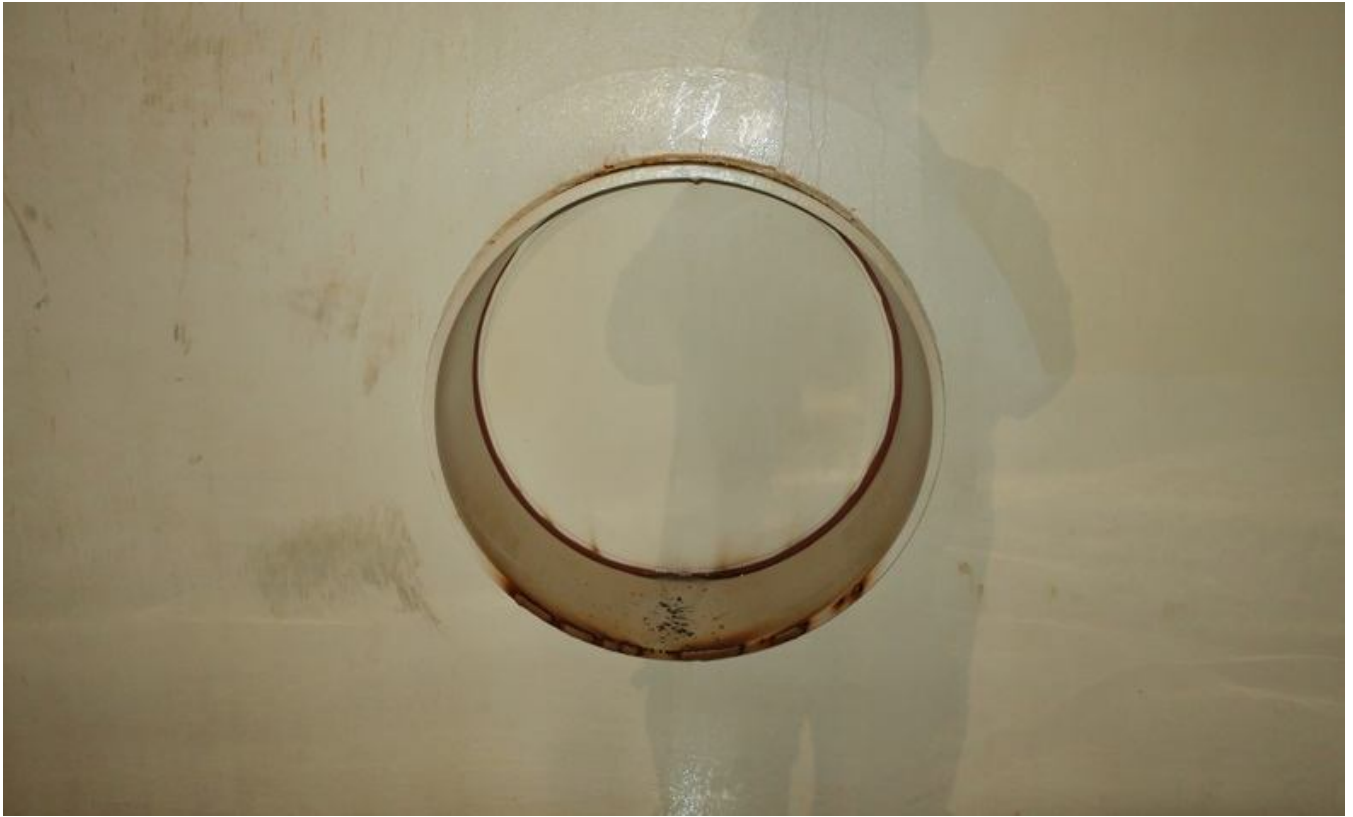
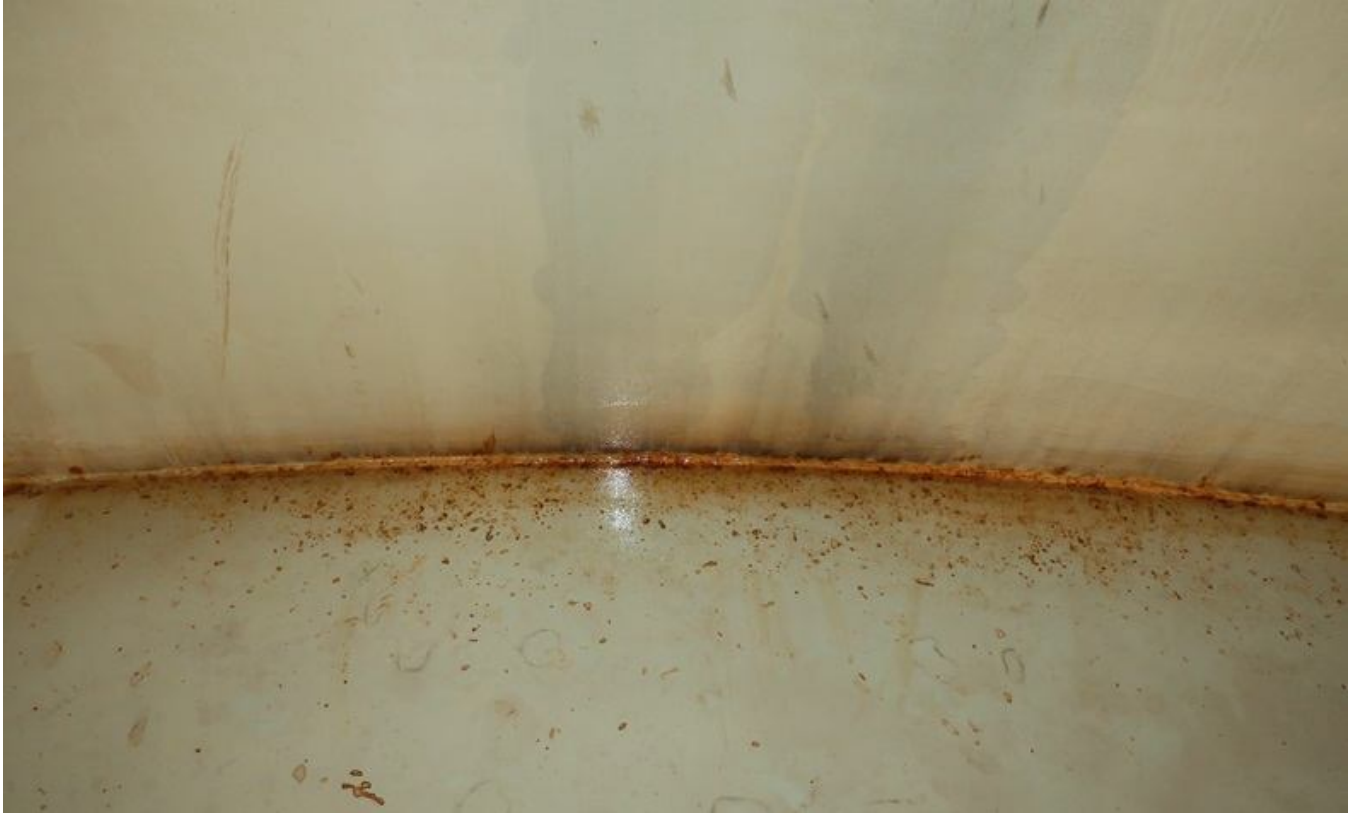
57. Shell manhole.

58. Interior shell and floor.
