**EVALUATION OF THE  
710,000 GALLON CONCRETE GROUND STORAGE TANK**

**“CRESTWOOD TANK”  
BOSTON, NEW YORK**

**ERIE COUNTY WATER AUTHORITY  
BUFFALO, NEW YORK**

**March 31, 2017**

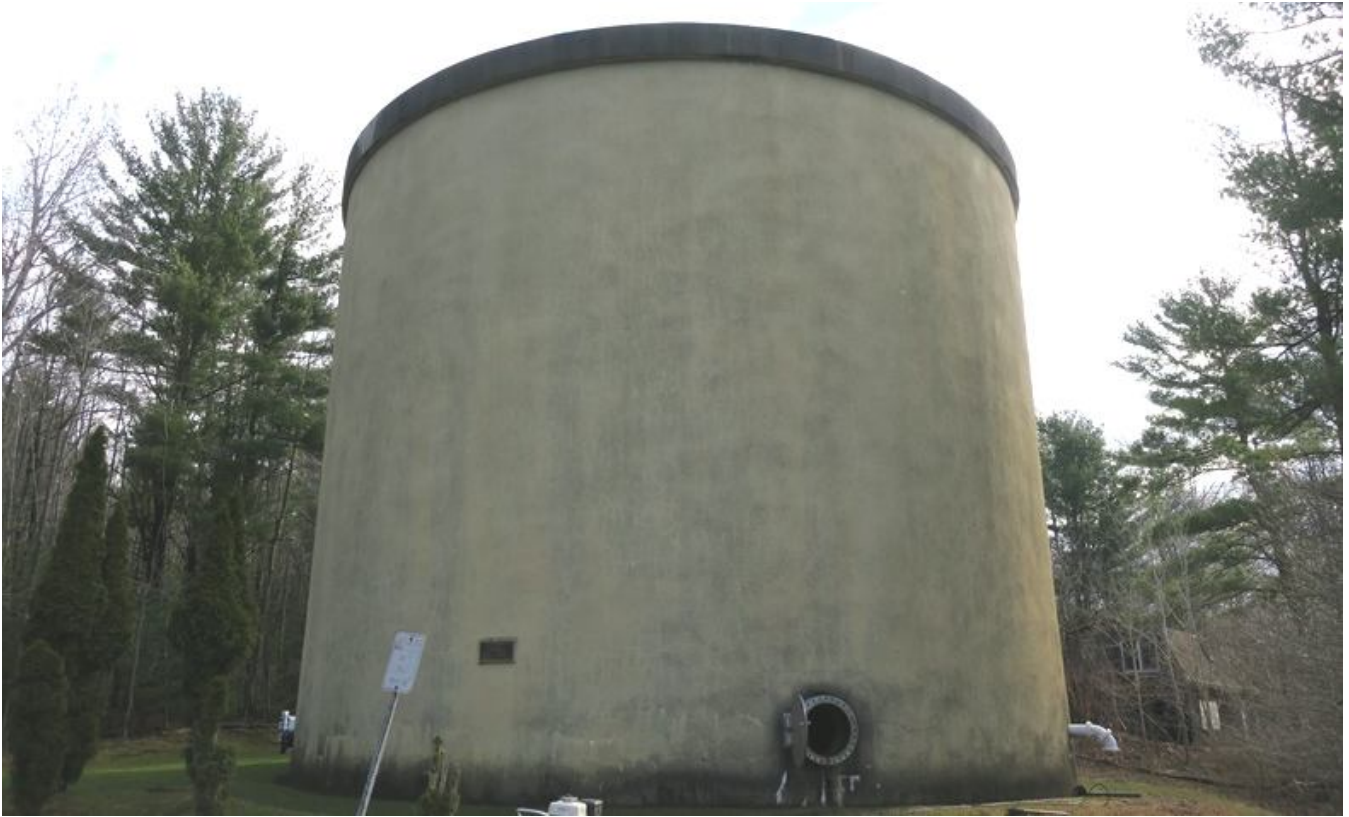
2. **Site Conditions:** The tank site was covered with grass. The site was graded such that water was standing around the base of the tank. The tank site was not fenced. A control building was located on the site northwest of the tank. (See photos 1-2, 5)

1. Tank and site.

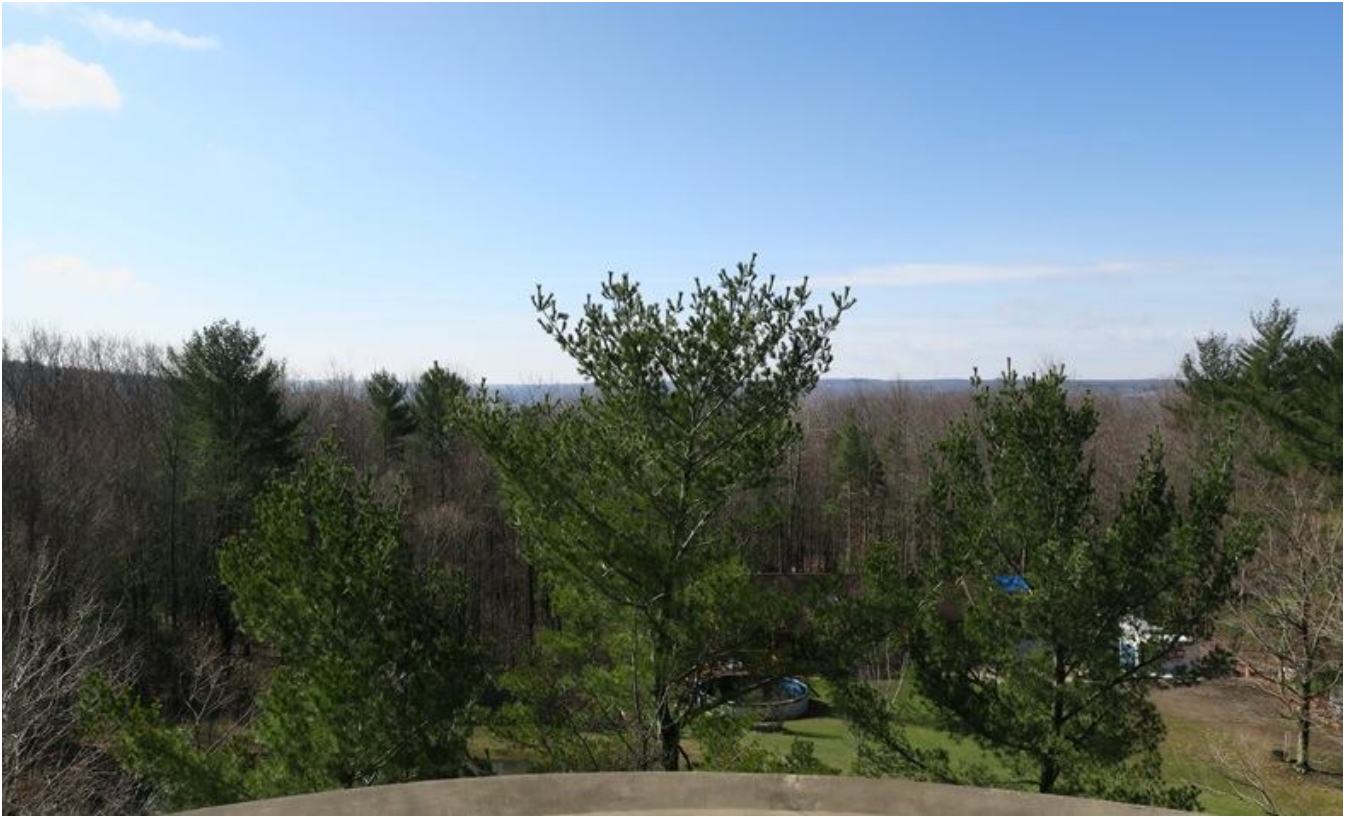
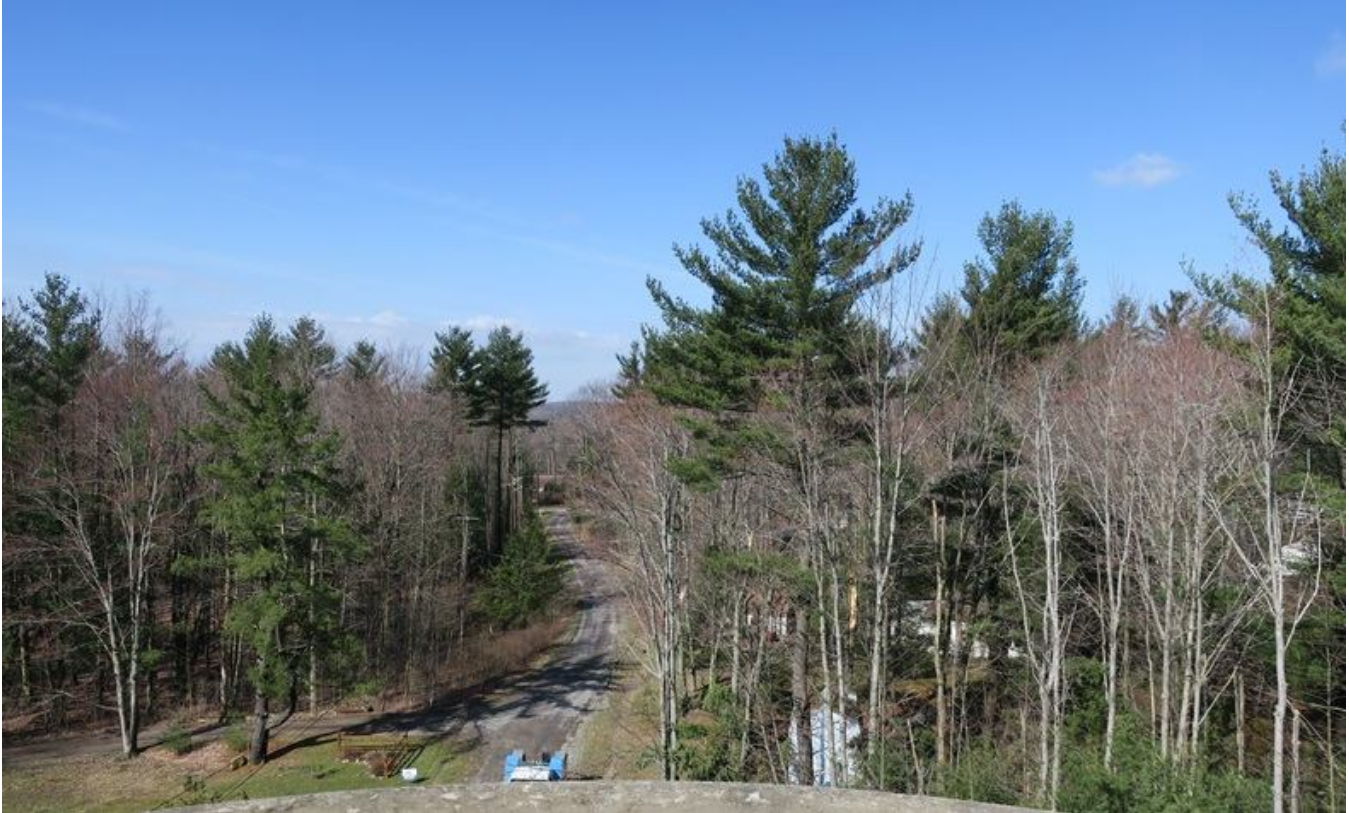
1. **Site Location:** The tank site was located at 7491 Chestnut Ridge Road in Boston, New York. The site was accessed from a gravel and dirt-covered drive which had several ruts in it. The site was located in a residential and wooded area. The nearest residence was located east of the tank site. The nearest overhead power lines were located southwest of the tank site, and there was a pond to the south. (See photos 3-4)

3. Surrounding area.

4. Surrounding area.

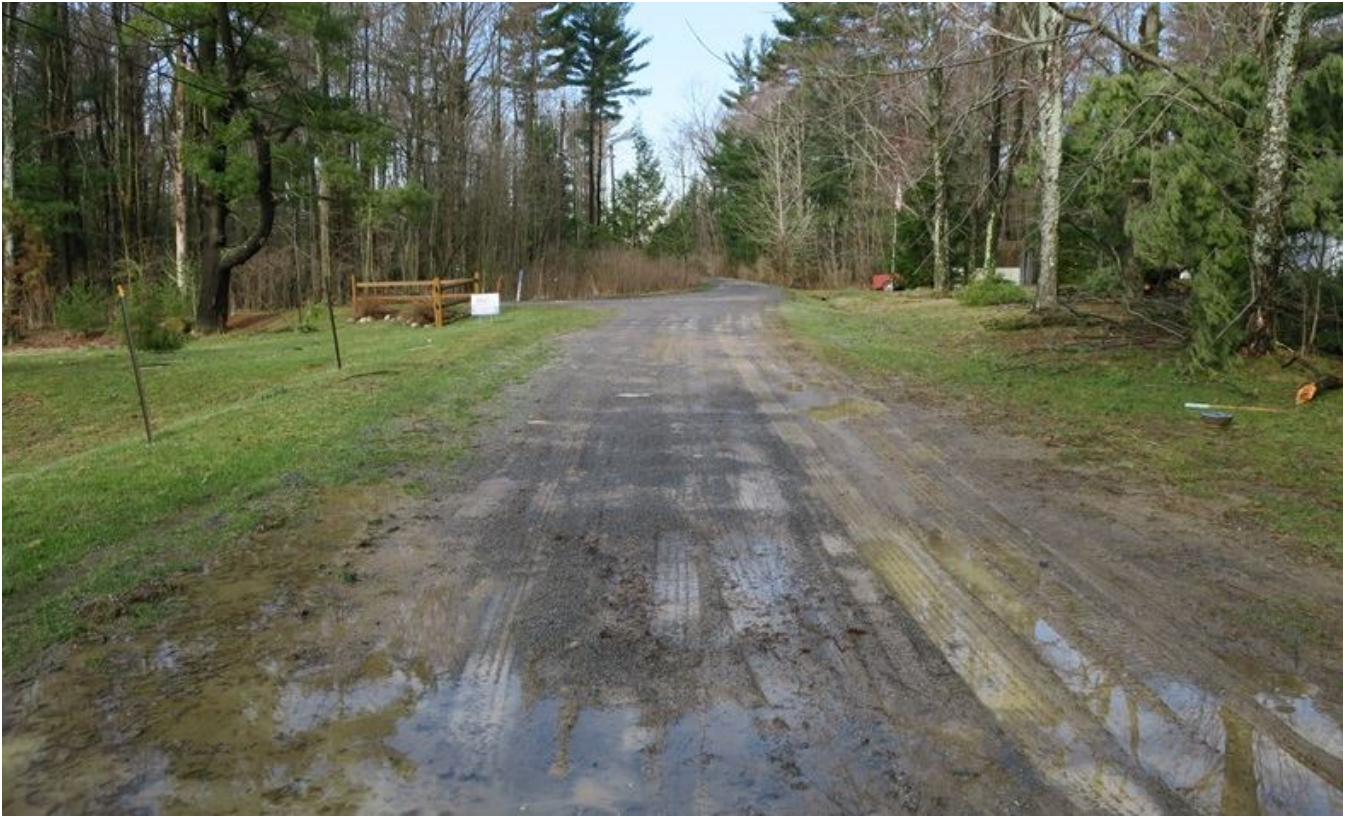
5. Access road to site.

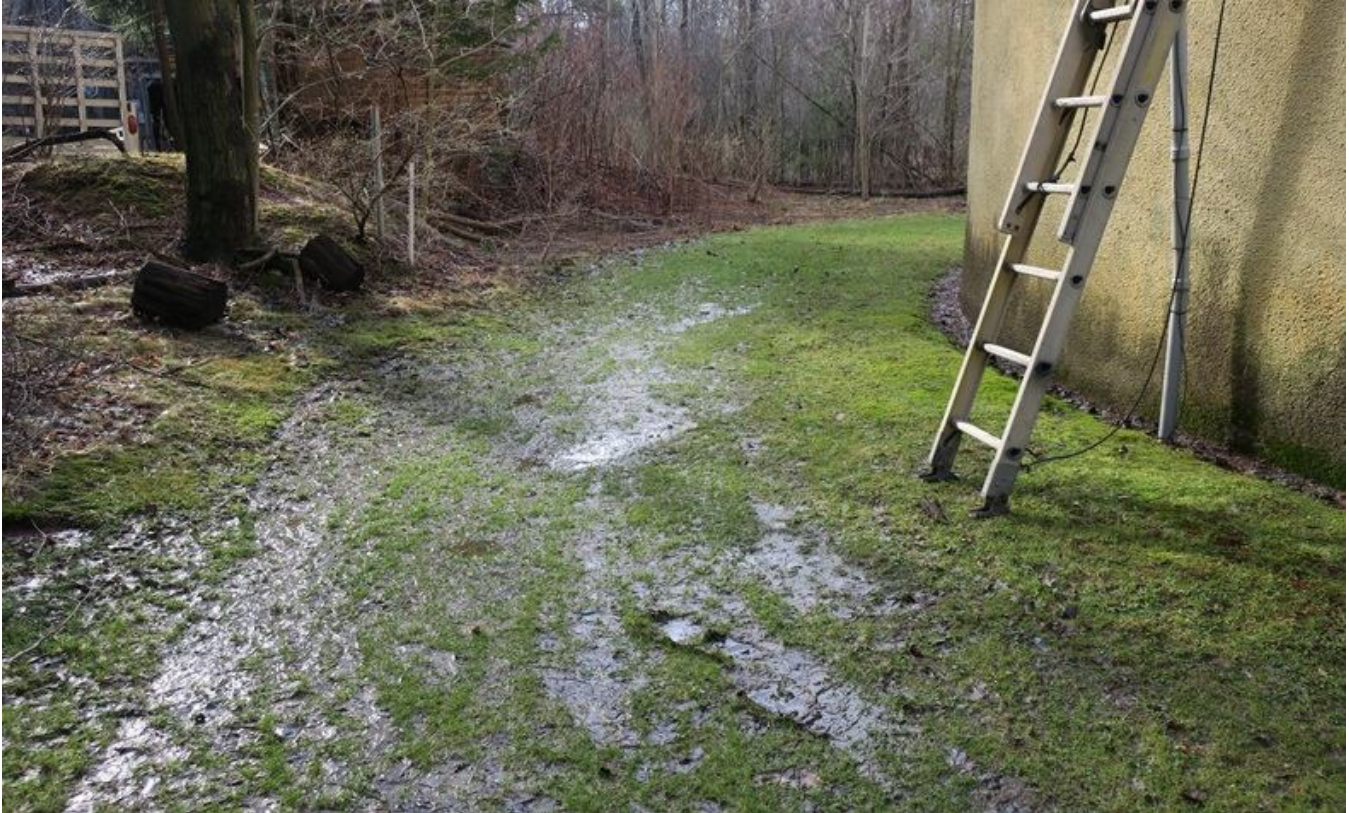
6. Water standing around tank.

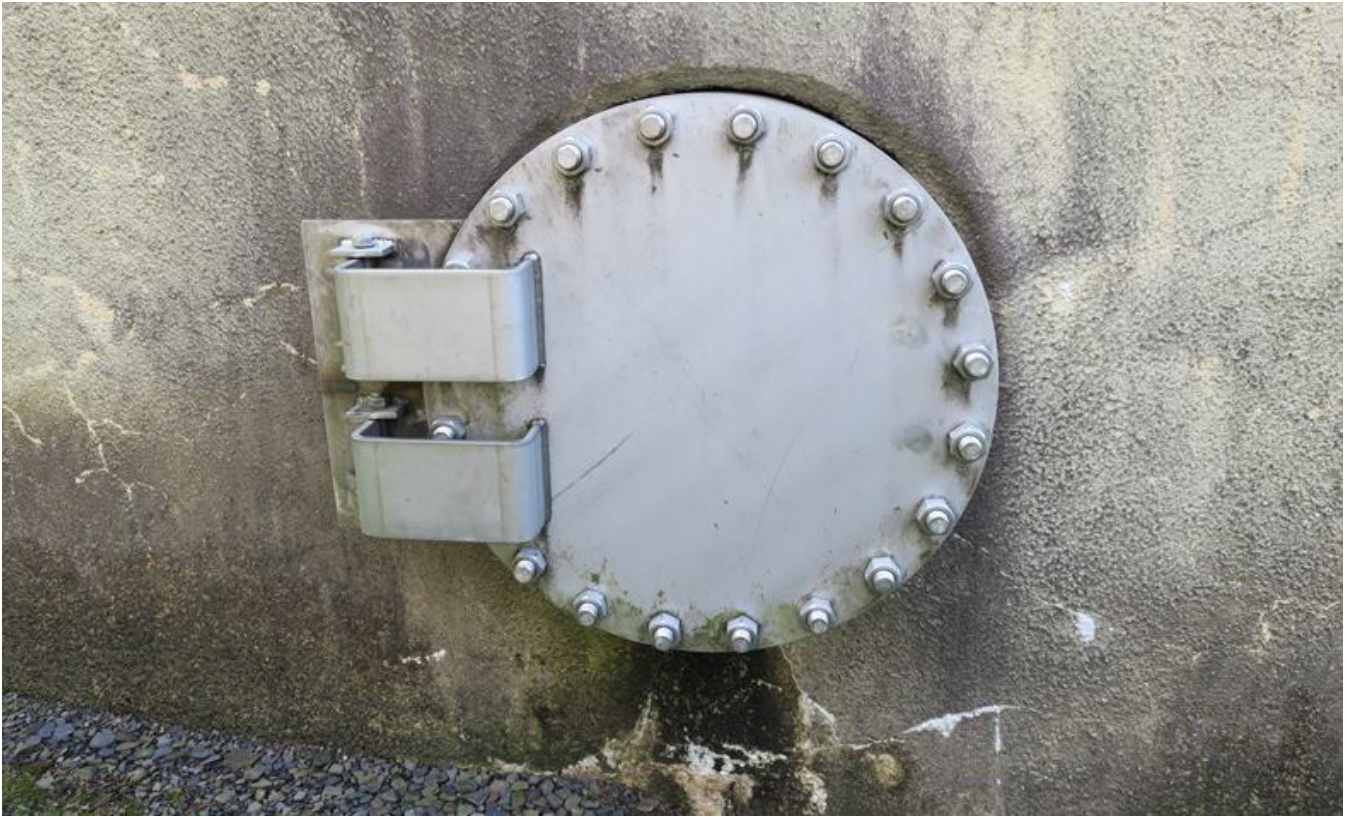
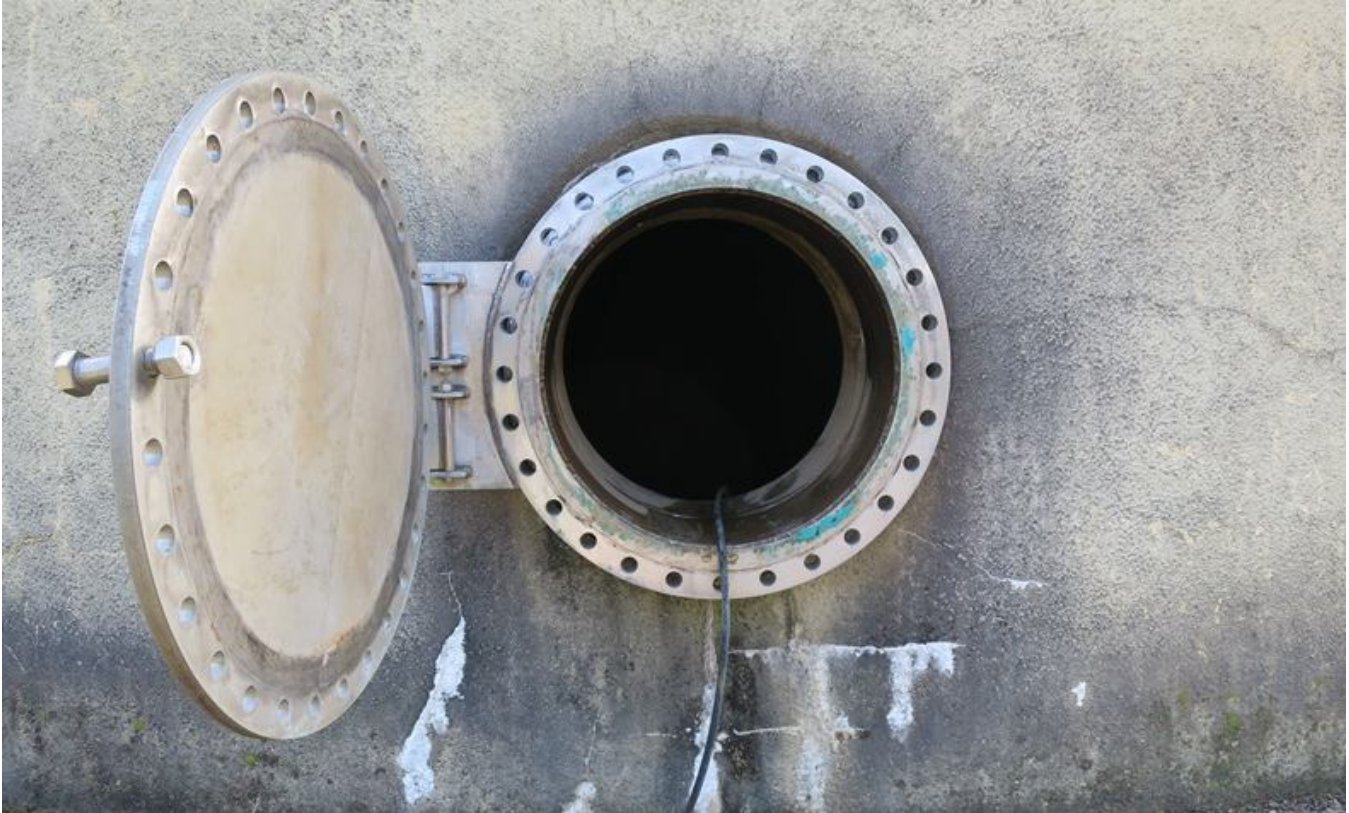
3. **Shell Manholes:** The tank was equipped with two circular flanged and bolted shell manholes located on the northwest and southwest sides of the tank. The manhole covers were equipped with hinged support arms located on the exterior of the tank. (See photos 7-8)

7. Shell manhole.

8. Shell manhole.

5. **Existing Shell Manholes:** At the time of recoating and repairs, the gaskets for the existing shell manholes should be replaced. The bolts should be replaced with galvanized steel bolts.

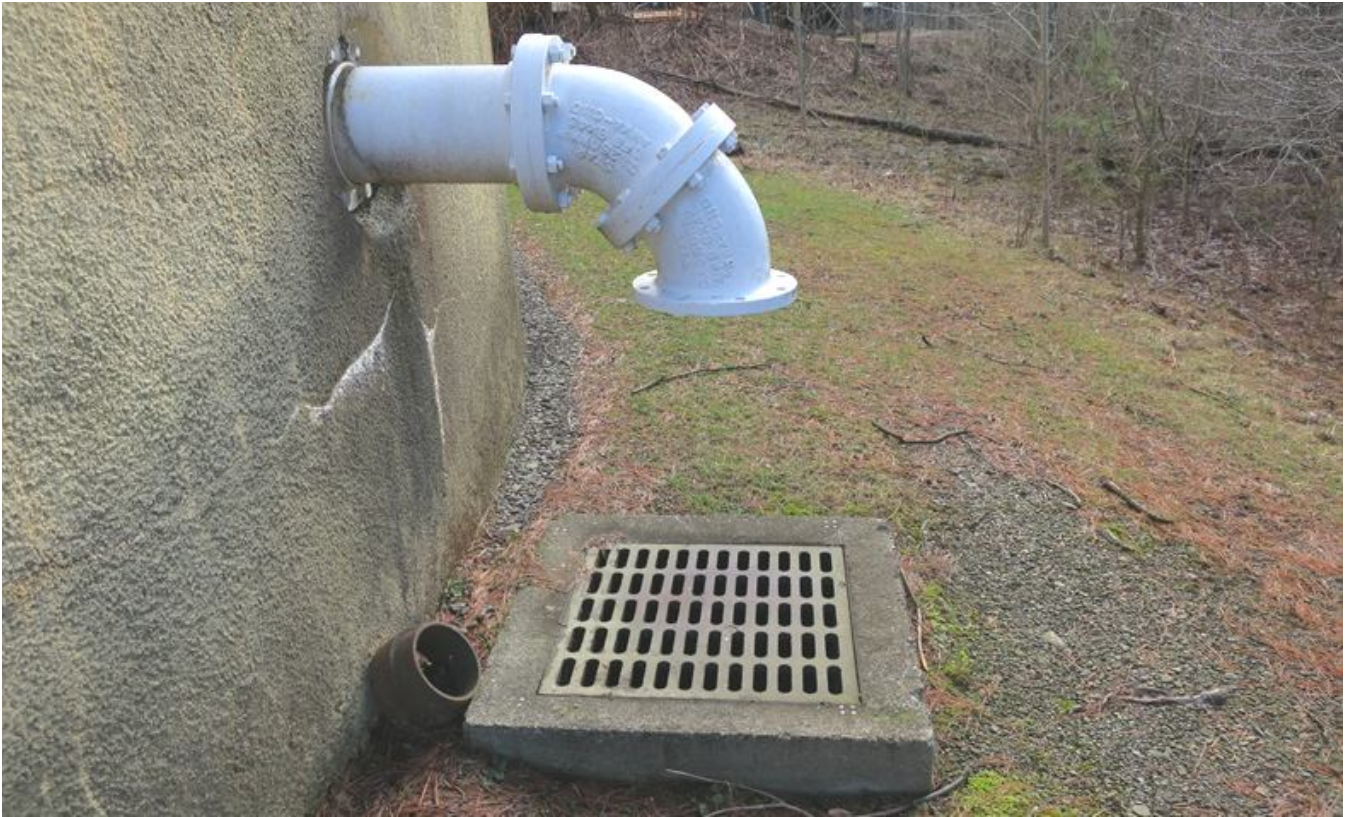
4. **Overflow Pipe:** The overflow pipe exited near the base of the shell and discharged above a grate-covered drain basin. The discharge end was equipped with fine mesh screening which appeared to be in adequate condition at the time of the field evaluation. A significant amount of peeled coating and corrosion were observed on the overflow pipe, bolts, and flange surrounding the protective screening. (See photo 9)

9. Overflow pipe discharge above drain basin.

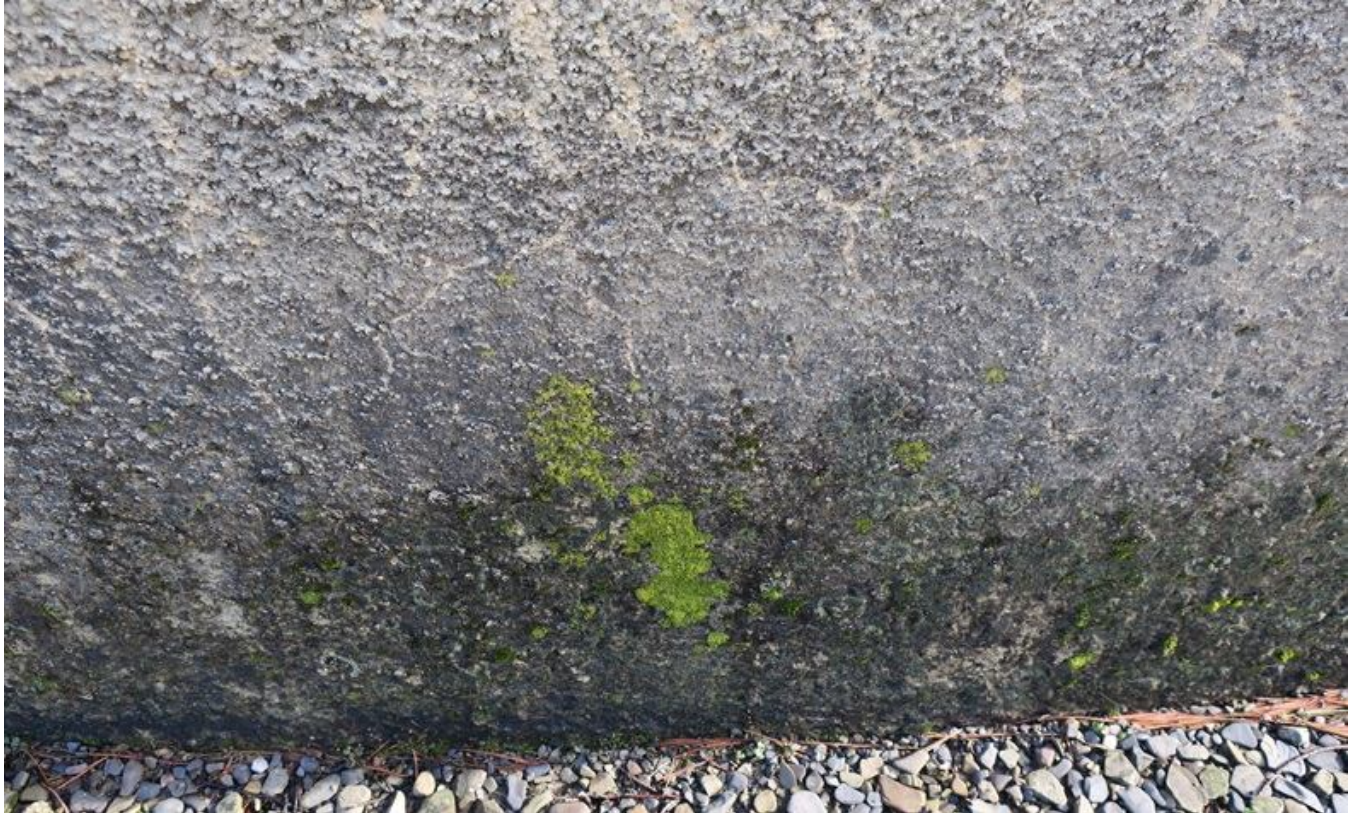
2. **Shell Condition:** The concrete shell exterior appeared to be in fair to good overall condition with numerous cracks observed. The cracks measured less than 2 ft long, and efflorescence was observed at most of the cracks. The largest cracks were located in the surfaces beneath the shell manholes and overflow pipe projection. A significant amount of mildew and moss were also observed on the lower part of the shell. The tank nameplate was attached to the west side of the shell. (See photos 10-17, 22-23)

14. Moss near base of shell.

1. **Exterior Surfaces:** The exterior concrete surfaces appeared to be in fair to good overall condition at the time of the field evaluation. The exterior should be repaired in 3 years, in conjunction with the interior repairs. The cracks should be filled with a cementitious crack compound to prevent moisture collection from causing additional damage to the tank. For added weathering resistance, the exposed surfaces of the exterior could be coated with a cementitious waterproofing material or sealed with a silane or siloxane coating. If aesthetics are of concern, the mildew could be removed from the shell surfaces.

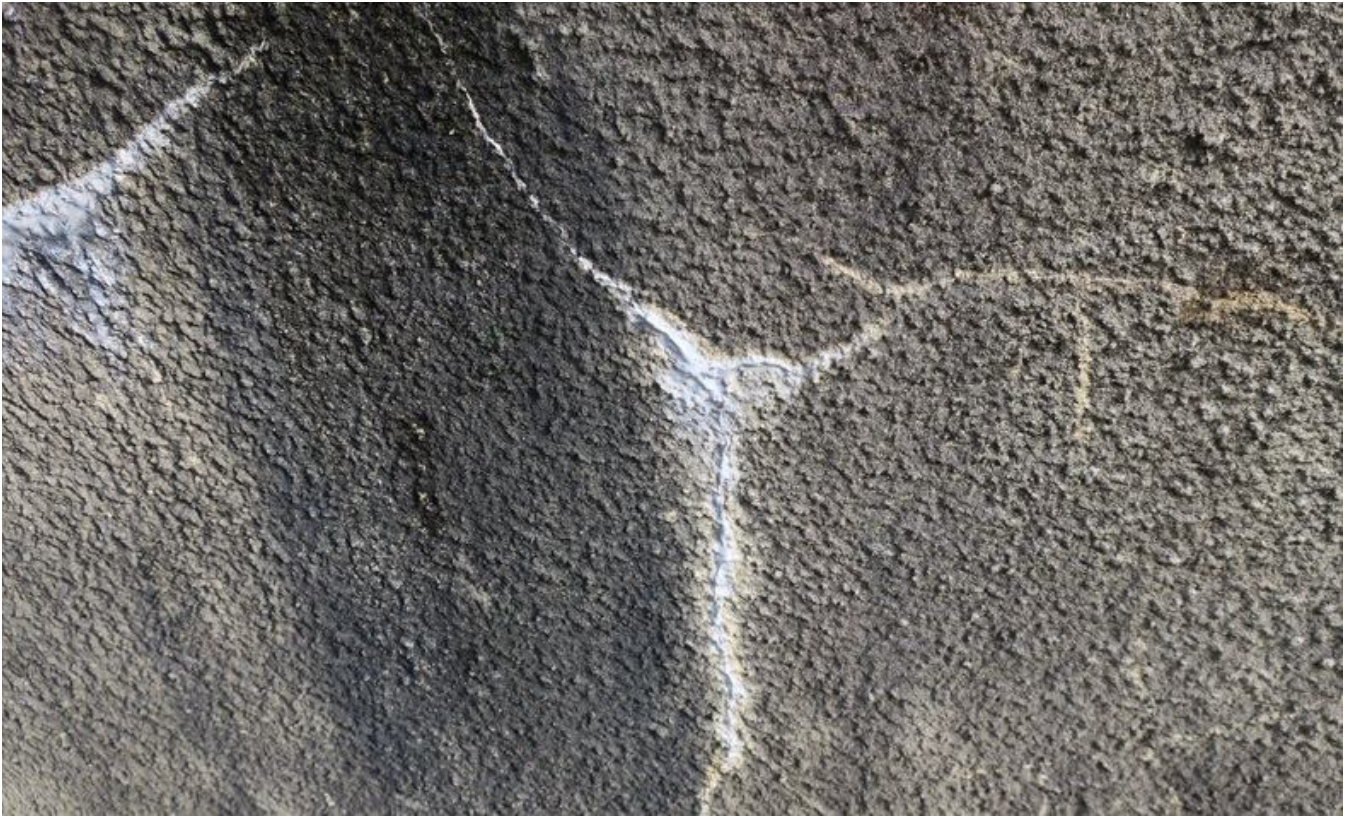
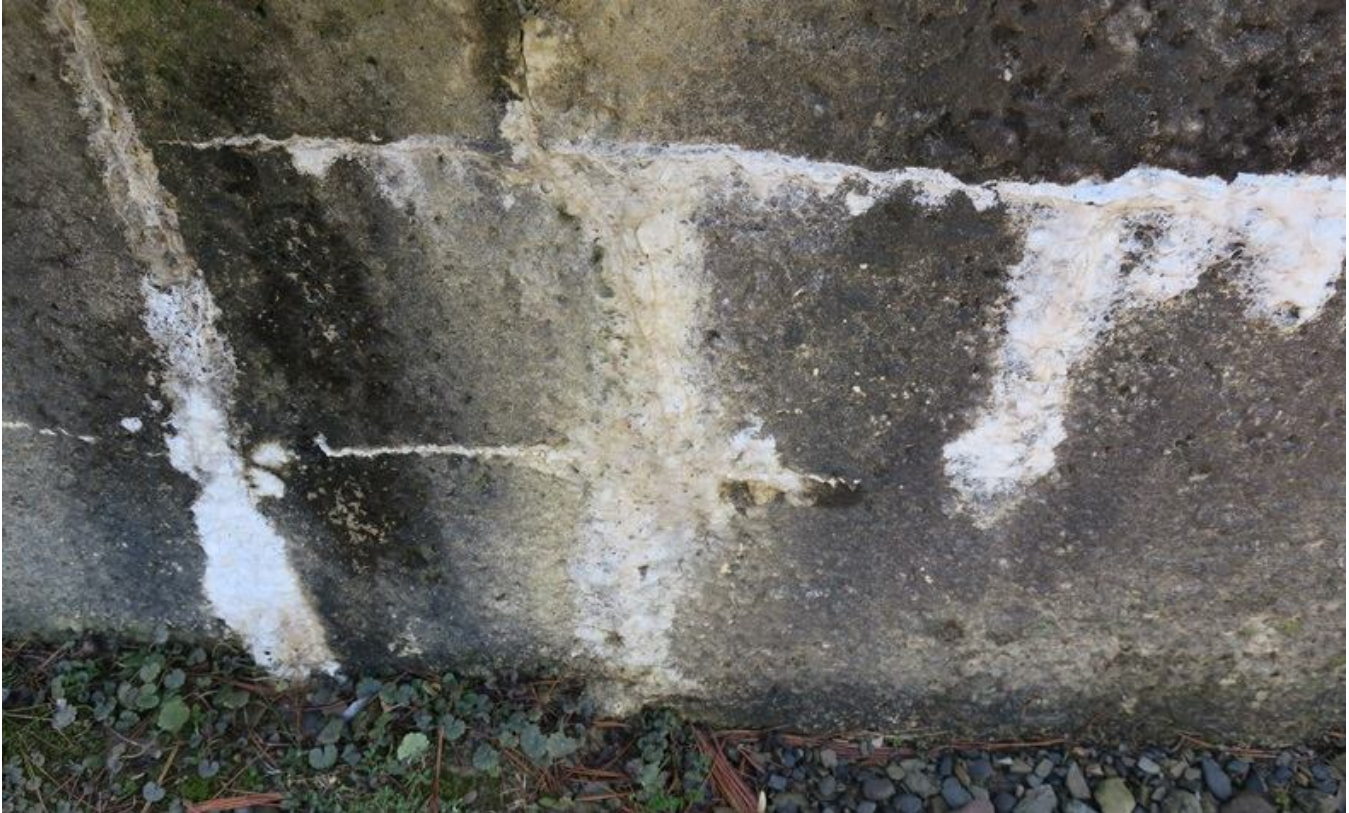
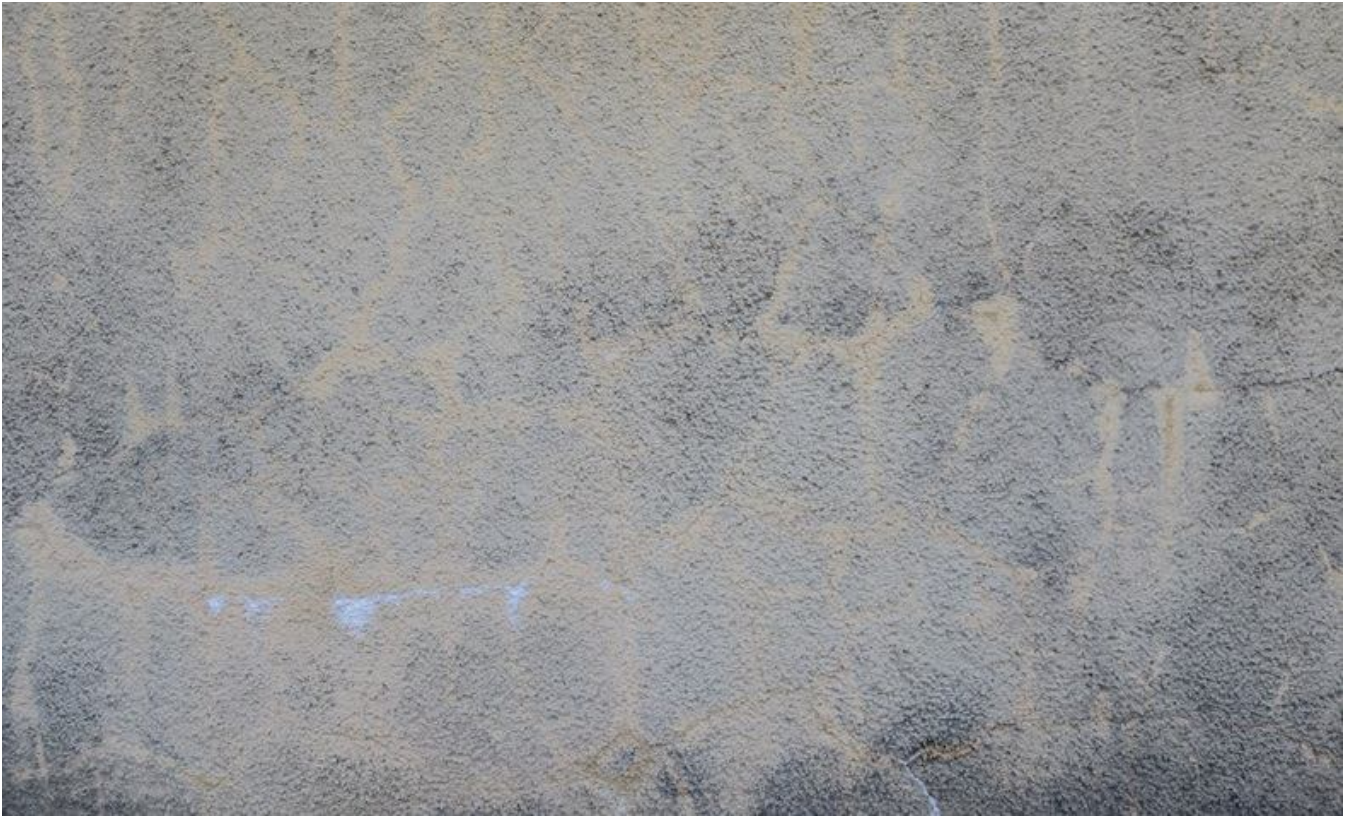
15. Efflorescence on shell.

16. Efflorescence on shell.

17. Efflorescence on shell.

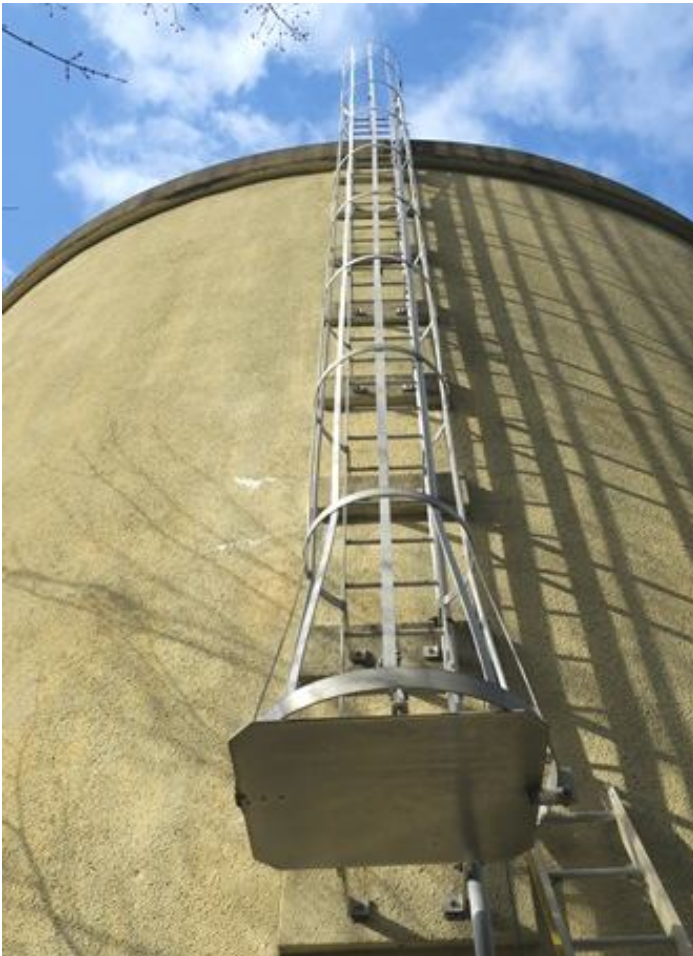
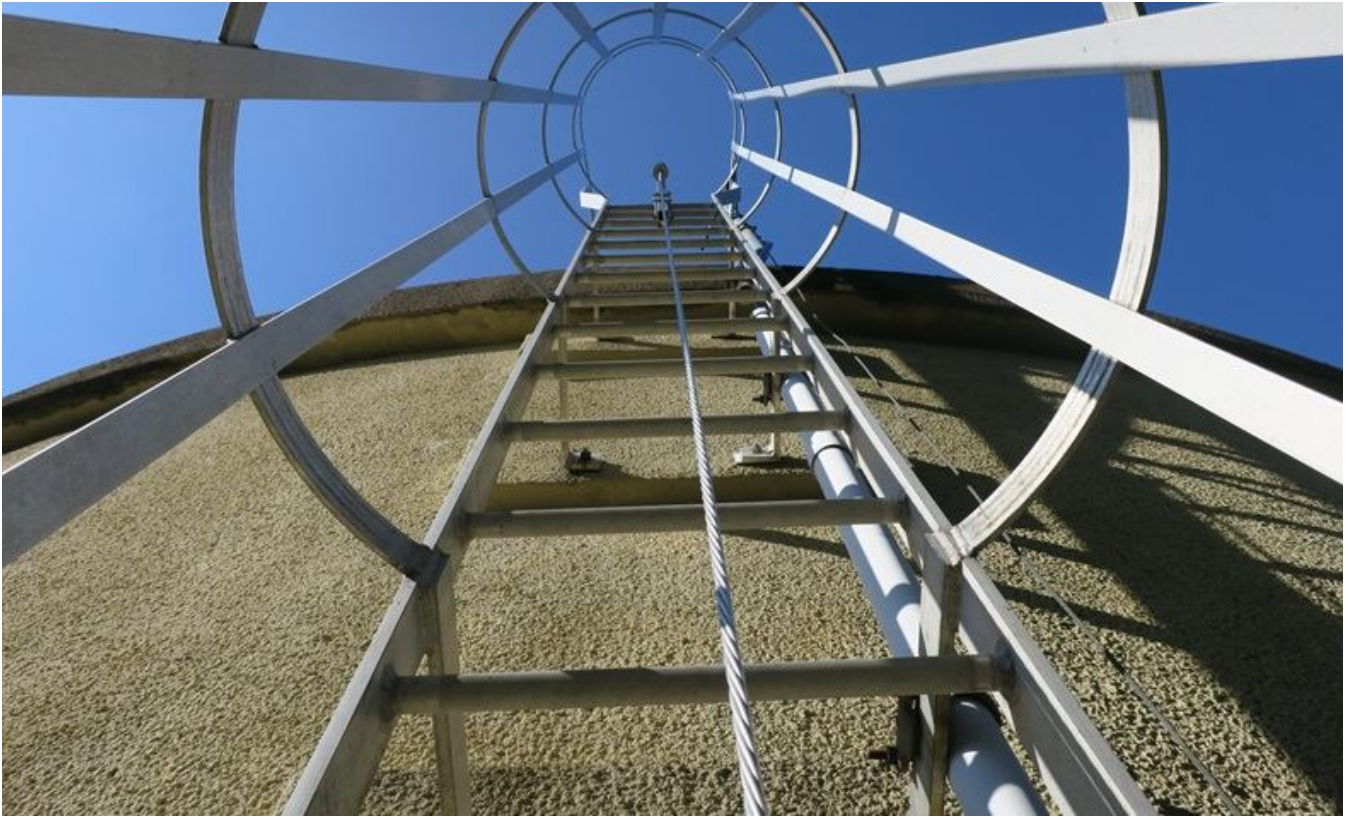
5. **Exterior Ladder:** **There were safety-related and ANSI/OSHA deficiencies noted: (1) the antenna and conduit attached to the ladder could interfere with the climber's use of the side rails, (2) the 26-1/4 in. extension of the safe-climbing device above the roof did not meet the industry recommended 54 in. minimum, (3) the bottom bracket of the safe-climbing device was loose and a nut was missing, and (4) the 25-1/2 in. depth of the ladder safety cage did not meet the minimum required 27 in. minimum.** A ladder provided access from near grade to the roof. The ladder was equipped with a cable-type safe-climbing device and a safety cage. The ladder was equipped with bolted brackets, and the ladder and brackets appeared to be in nearly their original structural condition at the time of the field evaluation. A conduit extended up the ladder brackets to an antenna located at the roof's edge. The conduit was bent just above grade level, and the conduit could interfere with the climber's use of the ladder side rail. The base of the ladder was equipped with a vandal deterrent. The ladder deterrent was locked prior to and after the field evaluation. The top of the ladder was equipped with terminals at the roof. (See photos 18-21, 24-25)

18. Exterior ladder, safety cage, and vandal deterrent.

19. Exterior ladder, safety cage, and safe-climbing device.

7. **Exterior Ladder:** A ladder safety cage is not required on a ladder equipped with a safe-climbing device. As the OSHA is phasing out safety cages, Tank Industry Consultants recommends that the exterior shell ladder safety cage be removed. The loose bracket on the safe-climbing device should be repaired, and the device should be modified to extend the industry recommended 54 in. above the roof. The conduit and antenna should be relocated away from the ladder side rails.

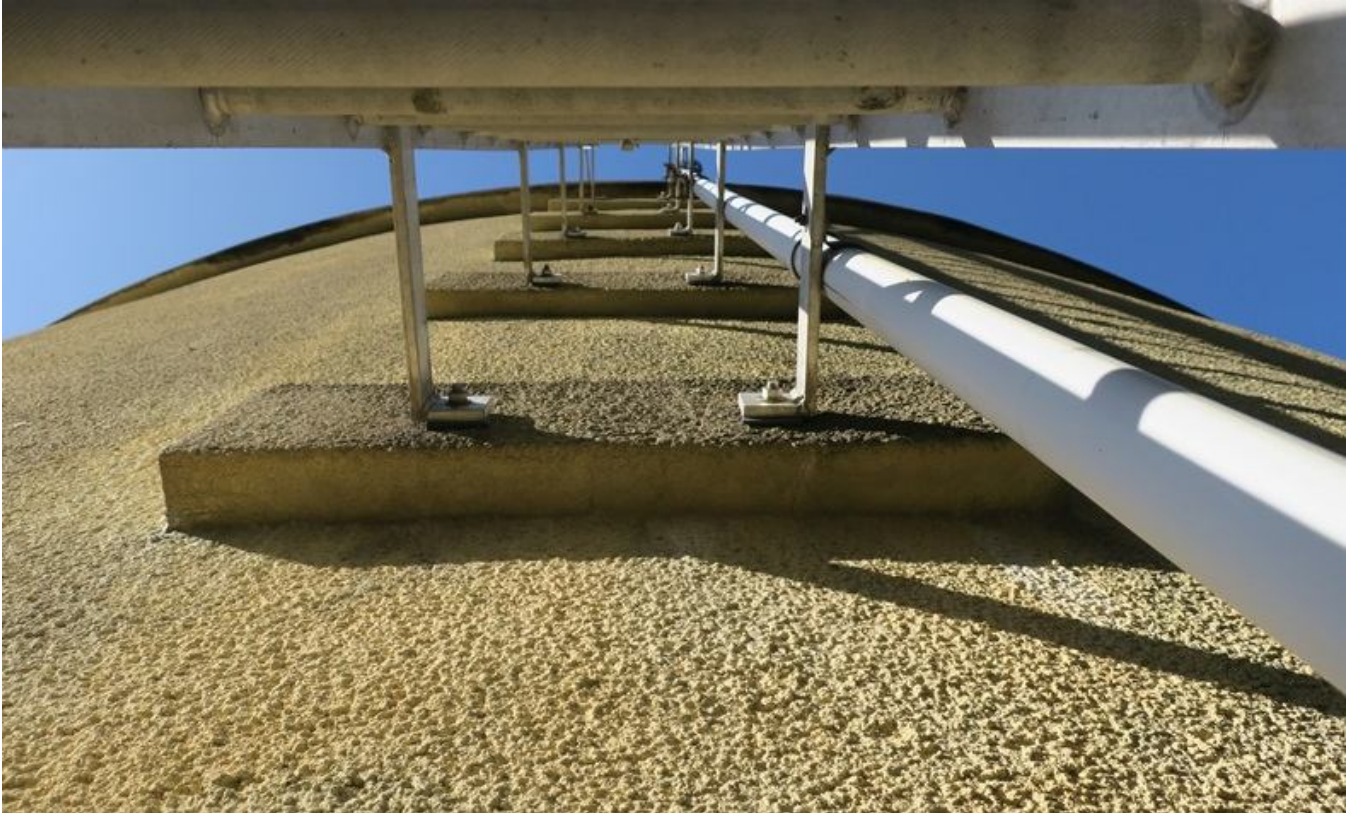
20. Exterior ladder, brackets, and conduit.

4. **Electrical Apparatus:** All unused electrical equipment should be removed from the tank and tank site. All required equipment should be repaired and maintained in accordance with the National Electric Code (NEC). The bent conduit should be repaired.

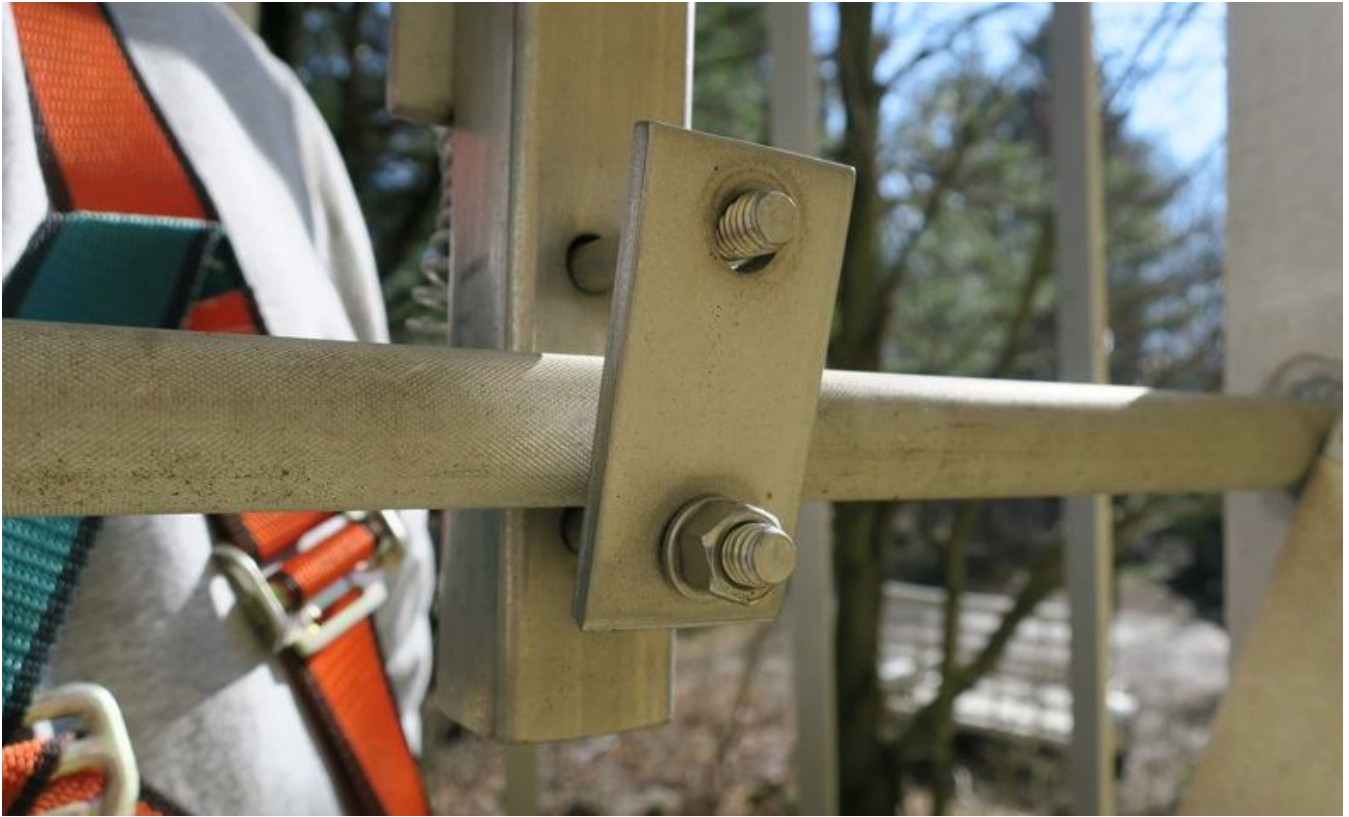
21. Safe-climbing device bracket not equipped with washer and nut.

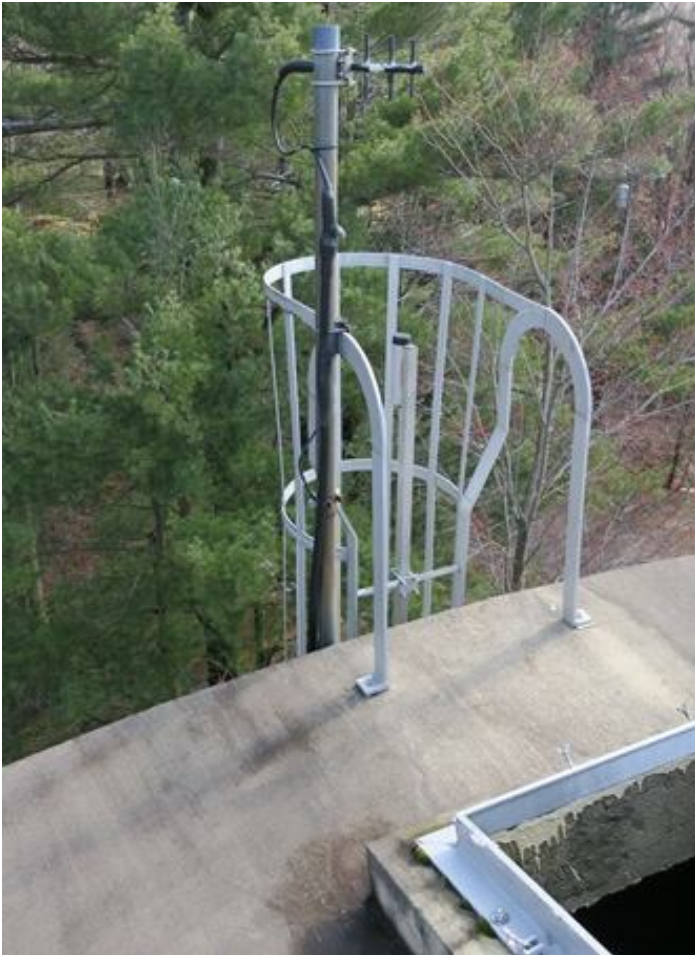
25. Antenna and roof access.

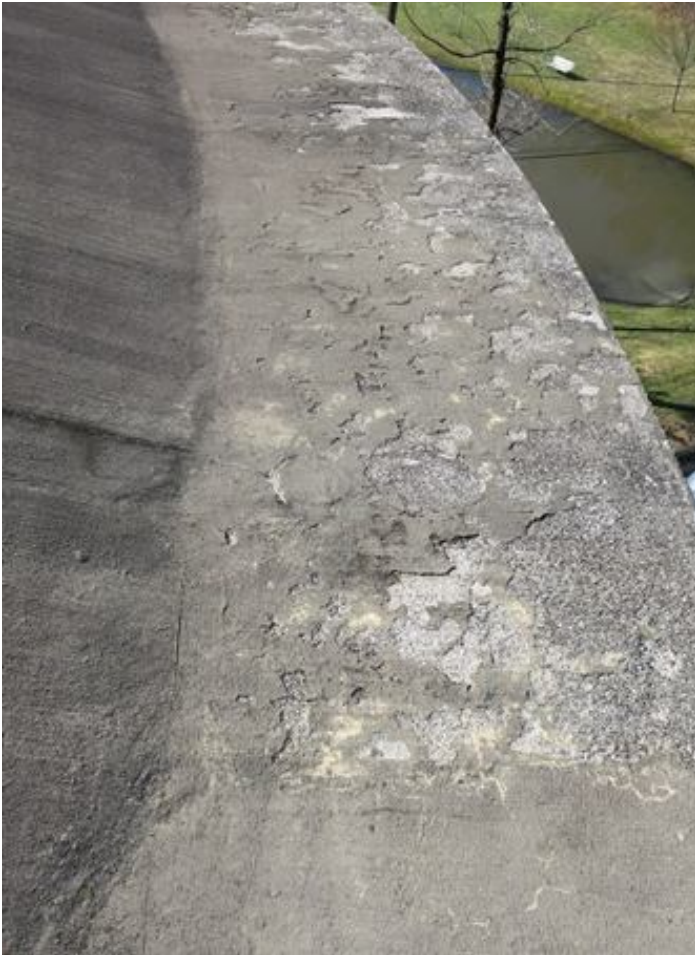
7. **Roof Condition:** The concrete roof exterior appeared to be in fair condition at the time of the field evaluation. Several hairline cracks were observed, and surface voids were located near the edge of the west side of the roof. An area of spalling was also located on the west side of the roof near the edge. Efflorescence was observed at some of the hairline cracks. (See photos 27-33)

27. Surface deterioration in roof perimeter.

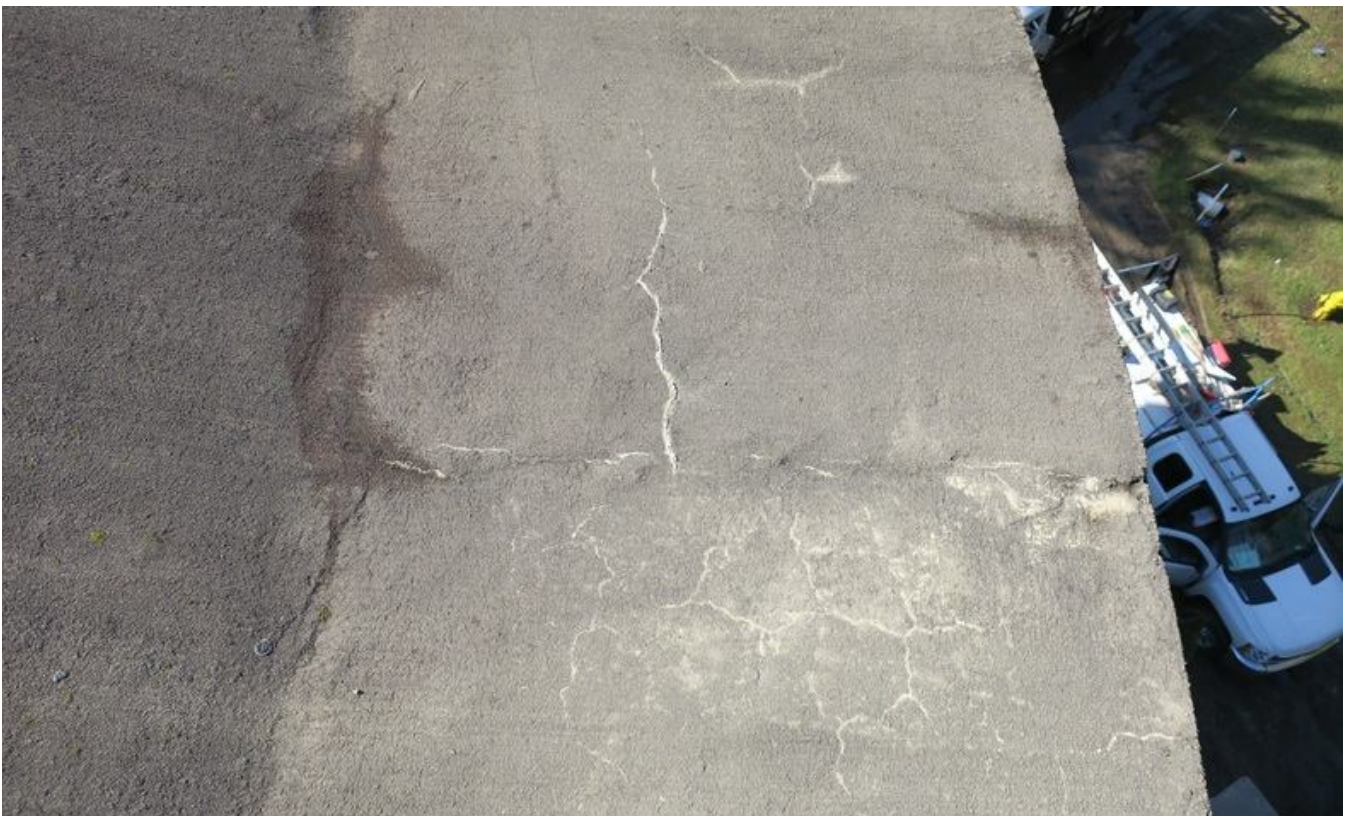
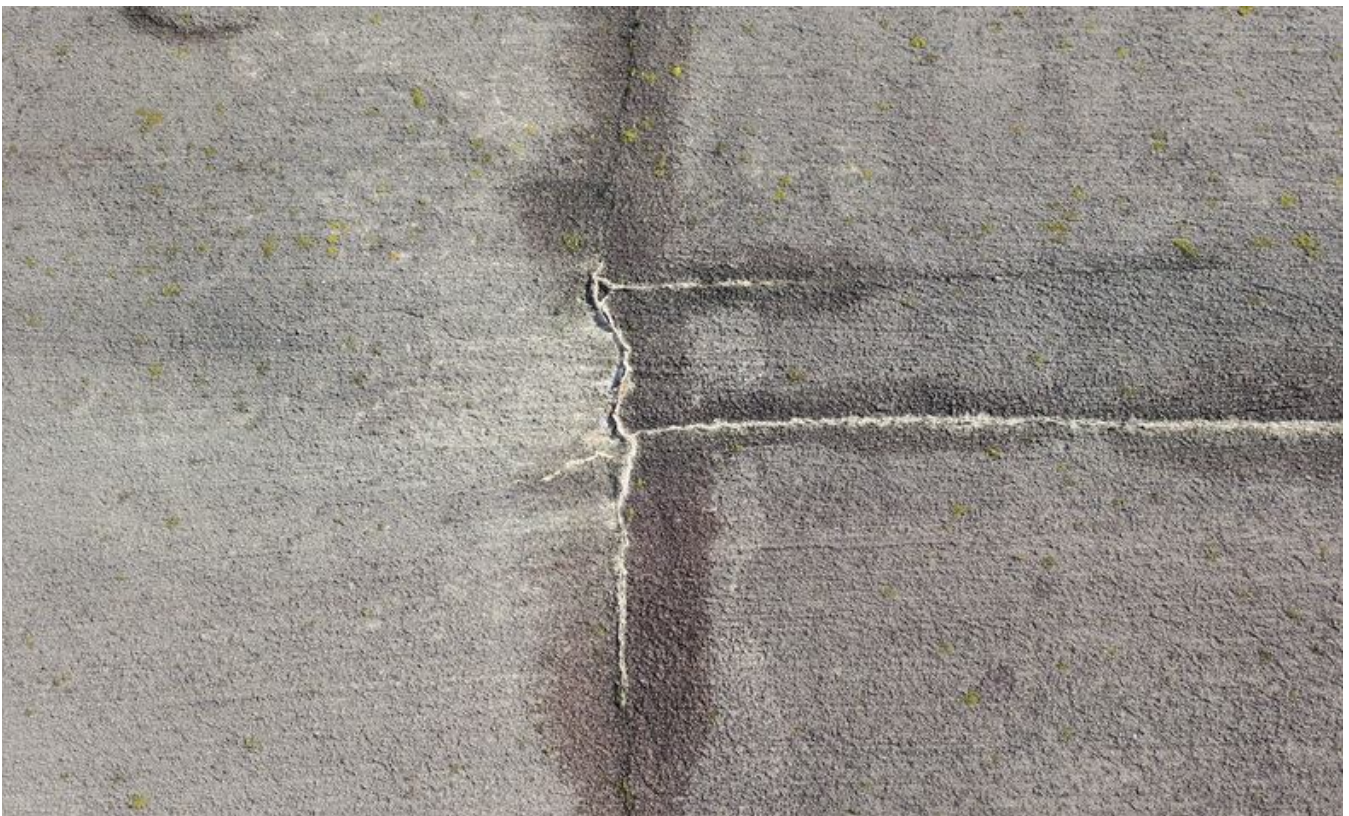
28. Efflorescence in roof.

32. Efflorescence on roof.
