**EVALUATION OF THE  
710,000 GALLON CONCRETE GROUND STORAGE TANK**

**“CRESTWOOD TANK”  
BOSTON, NEW YORK**

**ERIE COUNTY WATER AUTHORITY  
BUFFALO, NEW YORK**

**March 31, 2017**

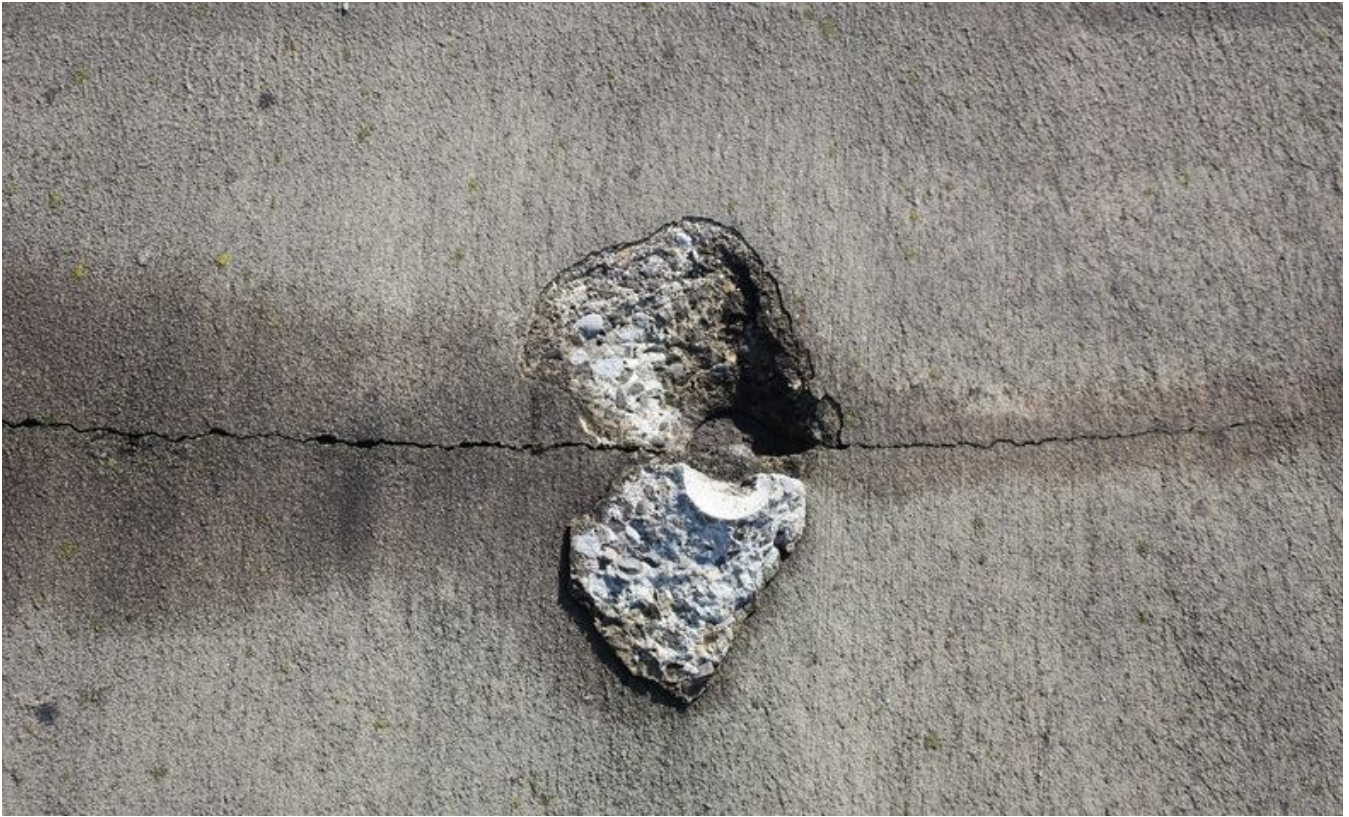
7. **Roof Condition:** The concrete roof exterior appeared to be in fair condition at the time of the field evaluation. Several hairline cracks were observed, and surface voids were located near the edge of the west side of the roof. An area of spalling was also located on the west side of the roof near the edge. Efflorescence was observed at some of the hairline cracks. (See photos 27-33)

33. Spalling and cracking in roof.

1. **Exterior Surfaces:** The exterior concrete surfaces appeared to be in fair to good overall condition at the time of the field evaluation. The exterior should be repaired in 3 years, in conjunction with the interior repairs. The cracks should be filled with a cementitious crack compound to prevent moisture collection from causing additional damage to the tank. For added weathering resistance, the exposed surfaces of the exterior could be coated with a cementitious waterproofing material or sealed with a silane or siloxane coating. If aesthetics are of concern, the mildew could be removed from the shell surfaces.

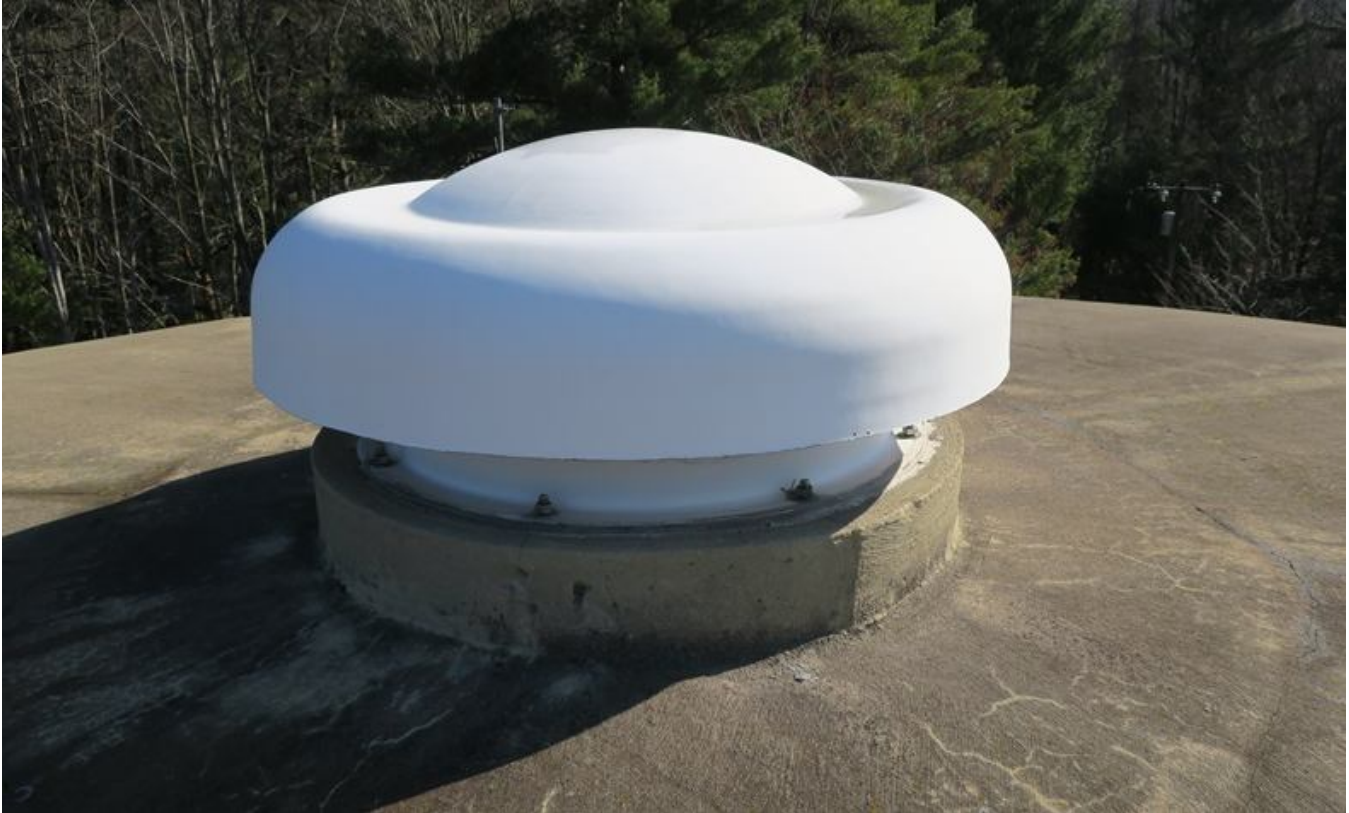
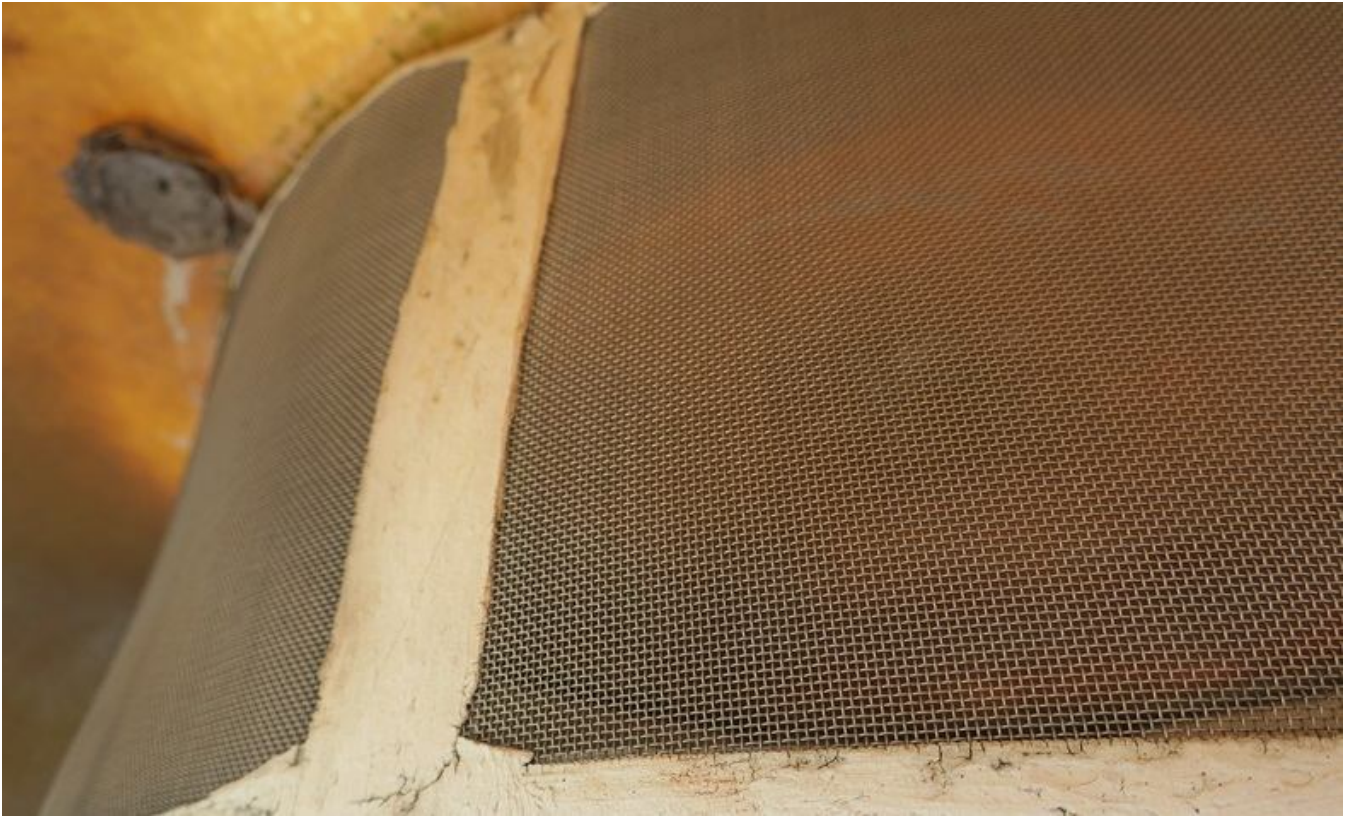
9. **Roof Vent:** The roof was equipped with a dome-cover vent located in the approximate center of the roof. The vertically oriented screening was shielded from wind-driven dust and debris. The screening appeared to be in adequate condition at the time of the field evaluation. (See photos 34-35)

34. Roof vent.

35. Roof vent screening.

9. **Clog-Resistant Vent:** The tank was not equipped with a clog-resistant vent. AWWA D100 Standard (applicable for steel tanks) recommends that all vents with screening against insects be designed to ensure "fail-safe" operation if the insect screens become occluded. However, a concrete roof is typically capable of withstanding more pressure or vacuum than a steel roof. If the Owner desires to provide the utmost in safety, the center vent should be removed and a clog-resistant vent installed in its place. The vent should include a removable cover in order to provide a means of access and egress for personnel.

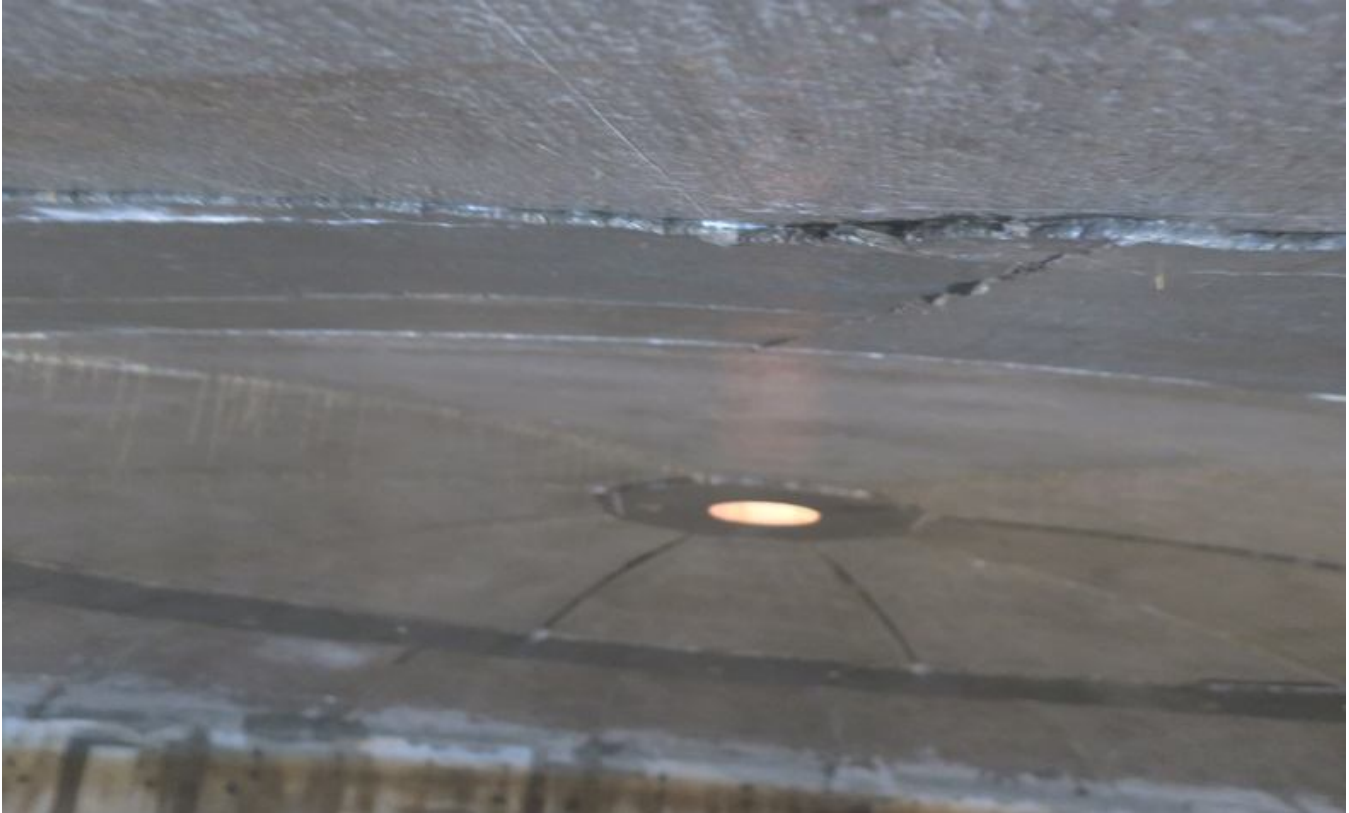
2. **Roof Condition: There was a sanitary deficiency noted: stalactites on the roof indicated that water had infiltrated the roof.** The concrete roof appeared to be in fair condition at the time of the field evaluation. No significant cracks or spalls were observed, but the concrete surface was exceedingly rough. Stalactites were located in a few areas which indicated water had infiltrated the roof. (See photos 36-41)

38. Crack in roof.

1. **Interior Surfaces:** The interior surfaces appeared to be in fair overall condition with cracking noted and stalactites located on the roof. It is recommended the interior be repaired within the next 3 years. A cementitious leak-stopping coating system such as Xypex or Vandex, or a solventless elastomeric polyurethane system such as Polibrid, could be applied to help deter leaks. The coating system should meet the certification criteria of ANSI/NSF 61 regulations.

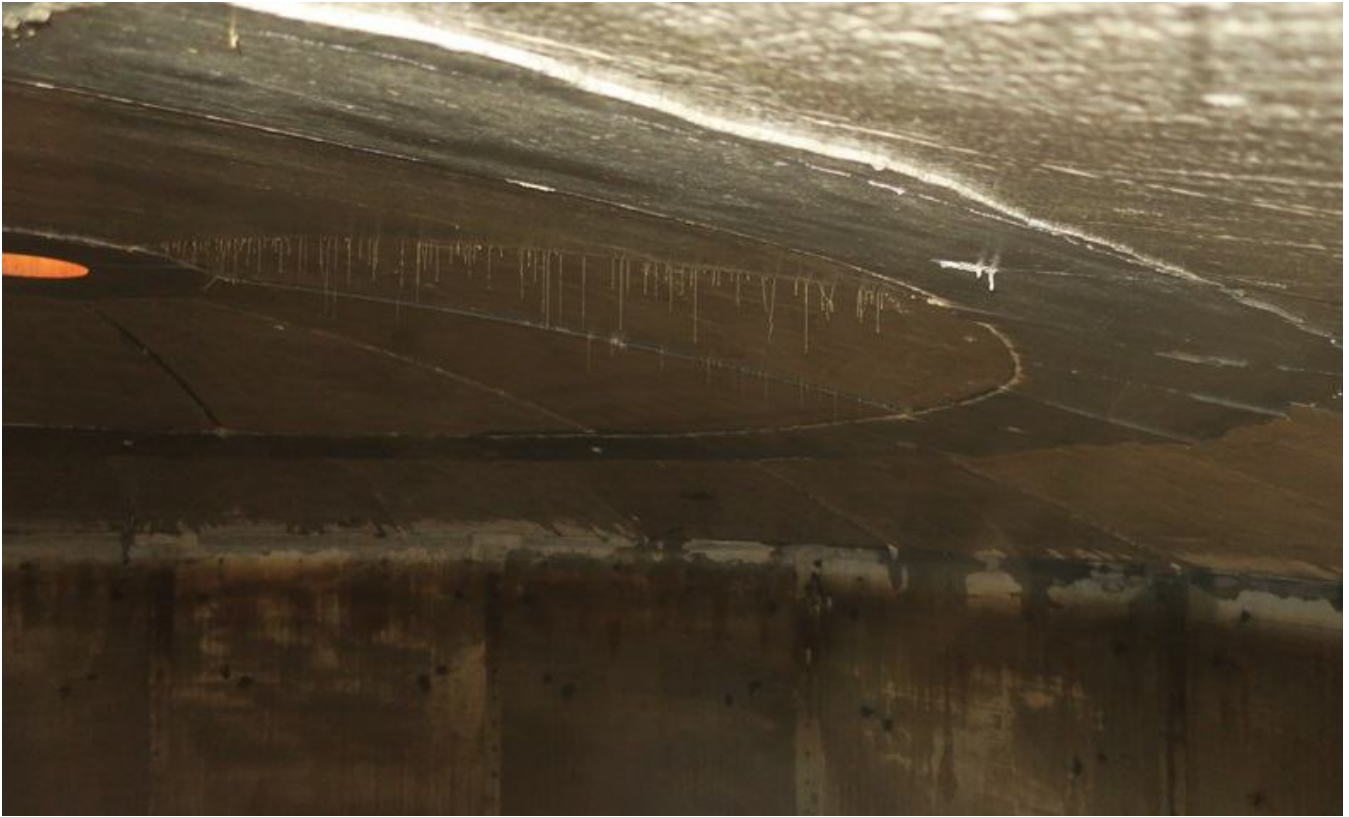
39. Stalactites on roof.

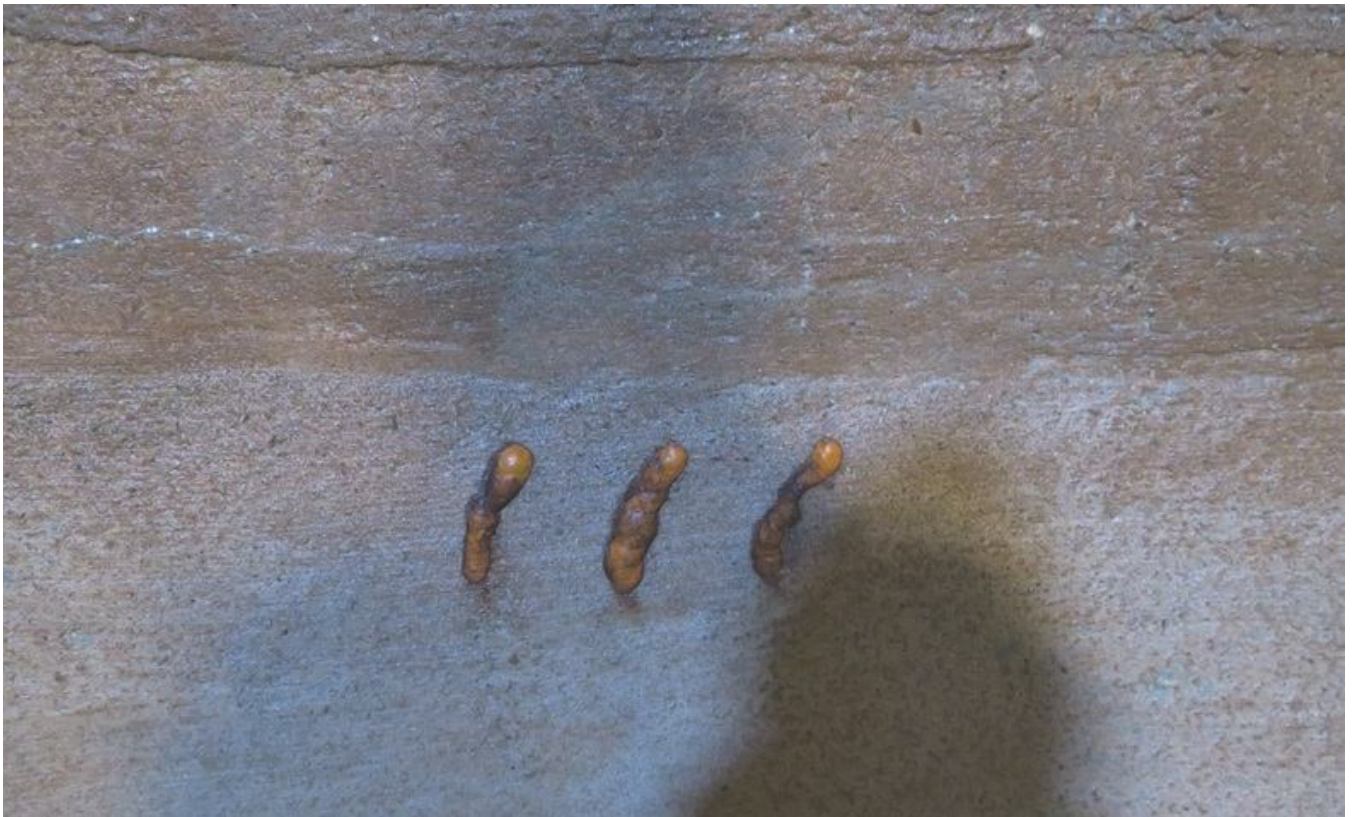
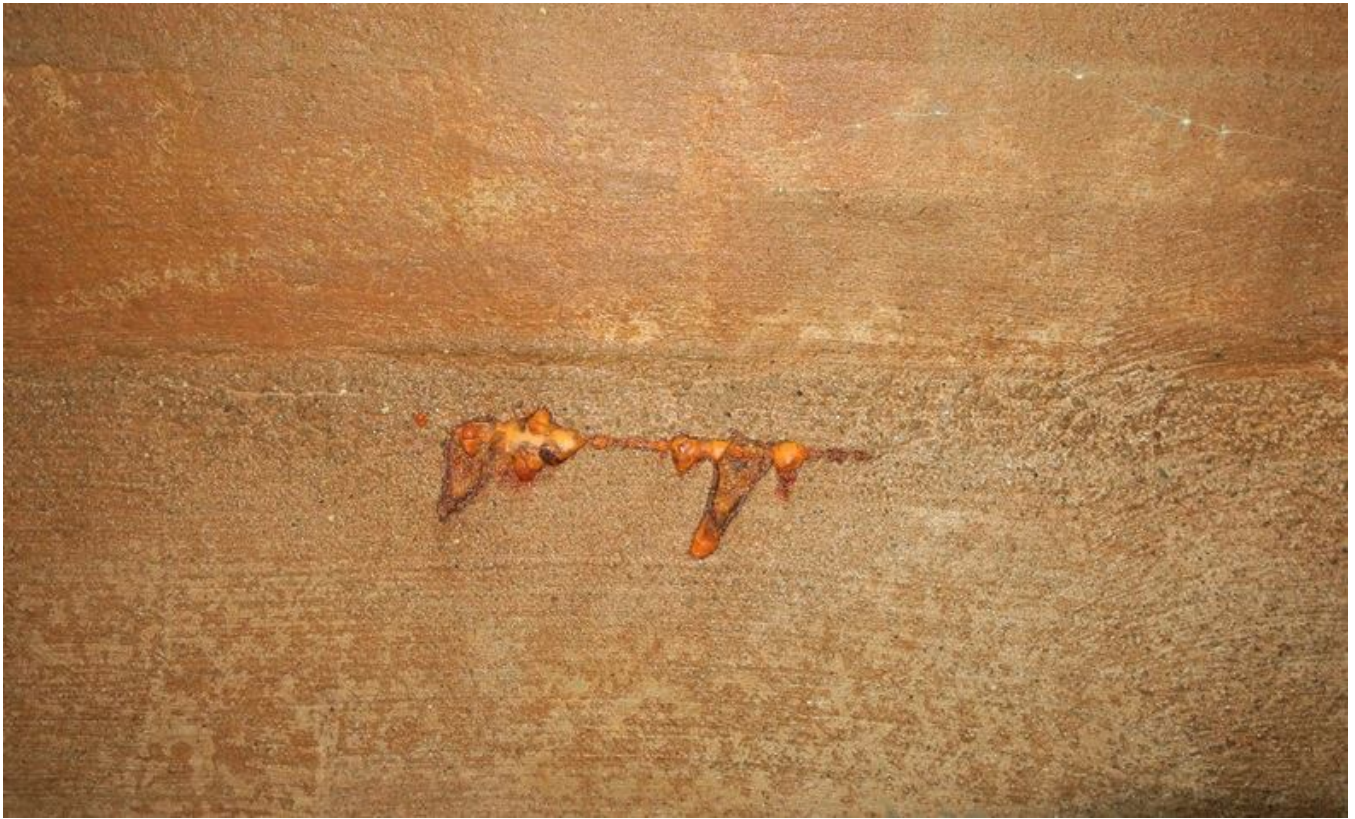
3. **Shell Condition:** The concrete shell appeared to be in generally fair condition as no significant areas of chipping or spalling were noted. Corrosion and rust tubercles were observed at approximately 12 locations where exposed rebar had corroded. Hairline cracks were noted on the shell especially around the overflow pipe pilaster. Sealant was located in a horizontal area near the base of the shell. (See photos 42, 45-49, 53)

48. Rust tubercles at exposed steel in shell.

49. Rust tubercles at exposed steel in shell.

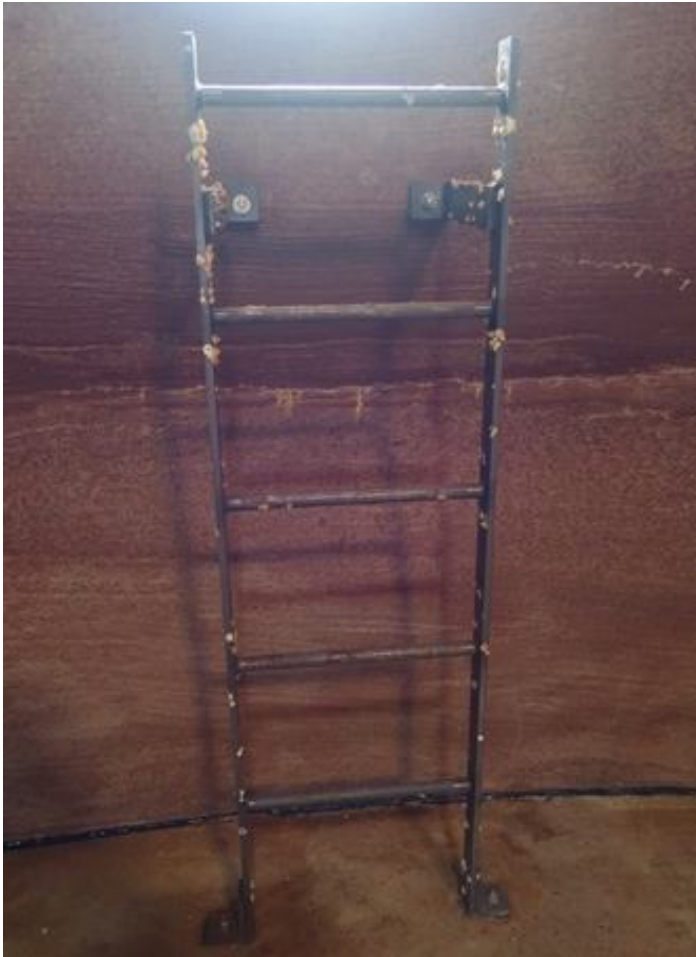
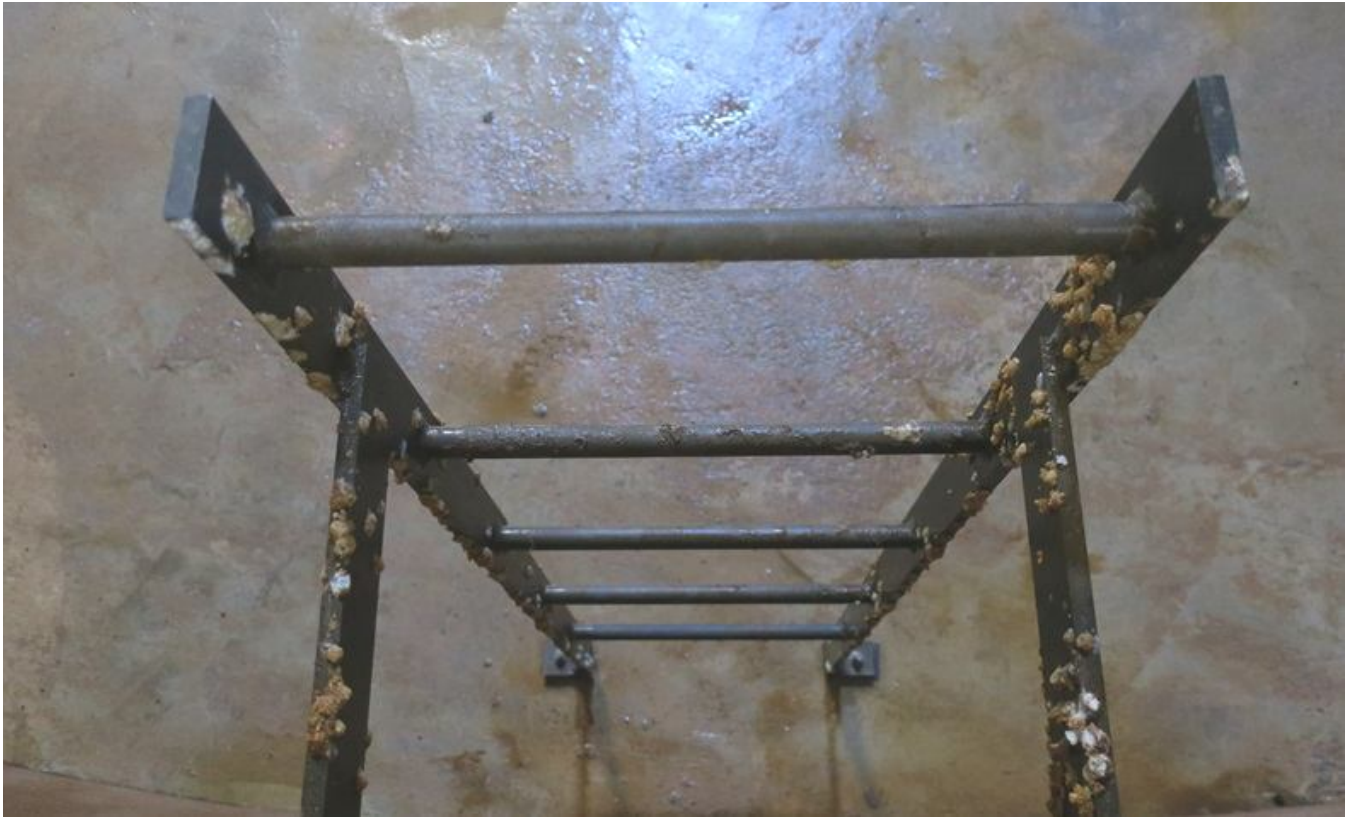
4. **Interior Ladders: There was a safety-related deficiency noted: the deposits on the ladders could injure the climber's hands.** The tank was equipped with two interior ladders which provided access from each shell manhole to the floor. The ladders were welded to brackets which were bolted to the tank. Deposits were noted on the ladders which could injure the climber's hands. Except for the deposits, the ladders and brackets appeared to be in adequate condition at the time of the field evaluation. A bolted grab bar was located above each manhole. (See photos 50-52)

51. Deposits on interior ladder.

53. Deposits on interior ladder.

4. **Interior Ladders:** Interior ladders may be susceptible to ice damage and corrosion. If the Owner decides to keep the interior ladders, the existing ladders should be replaced with fiberglass

ladders. If the ladders are not removed or replaced, the deposits should be removed so they do not injure the climber's hands.

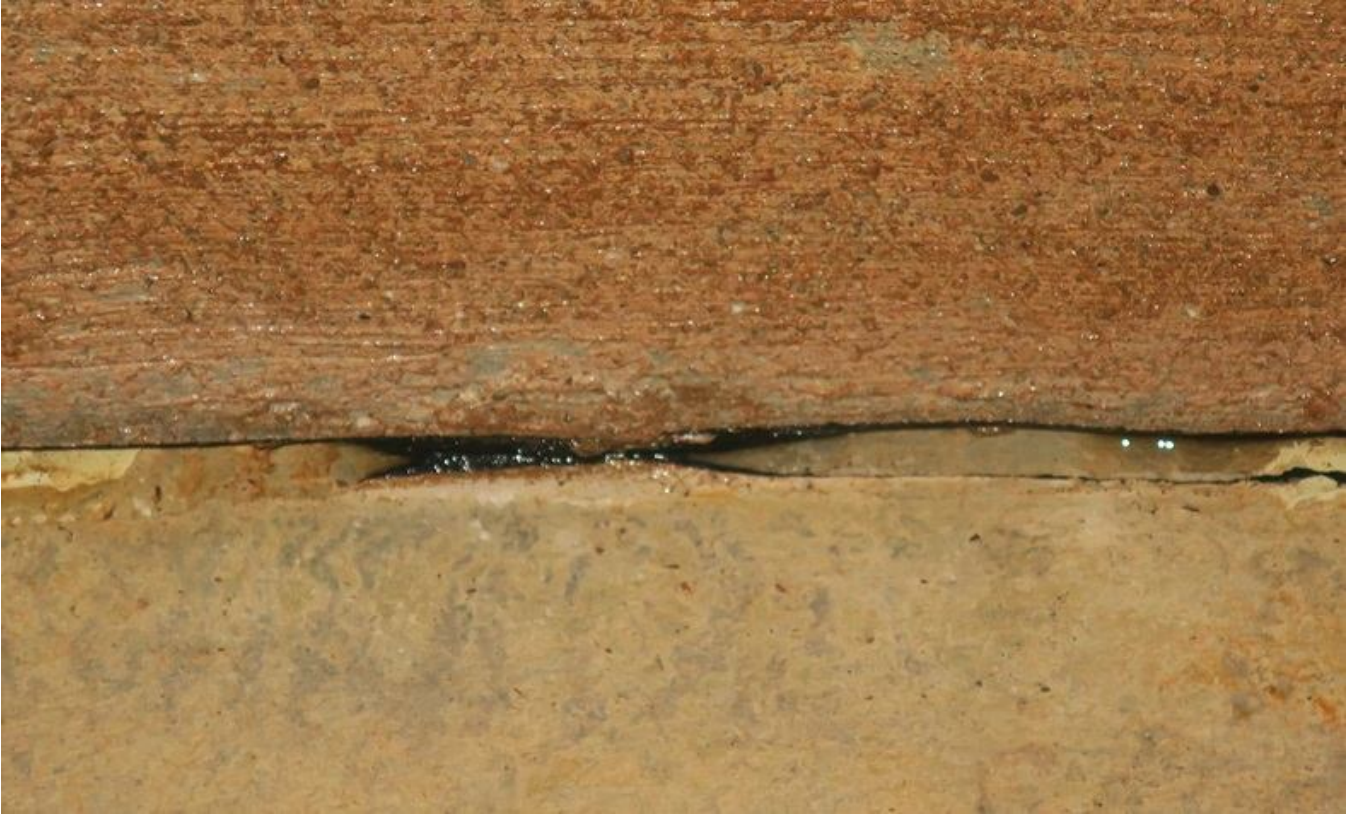
6. **Floor Condition:** The floor appeared to be in good overall condition as no significant areas of cracking or spalling were observed at the time of the field evaluation. A foam gasket-type material was located at the shell-to-floor connection. The gasket material appeared to be in fair condition at the time of the field evaluation with a few voids noted. (See photos 54-56)

54. Voids in material along shell-to-floor connection.

5. **Shell-to-Floor Connection:** The gasket-material located at the shell-to-floor joint should be replaced to eliminate the voids.

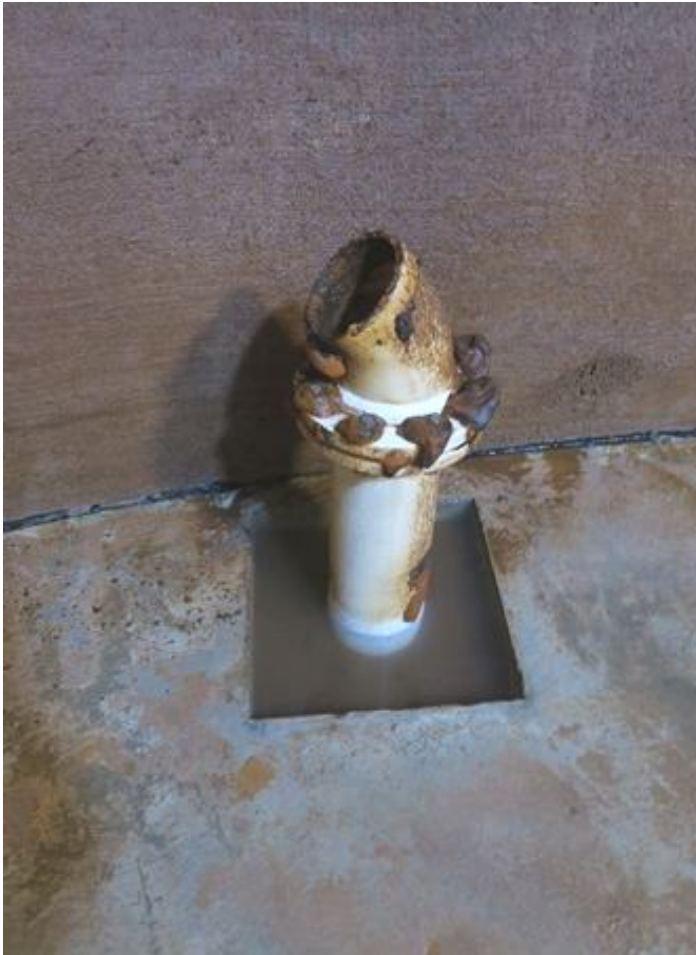
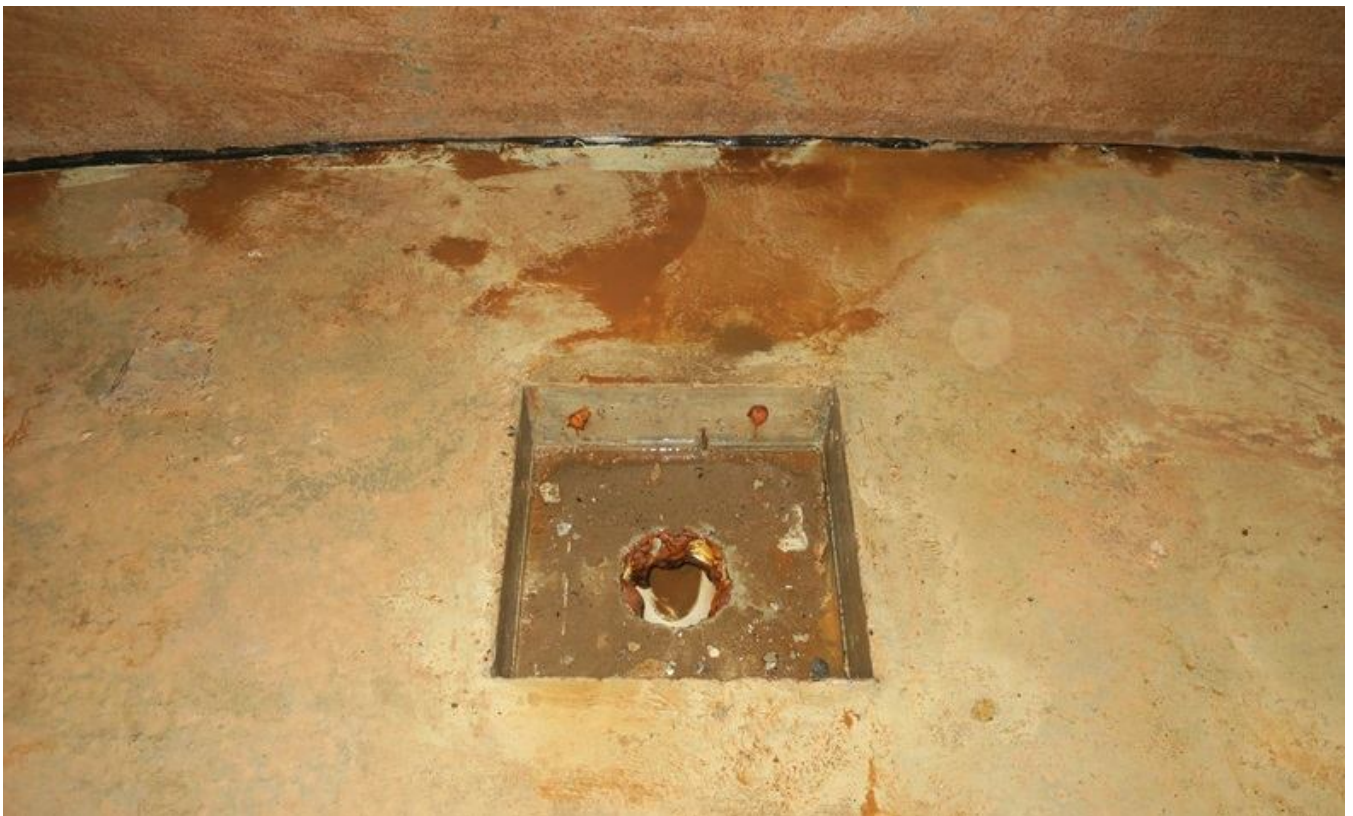
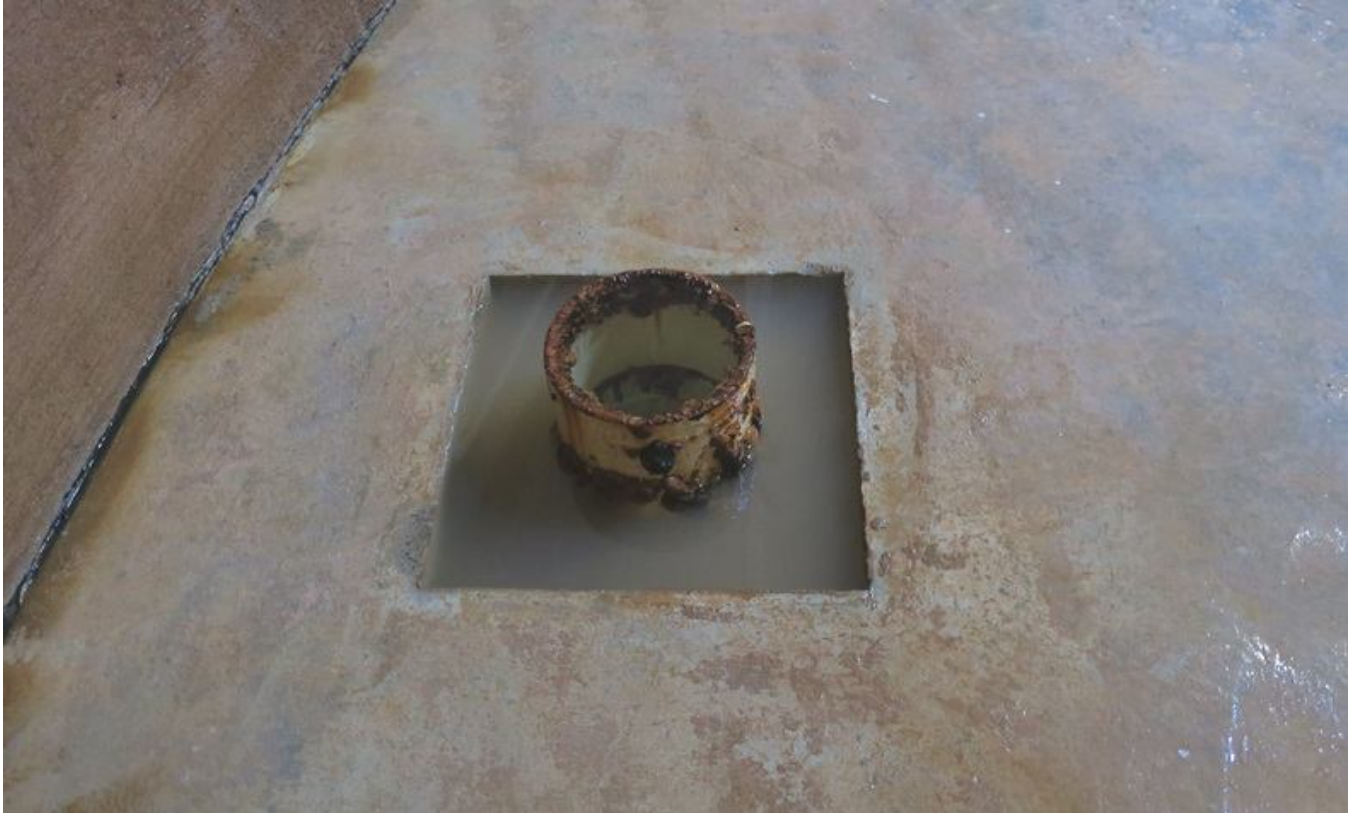
7. **Interior Piping:** The tank was equipped with three pipes which were located within separate basins in the concrete floor. Two of the pipes projected above the basin and tank floor level, and one pipe, the apparent drain pipe, was flush with the basin. The pipes were not equipped with protective covers. Corrosion and rust tubercles were observed on all of the pipes and on the piping bolts. (See photos 57-60)

57. Corrosion on interior pipe projection.

58. Corrosion on piping in sump.

60. Corrosion on piping in sump.

2. **Metal Piping:** The existing metal piping should be cleaned to the equivalent of an SSPC-SP 10, Near-White Blast Cleaning and a three-coat epoxy system applied. Due to the extent of corrosion observed, it is recommended this be performed within the next 2 years.
