**EVALUATION OF THE
350,000 GALLON STEEL STANDPIPE
“RICE HILL TANK”
BOSTON, NEW YORK
FOR
ERIE COUNTY WATER AUTHORITY
BUFFALO, NEW YORK**

October 16 and 17, 2016

16.081.L614.010

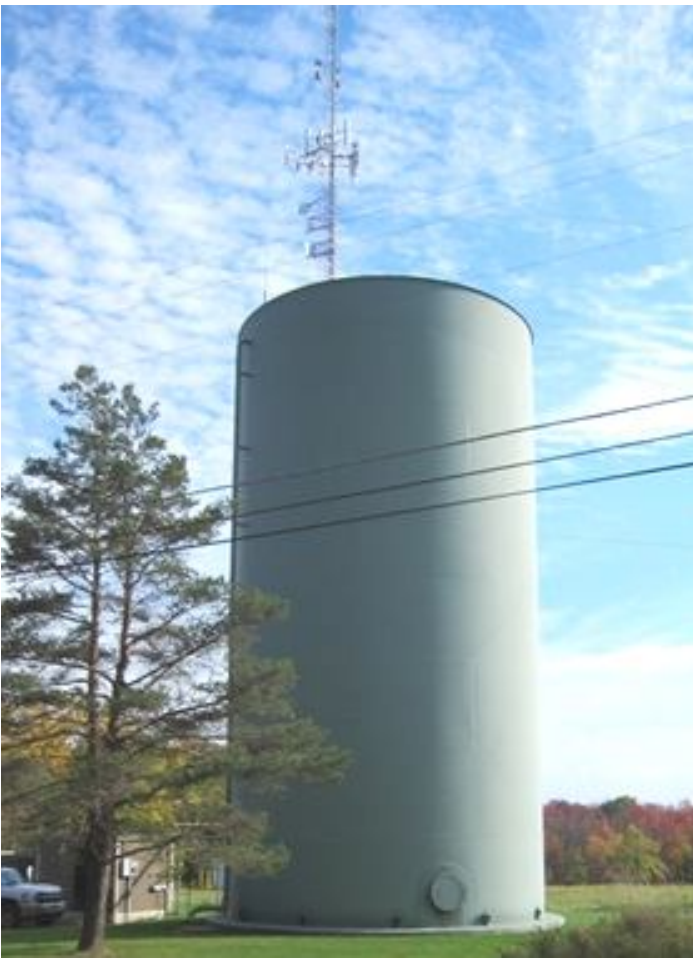
2. **Site Conditions:** The tank site was covered with grass. The site was flat but it appeared to be graded to provide adequate drainage away from the foundation. The tank site was not fenced. However, a locked gate extended across the site access from Zimmerman Road. Two buildings were located on the site. Antenna cables extended under an ice bridge from one of the buildings to the tank. A hydrant was located adjacent to the site access. A T-handle for a valve stem was located adjacent to the overflow pipe storm drain on the site. (See photos 1-2, 7, 12)

1. Tank and site.

1. **Site Maintenance:** The site should be maintained so that the top of the foundation projects a minimum of 6 in. to a maximum of 12 in. above grade and so that proper drainage away from the foundation continues. Site maintenance should be performed with the mower discharge directed away from the base of the tank to prevent rock chips in the coating and the accumulation of grass on the bottom plate.

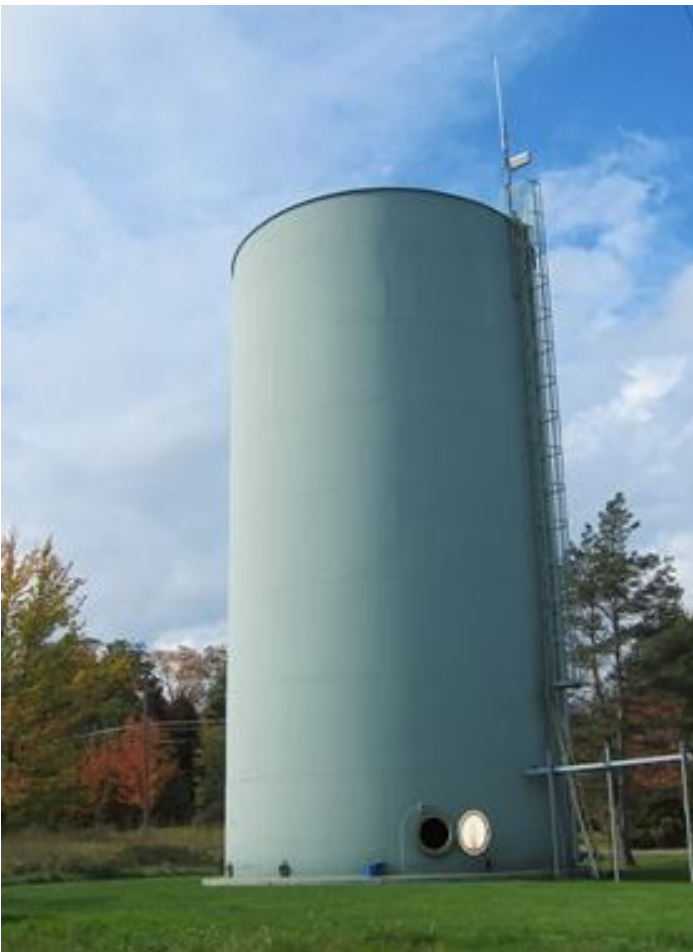
2. Tank and site.

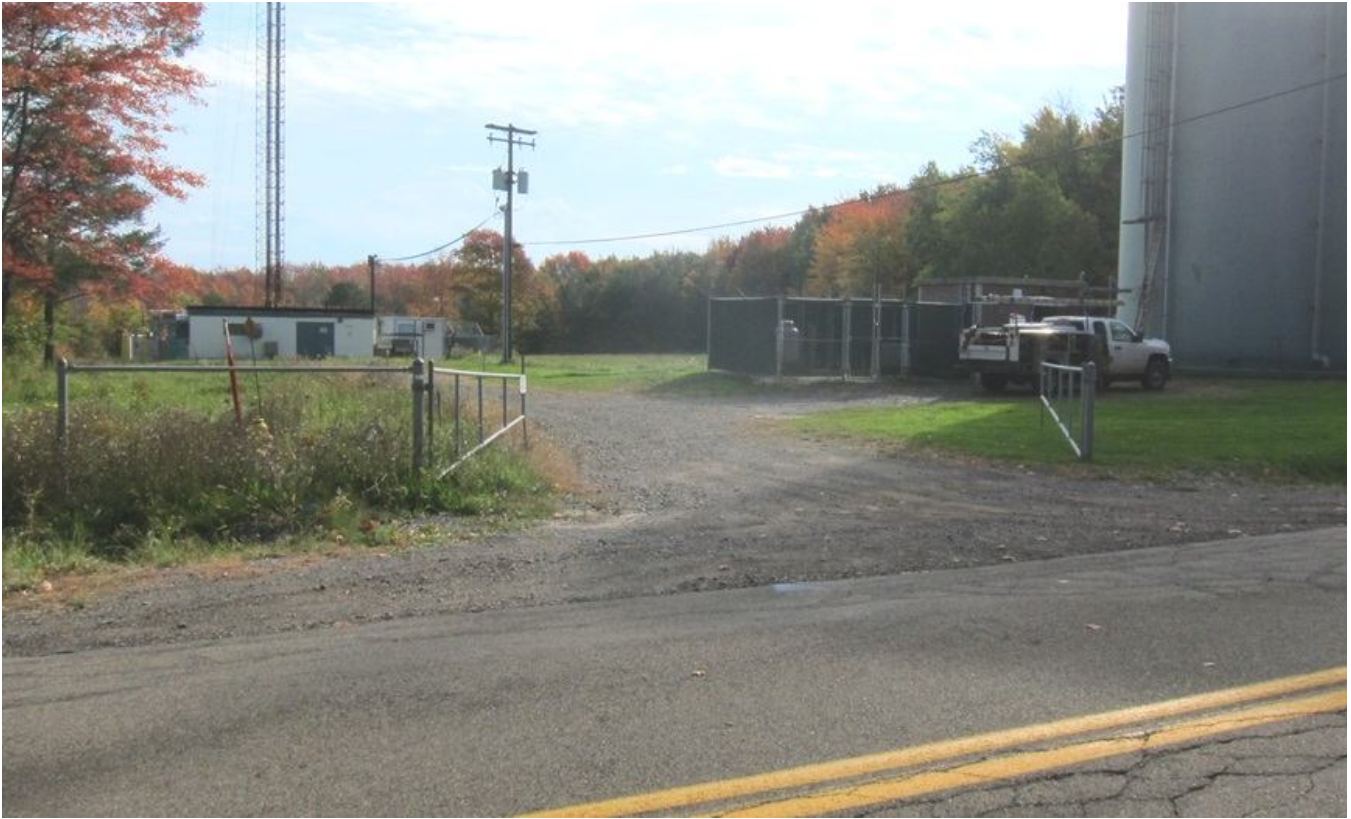
7. Site access.

2. **Tank and Site Security:** Water tanks have been defined by some courts under certain circumstances as attractive nuisances. As such, there may be a significant potential liability to the Owner for injury to persons on the tank and tank site, even if access is not authorized. Recent events have prompted the entire water industry to consider measures that inhibit intentional acts that could threaten the water supply. A review of the security requirements for the tank and site is recommended to confirm that the existing measures are consistent with the Owner's security requirements for their water system. Primary tank and site security should be focused on eliminating, preventing, and detecting unauthorized access to the tank. Such security measures might include routinely and periodically verifying all manholes and gates are locked, and all exterior ladders have suitable deterrents. Other security measures might include installing no-trespass signs, site lighting, surveillance cameras, motion detectors, installing alarms on gates and tank manholes, and arranging more frequent site visits by law enforcement agencies. At a minimum, a chain link fence topped with barbed wire and equipped with a locked gate should be installed around the entire site.

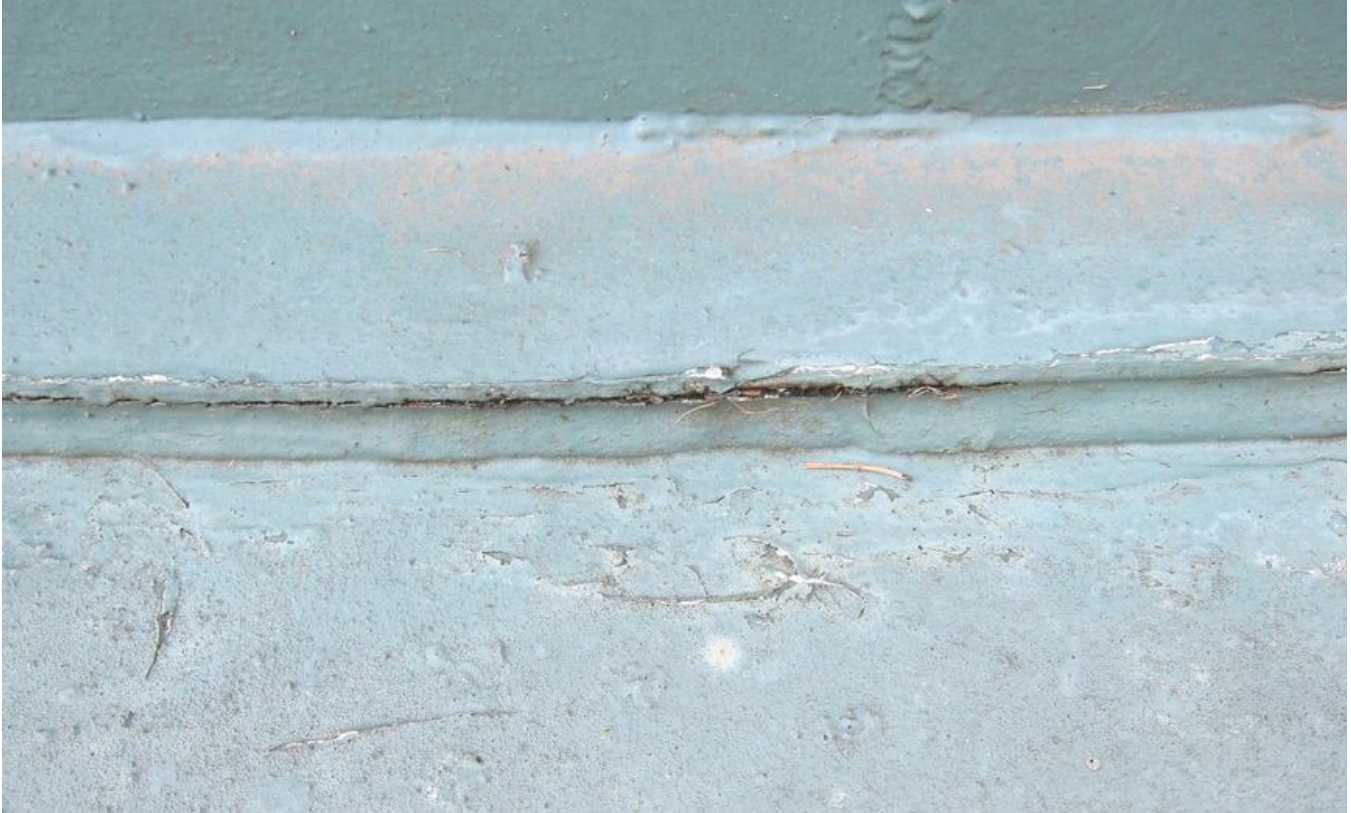
3. **Foundation:** The tank foundation appeared to be a concrete ringwall. No significant areas of chipping, cracking, and or spalling were noted in the exposed surface of the foundation. The foundation exhibited and/or exceeded the AWWA recommended 6 in. to 12 in. projection above grade. The top surface of the foundation had been coated, and the coating appeared to be in good condition. A bracket was bolted to the top of the foundation. (See photos 8-10)

4. **Grout and Sealant:** There was a pad of grout between the tank bottom plate and the concrete foundation. The grout was not visible due to the polyurethane sealant located around the bottom plate-to-foundation interface. The sealant appeared to be in fair overall condition. Isolated areas of cracking and disbonding were observed in the sealant. (See photos 8, 10)

2. **Bottom Plate:** The tank bottom plate extension appeared to be in nearly its original condition at the time of the field evaluation. Random spots of corrosion were located along the perimeter of the bottom plate. (See photos 8, 10)

8. Tank foundation, sealant, and bottom plate projection.

3. **Foundation:** When the tank exterior is repainted, any unsound concrete should be chipped to sound material and the concrete should be brush-off blasted. Any deteriorated areas or voids found should have a bonding agent and a vinyl emollient modified concrete patching mortar applied to build up the surface to its original contour. The concrete should then be painted with a concrete sealer.

5. **Sealant Maintenance:** When the exterior repainting is performed, the existing sealant located between the bottom plate and the foundation should be removed and replaced with a flexible polyurethane sealant.

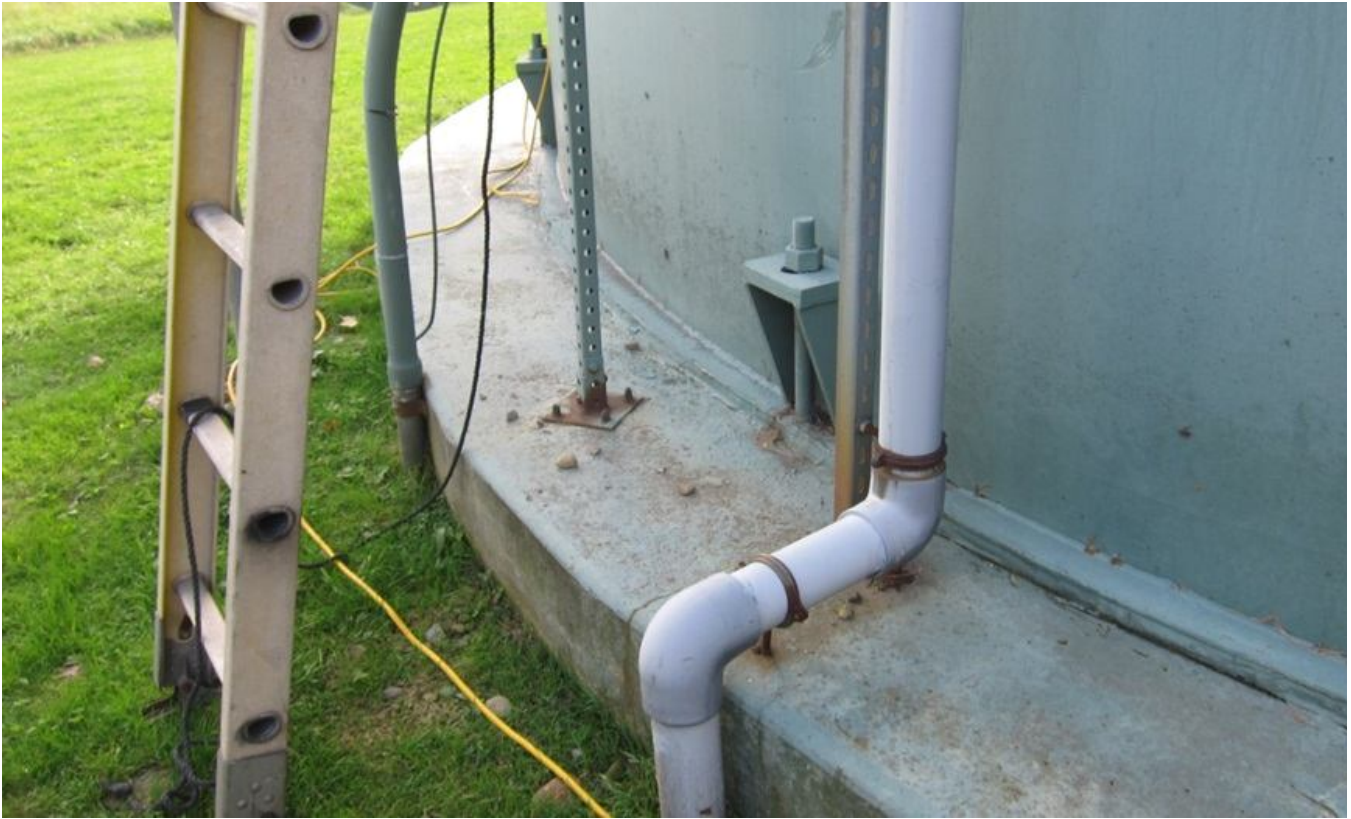
9. Tank foundation, flexible conduit, bracket, and PVC pipe.

13. **Electrical Apparatus:** All unused electrical conduit, antennas, fixtures, electrical metering equipment, and control cabinets should be removed from the tank and tank site. All required equipment should be repaired and maintained in accordance with the National Electric Code (NEC).

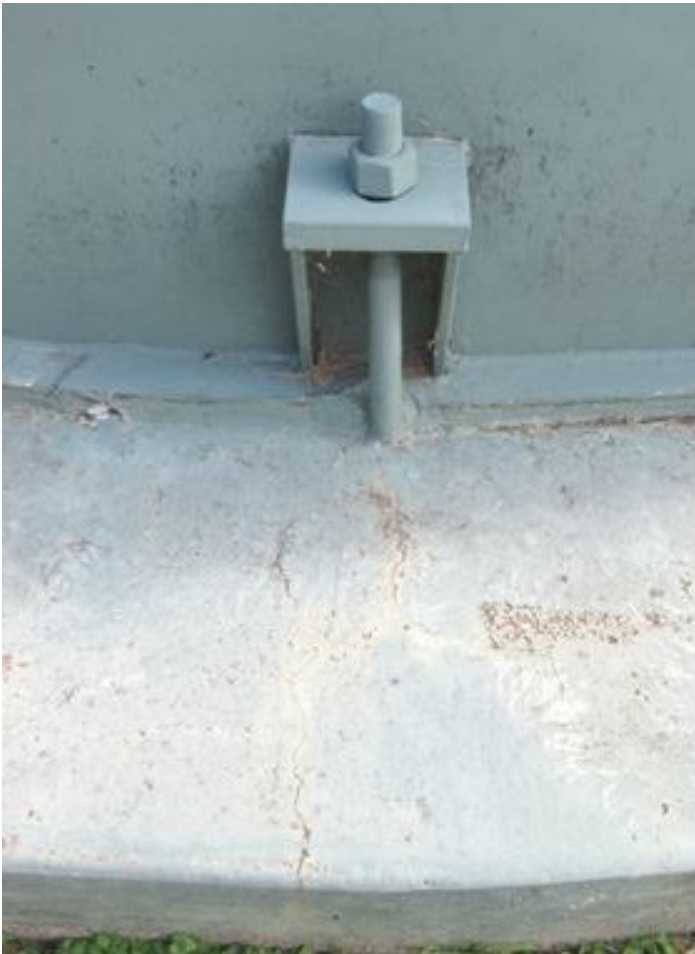
10. Tank foundation, sealant, bottom plate projection, anchor bolt, and chair.

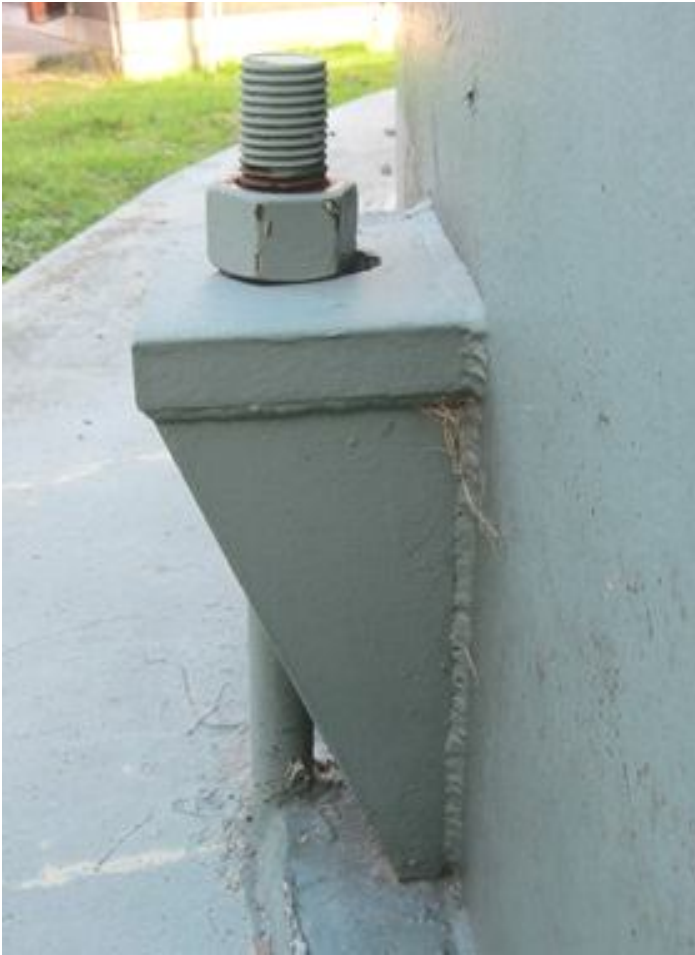
3. **Anchor Bolts and Chairs:** The tank was equipped with twelve anchor bolts and chairs. Minor amounts of debris were observed within the chairs. Corrosion was observed on a few of the bolts. The bolts were not equipped with washers, and gaps were located at the top plate-to-nut interfaces. (See photos 11-12)

11. Anchor bolt and chair. Note gap at nut-to-top plate interface.

12. **Anchor Bolts:** After abrasive blast cleaning, the anchor bolts, chairs, and nuts should be examined for deterioration. If deterioration is found and the anchor bolts are mild steel, the deteriorated areas of the anchor bolts should be repair welded as necessary. Dirt, debris, and grass clippings can accelerate corrosion and should not be allowed to accumulate in the anchor bolt chairs. The gaps at the nut-to-top plate interfaces should be eliminated with washers.

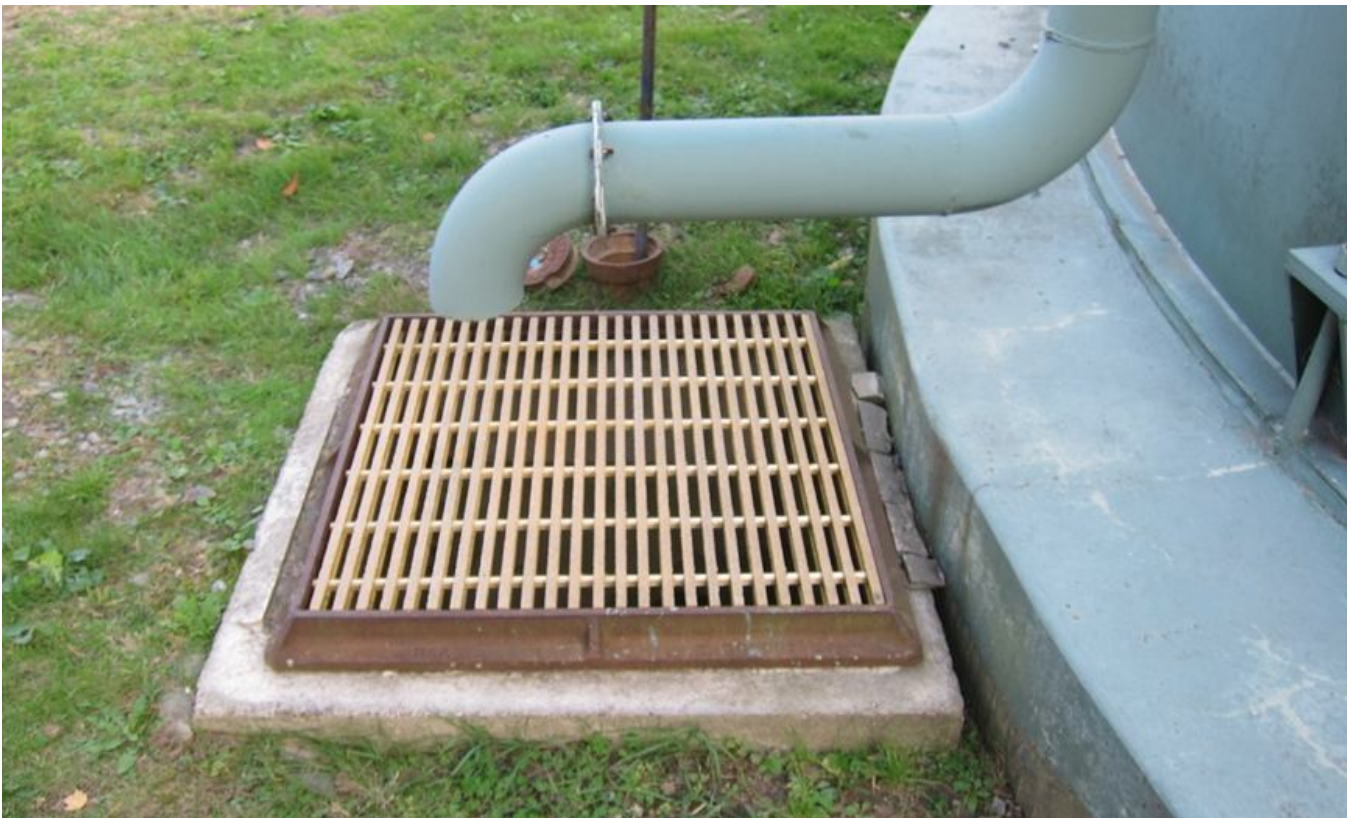
6. **Overflow Pipe:** The overflow pipe exited through the top shell ring and extended down the shell before discharging above a grate-covered storm drain. The discharge end of the pipe was equipped with protective screening to prevent the ingress of insects into the tank. The pipe was equipped with welded steel brackets which appeared to be in their original structural condition at the time of this field evaluation. (See photos 12, 17-18)

12. Overflow pipe discharge above storm drain. Note T-handle behind storm drain.

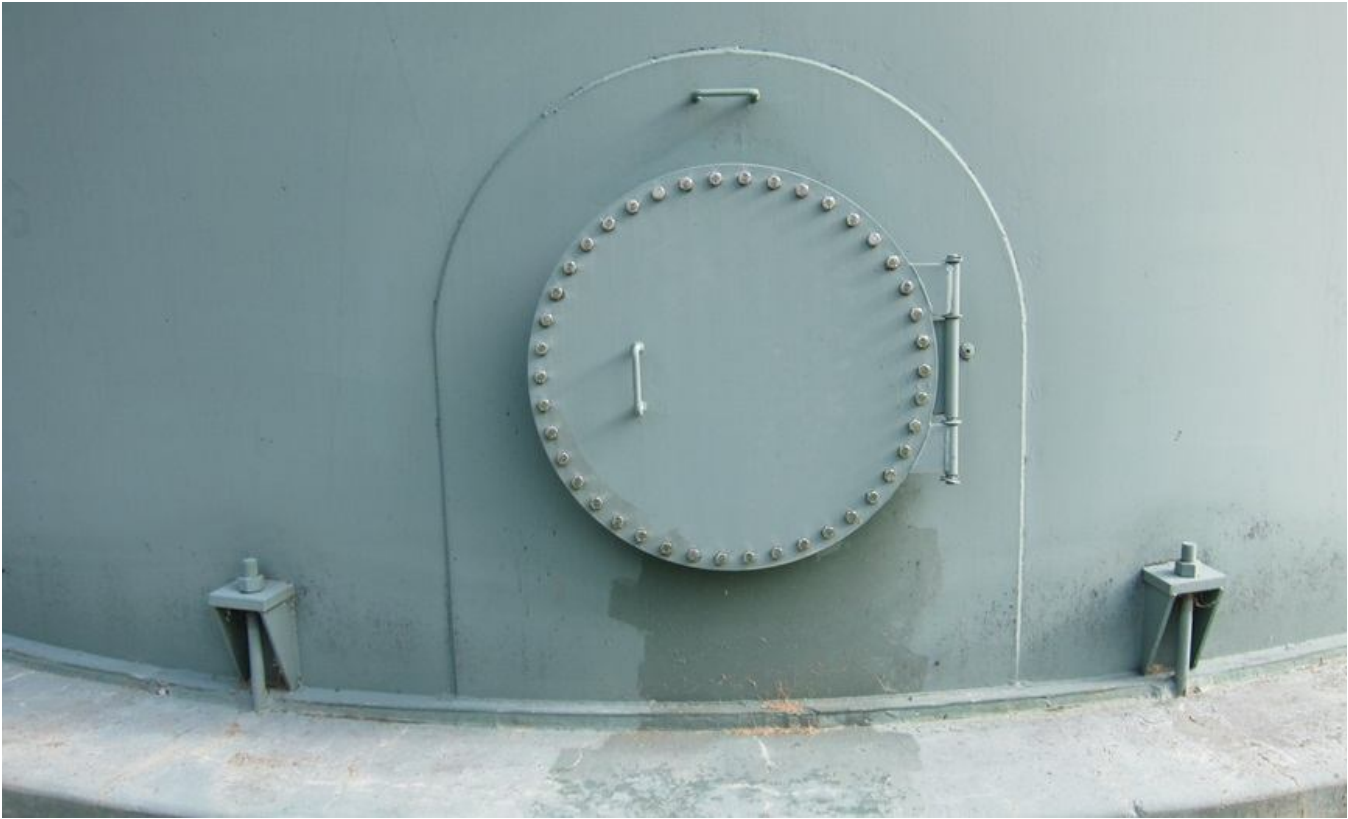
5. **Shell Manholes:** The tank was equipped with two flanged and bolted circular manholes located on the northeast and southwest sides of the tank. The shell plate around each of the manholes was equipped with a reinforcing plate. Open weep holes were located in the reinforcing plates. The manhole covers were equipped with hinged supports located on the exterior of the tank. A hand hold was located on the shell above each manhole. Corrosion and metal loss were located on the interior of the manhole necks. (See photos 13-15)

13. Shell manhole.

14. **Existing Shell Manholes:** At the time of recoating and repairs, the gaskets for the shell manholes should be replaced. The unplugged weep holes should be tapped and plugged.

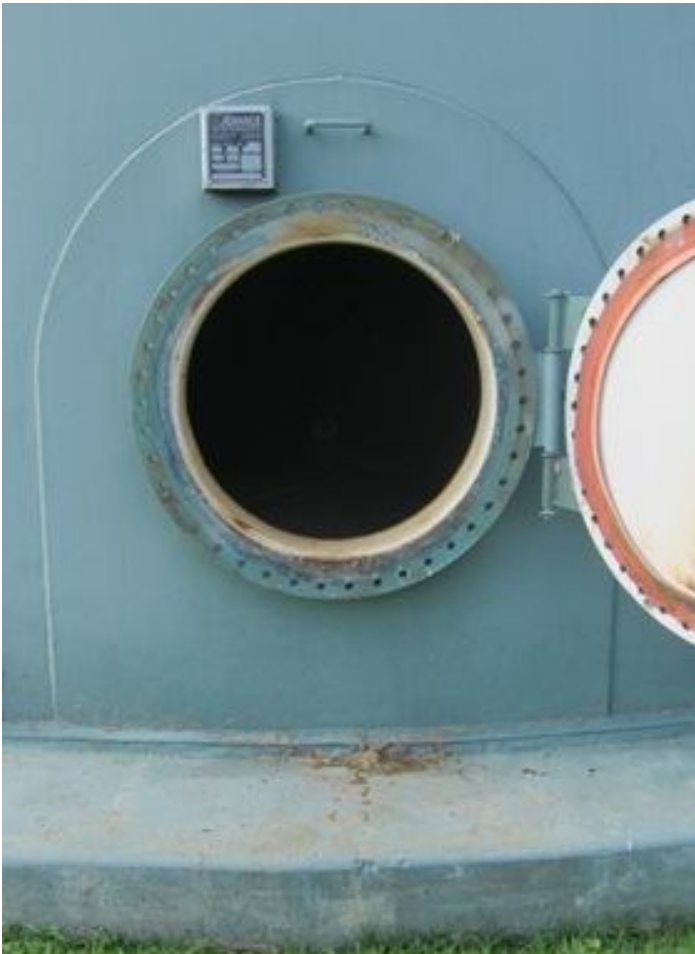
4. **Shell Condition:** The contour of the tank shell was good with no significant discontinuities observed. The coating appeared to be in good overall condition as no significant corrosion was noted. The coating had been touched-up in areas. Overspray, runs, and minor amounts of debris were present in the coating. The coating had chalked and faded, and it exhibited good adhesion to the steel. A tank nameplate was located on the northeast side of the shell on the reinforcing pad for the shell manhole. (See photos 14, 16-17, 24-25)

14. Shell manhole and tank nameplate.

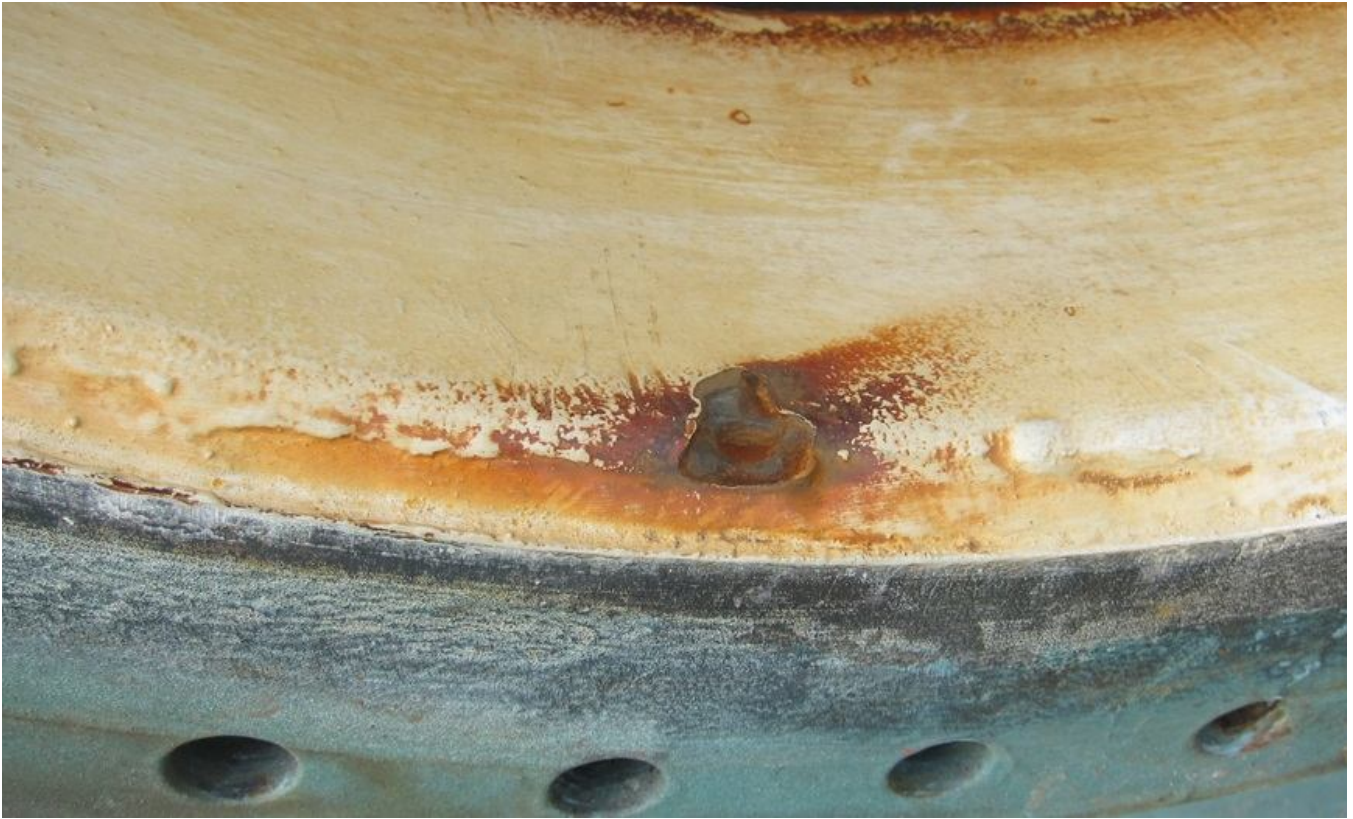
15. Corrosion and metal loss in shell manhole neck.

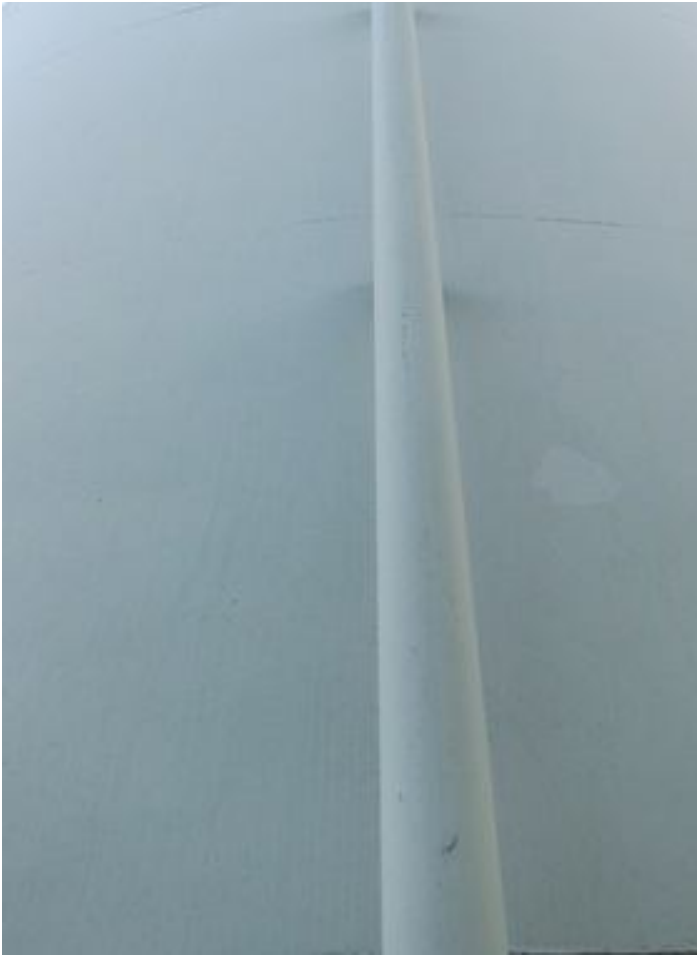
17. Overflow pipe.

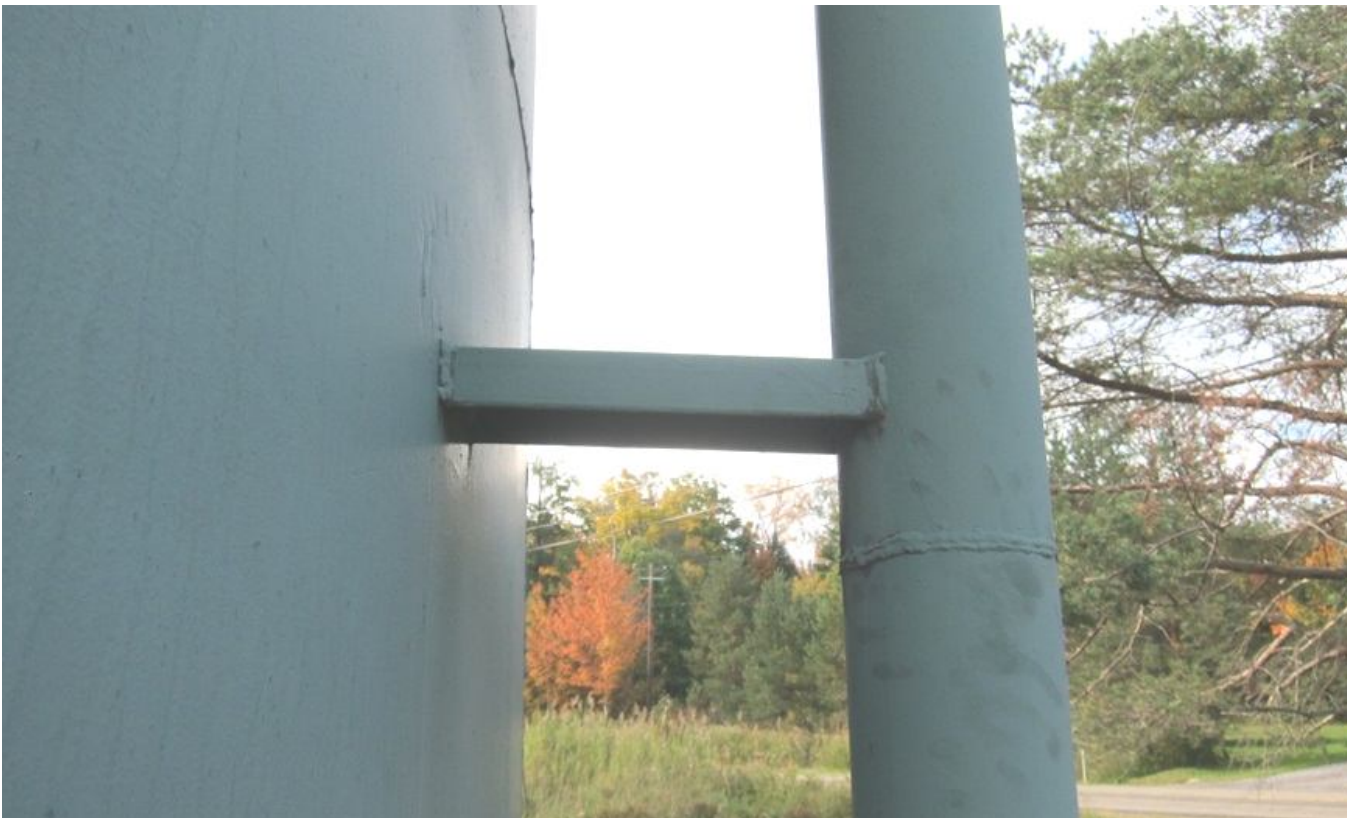
18. Overflow pipe and bracket.

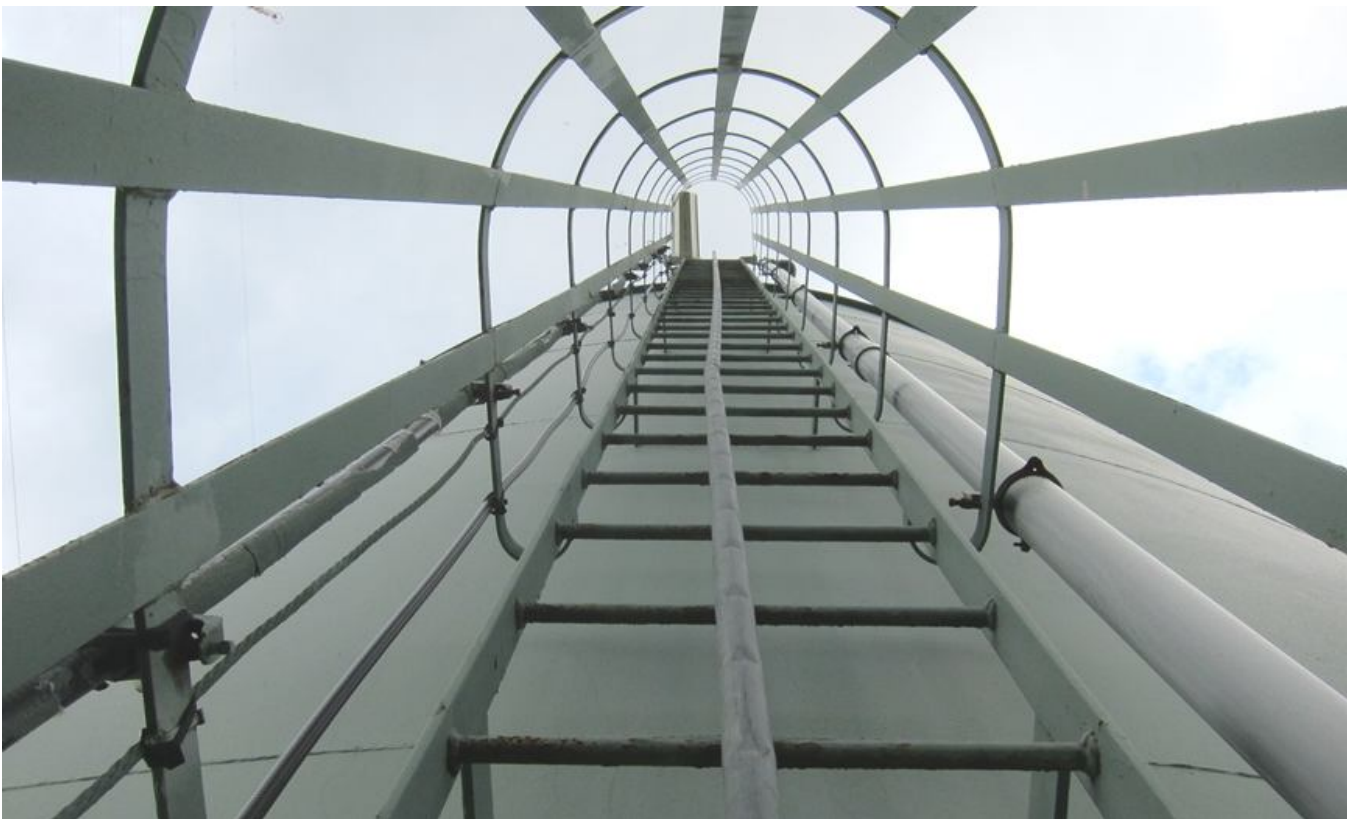
7. **Exterior Shell Ladder:** There were safety deficiencies noted: **(1) the misaligned sections of the safe-climbing device would prevent the sleeve from sliding freely along it, and (2) the safe-climbing device was painted.** A ladder provided access from near grade to the roof. The ladder was equipped with a notched-tubular safe-climbing device. However, two of the rail sections were misaligned and the presence of paint on the device would prevent the sleeve from sliding freely along it. The exterior ladder was equipped with a safety cage constructed of welded flat bar members. The base of the safety cage was flared. A flexible conduit, grounding cable, and coaxial cable were clamped to one side of the safety cage, and a PVC pipe was clamped to the other side of the safety cage. The flexible conduit had been coated although the coating had peeled in widespread areas. The exterior ladder was welded to brackets which were welded to the shell. The exterior ladder and brackets appeared to be in nearly their original structural condition at the time of this field evaluation. The base of the ladder was equipped with a hinged door-type vandal deterrent. The vandal deterrent was locked prior to and after the field evaluation. Two antennas were attached to the safety cage at the roof access. A grate step was located at the roof access. (See photos 19-23, 26-27)

20. Exterior ladder, conduit, cables, safe-climbing device, PVC, and safety cage.

15. **Exterior Ladder:** The painted and misaligned safe-climbing device should be replaced. A safety cage is not required on a ladder with a safe-climbing device. To reduce cleaning and painting costs and future maintenance costs, the shell ladder cage could be removed. The exterior ladder not include slip-resistant rungs. Slip-resistant rungs are required for all ladders constructed after March 1991 by the OSHA Construction standards. However, slip-resistant rungs are not required by the OSHA General Industry standards for ladders or by AWWA D100.

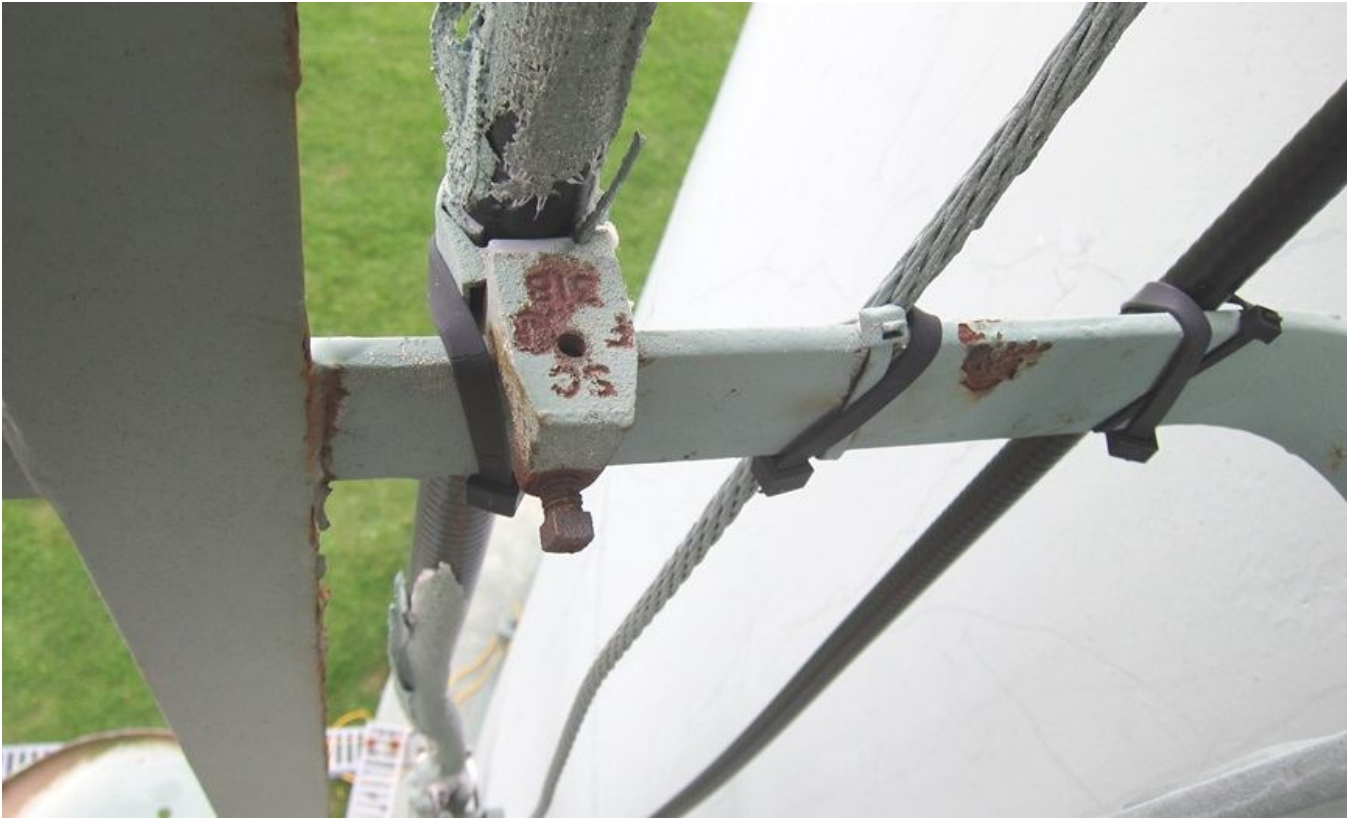
21. Flexible conduit, cable, and coaxial cable on safety cage.

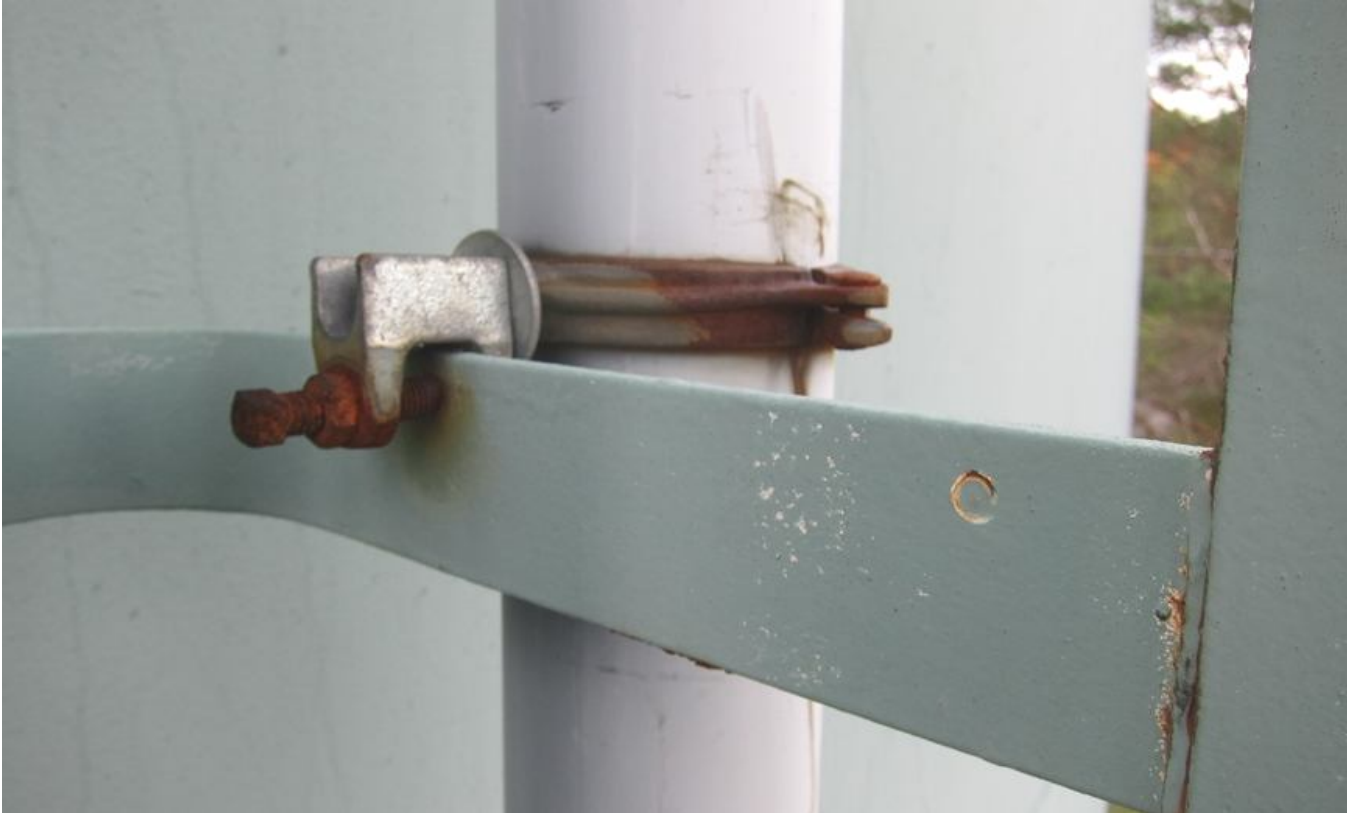
22. PVC pipe bolted to ladder safety cage.

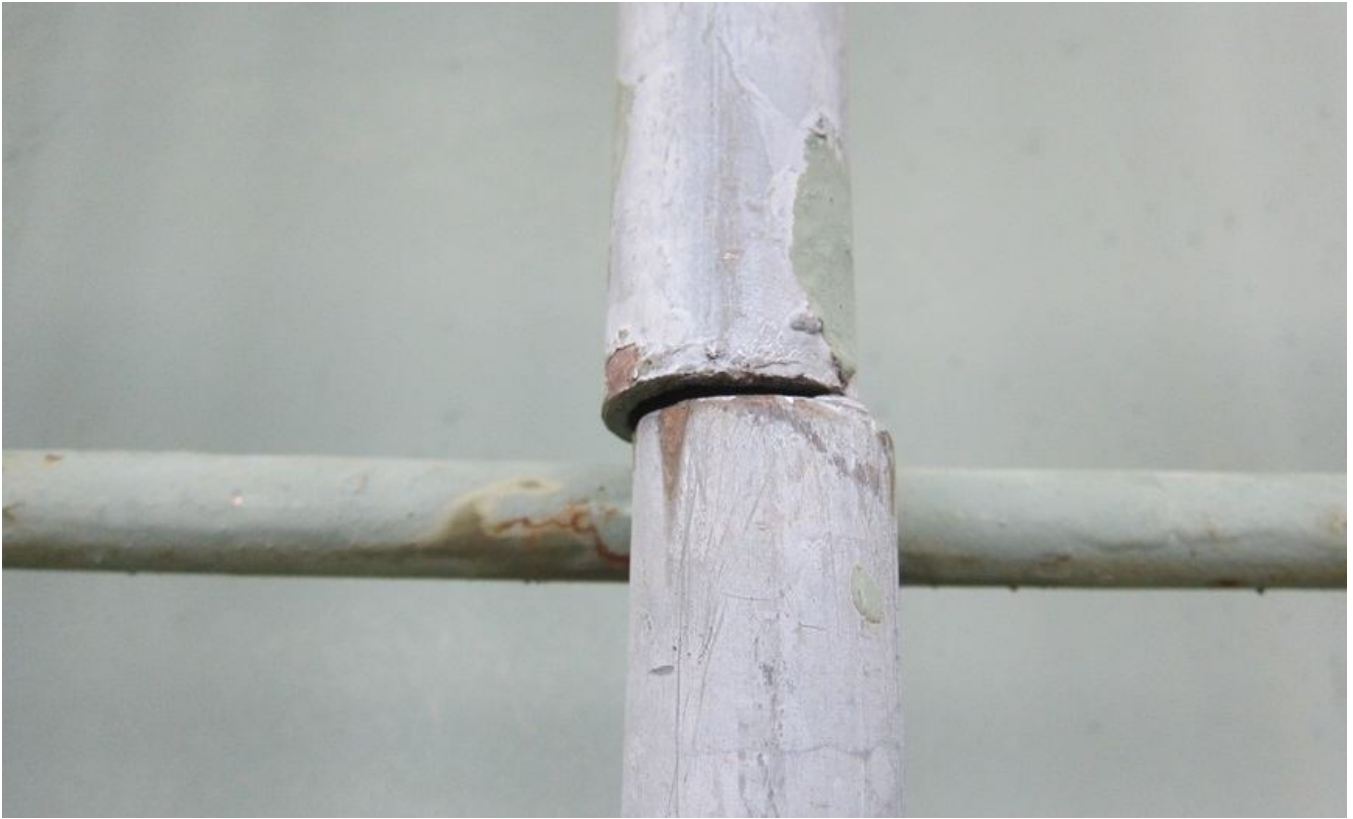
23. Misaligned notched-tubular rail sections.

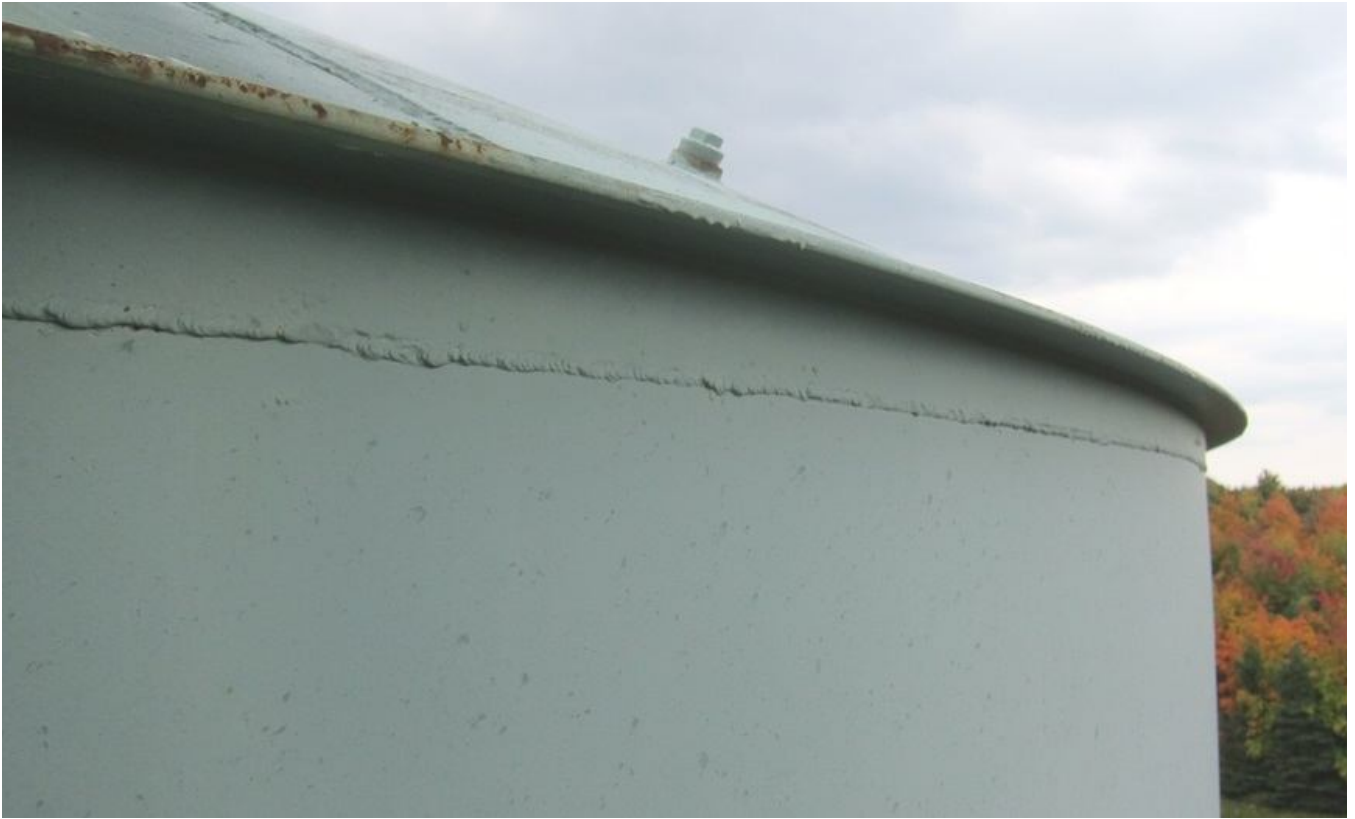
9. **Roof Condition:** There was a sanitary deficiency noted: **one coupling was open.** The contour of the roof appeared adequate with no significant discontinuities noted. The roof coating appeared to be good overall condition. A few areas of peeled coating and corrosion were located near the perimeter. The coating had chalked, faded, and weathered. The roof coating exhibited good adhesion to the steel. Ten couplings were located near the roof perimeter. Nine of these were threaded and plugged while the tenth was open. Four lugs were located on the upper finger plates. **The lugs should not be used for rigging purposes.** (See photos 25, 30-33)

25. Top shell angle and threaded and plugged roof coupling.

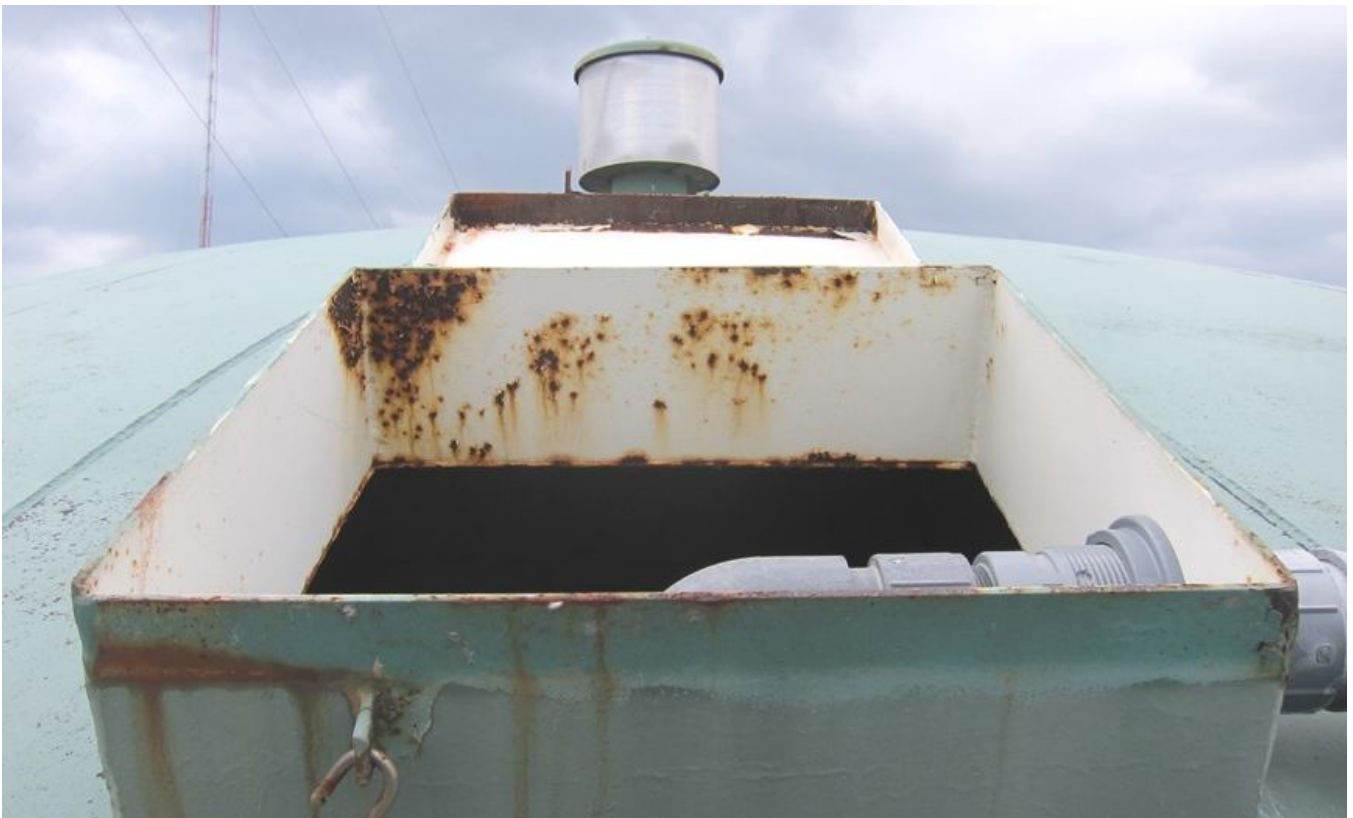
10. **Roof Manhole:** There were safety-related deficiencies noted: **(1) the ball valve penetrating the manhole neck restricted personnel access through the manhole, and (2) the manhole cover opened toward the center of the roof.** The roof was equipped with one hinged cover manhole. The roof manhole was locked prior to and after this evaluation. The roof manhole was welded on the exterior only. Corrosion was observed on the interior surfaces of the roof manhole. A 3 in. diameter PVC pipe penetrated the manhole neck and extended into the manhole opening before ending in a ball valve. (See photos 27-29)

28. Corrosion on roof manhole.

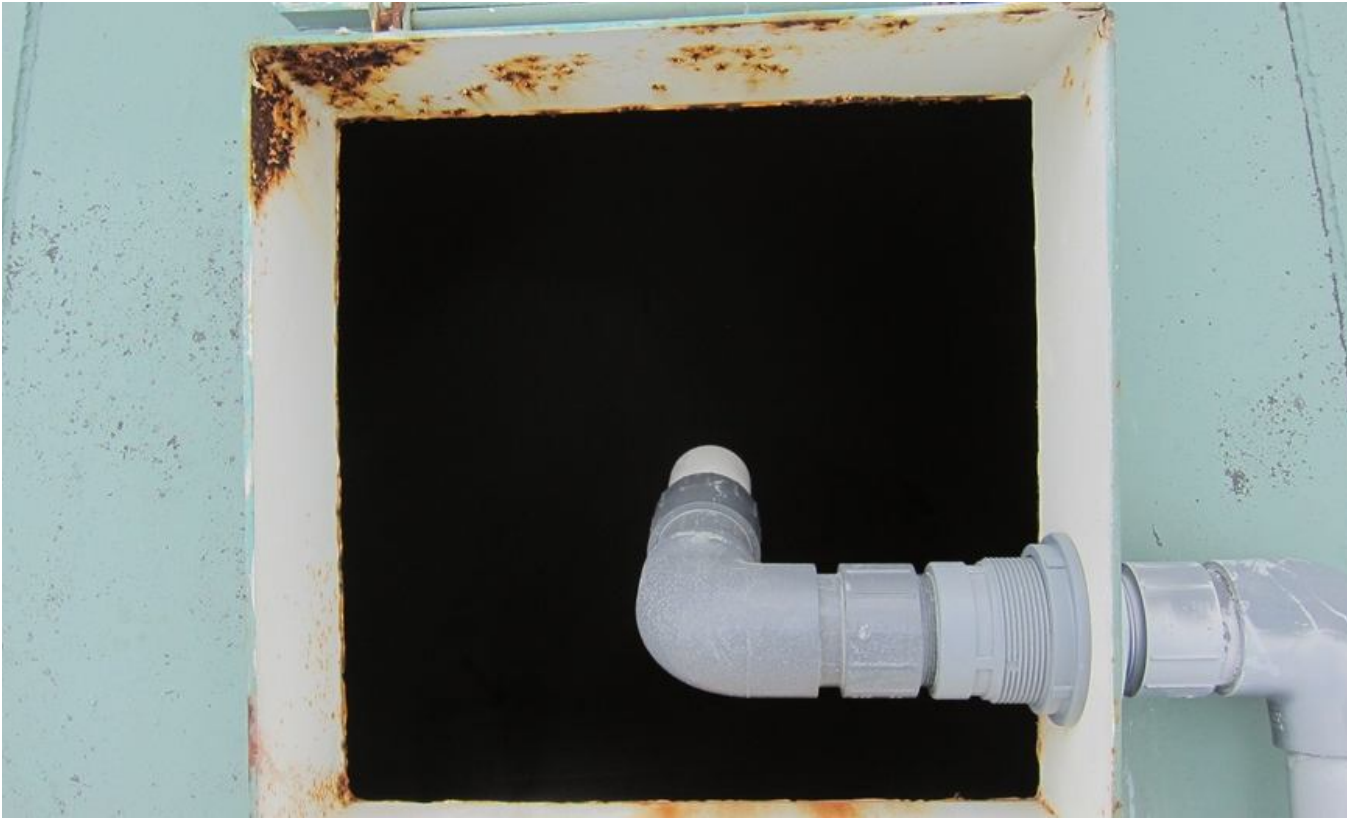
29. Piping extending into roof manhole.
