**EVALUATION OF THE
350,000 GALLON STEEL STANDPIPE
“RICE HILL TANK”
BOSTON, NEW YORK
FOR
ERIE COUNTY WATER AUTHORITY
BUFFALO, NEW YORK**

October 16 and 17, 2016

16.081.L614.010

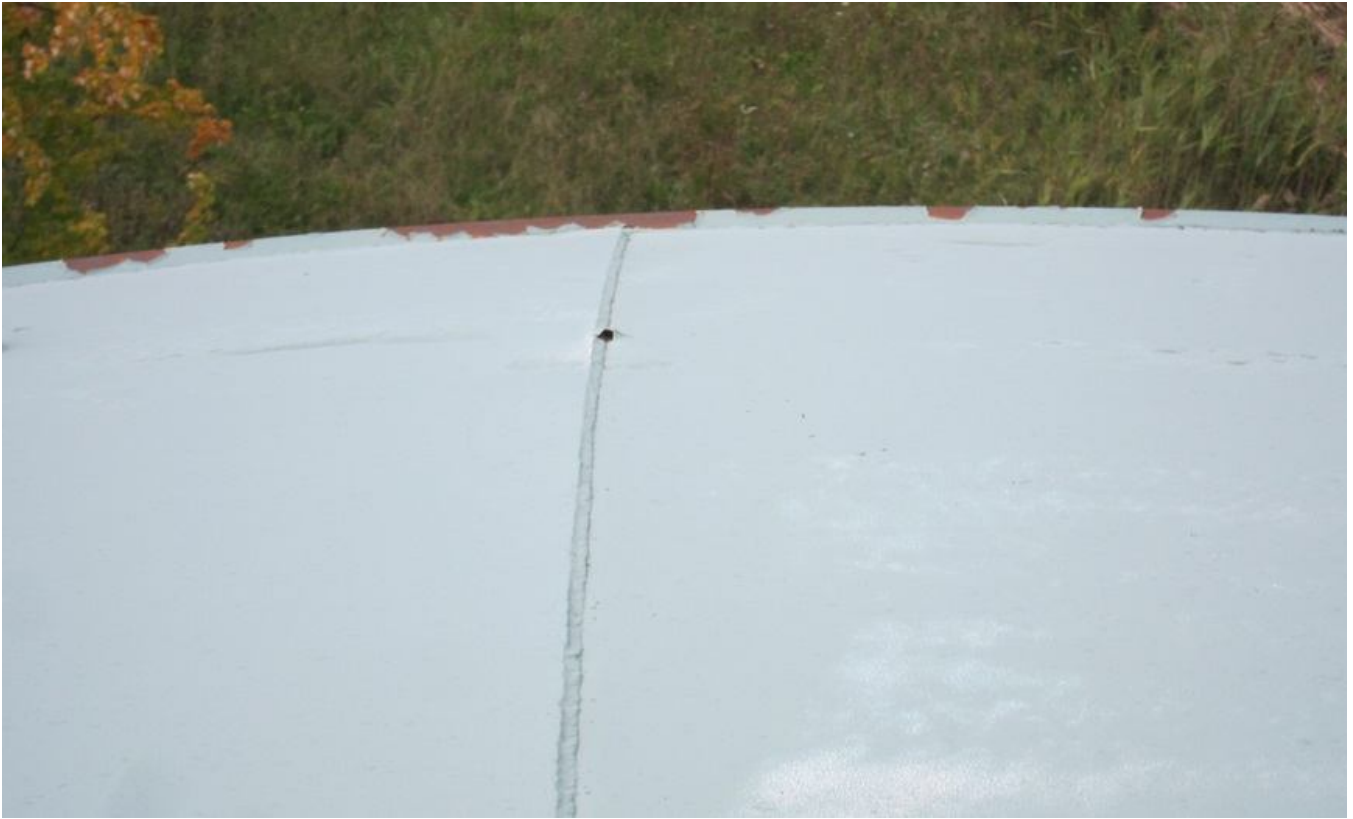
9. **Roof Condition:** There was a sanitary deficiency noted: **one coupling was open.** The contour of the roof appeared adequate with no significant discontinuities noted. The roof coating appeared to be good overall condition. A few areas of peeled coating and corrosion were located near the perimeter. The coating had chalked, faded, and weathered. The roof coating exhibited good adhesion to the steel. Ten couplings were located near the roof perimeter. Nine of these were threaded and plugged while the tenth was open. Four lugs were located on the upper finger plates. **The lugs should not be used for rigging purposes.** (See photos 25, 30-33)

31. Peeled coating and corrosion along roof perimeter.

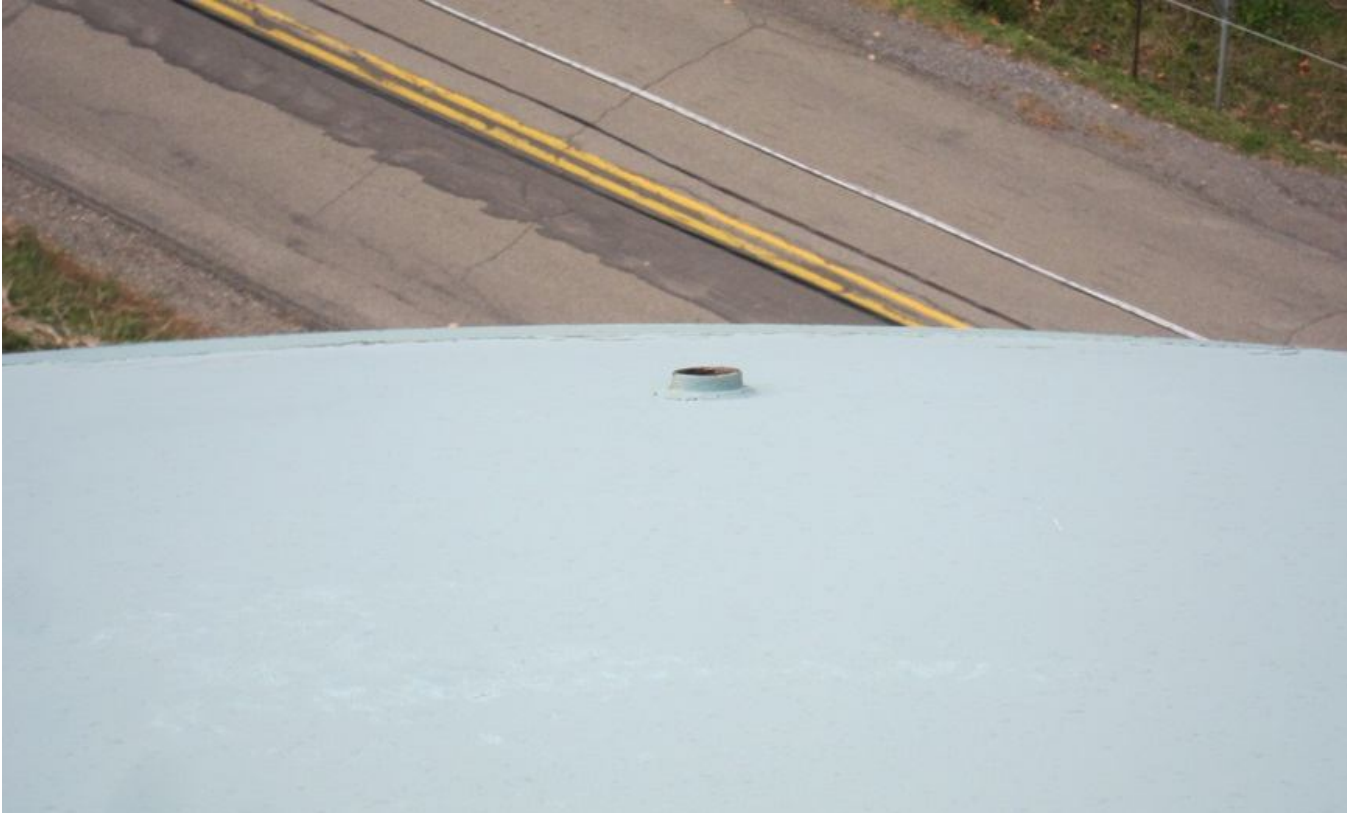
32. Open roof coupling.

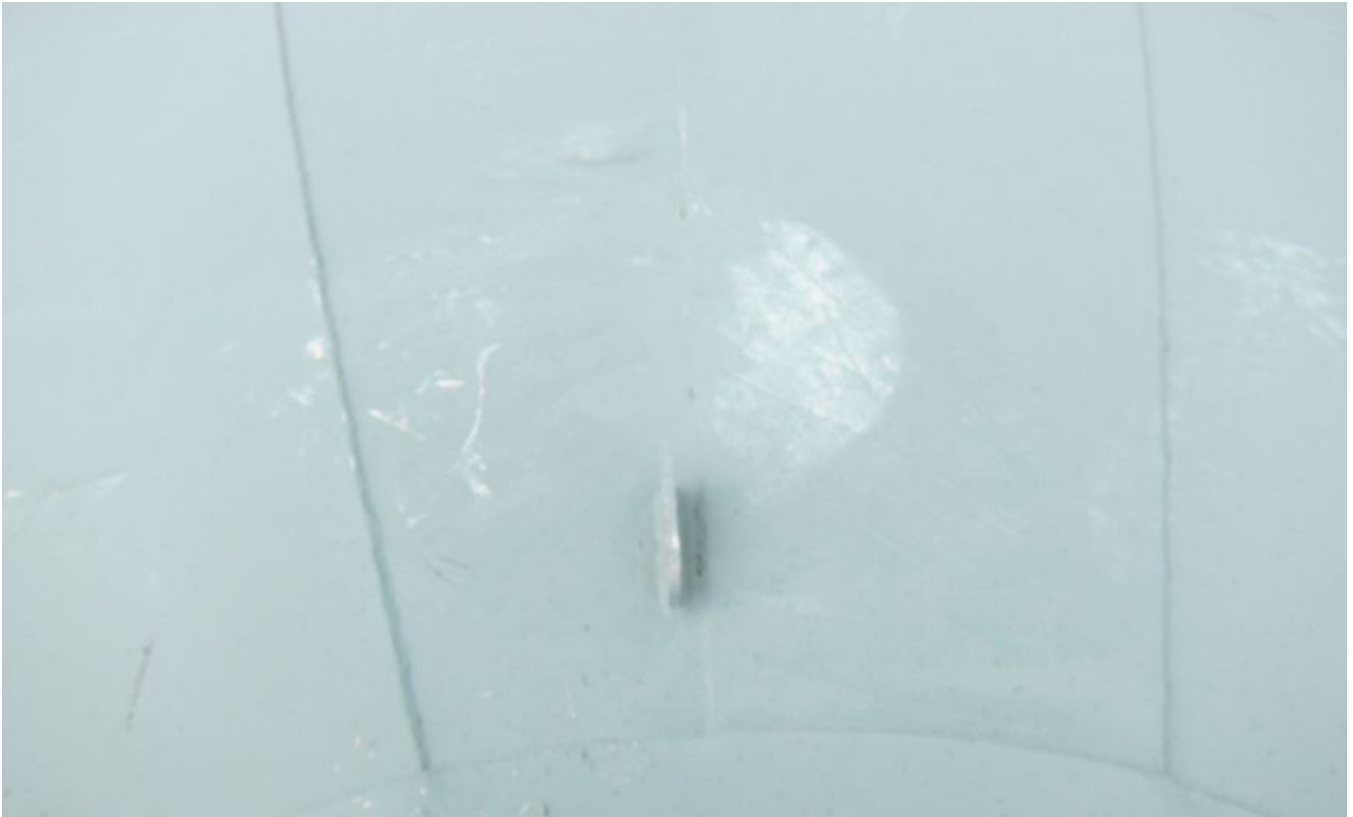
33. Lug on roof.

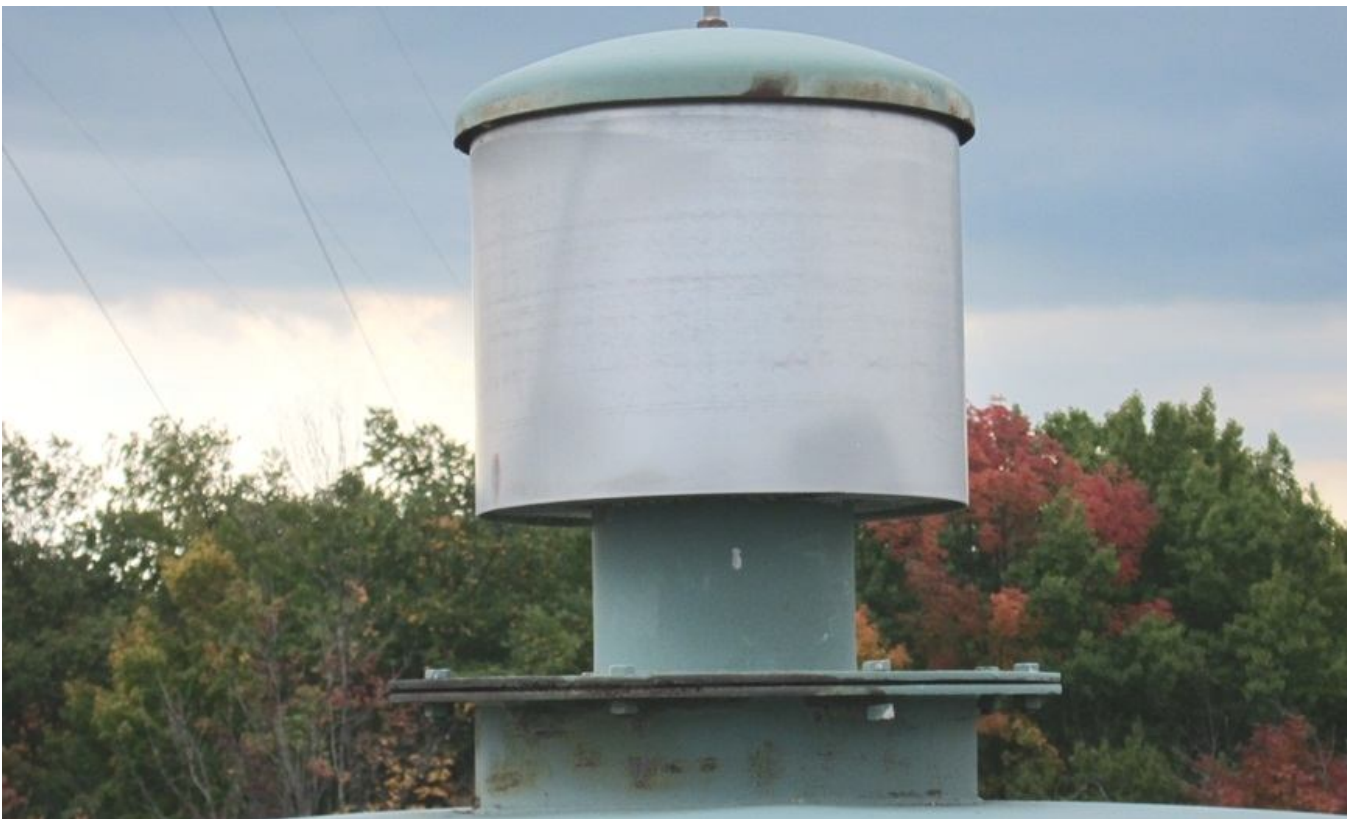
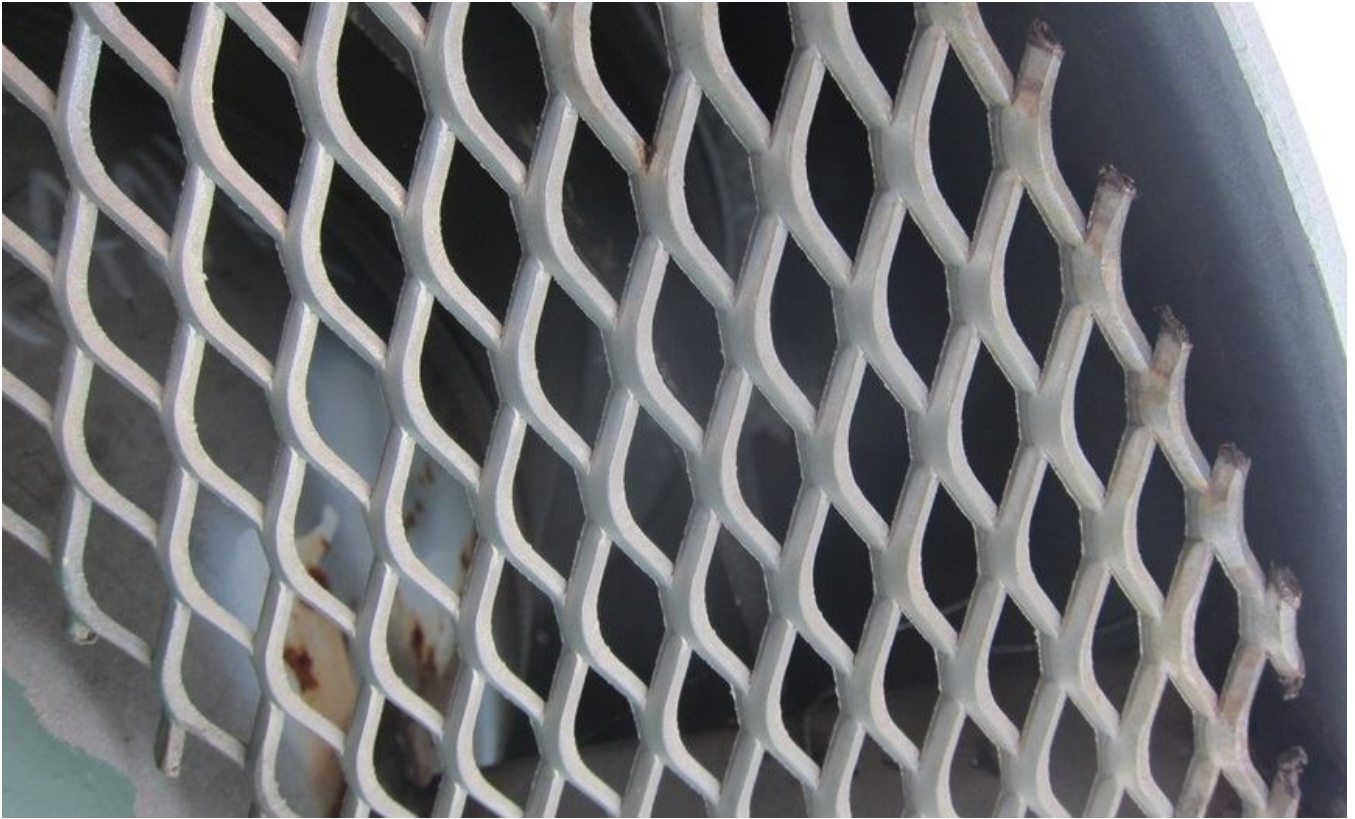
11. **Roof Vent:** There was a sanitary, AWWA, and operational deficiency noted: **the roof vent was not of clog-resistant design.** The roof was equipped with a vent attached to a flanged opening in the approximate center of the roof. The flanged connection appeared to have a gasket. The vent was equipped with fine mesh screening which was shielded from wind-driven dust and debris. Expanded metal screening was located at the base of the vent cover. Corrosion was observed on the vent neck and flange. (See photos 34-35)

34. Roof vent.

35. Roof vent.

18. **Clog-Resistant Vent:** The tank was not equipped with a clog-resistant vent. AWWA Standards recommend that all vents with screening against insects be designed to ensure "fail-safe" operation if the insect screens become occluded. Inadequate ventilation could cause a tank collapse if the tank is rapidly drained while the screen is occluded or frosted over. Therefore, a clog-resistant vent should be installed near the center of the roof. The vent should be designed so that it is removable in order to act as a second means of access to the tank interior.

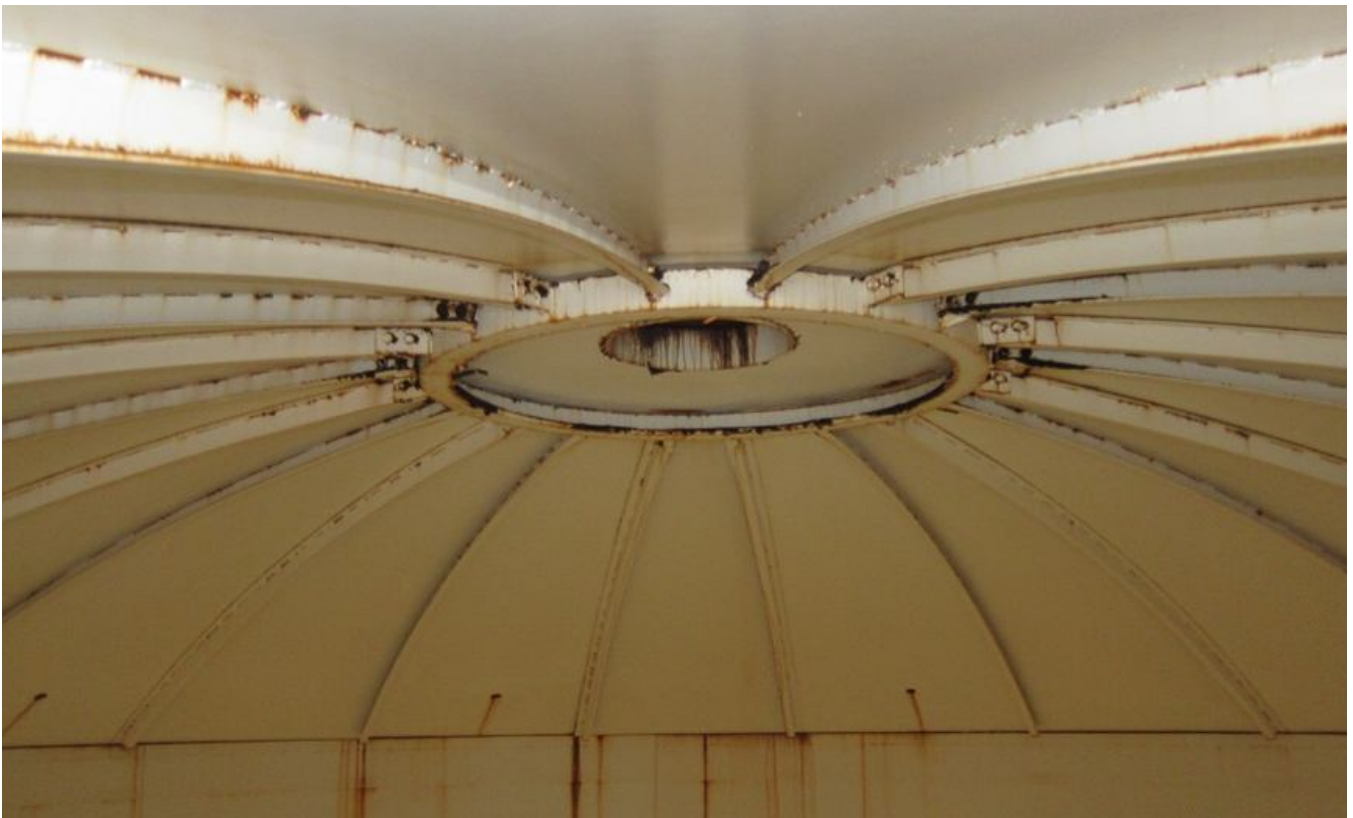
2. **Roof Condition:** The coating on the roof plates appeared to be in fair to poor overall condition. Corrosion and rust staining were noted along the top of the roof stiffeners, along the roof plate lap seams, along the stiffener edges, and around the roof vent opening. The interior roof support structure consisted of intermittently welded radial stiffeners and a center hub stiffener. Metal loss was located along the stiffener flanges. Daylight was present at an open coupling in the roof. (See photos 36-42)

38. Corrosion on roof stiffeners.

10. **Overflow:** The overflow inlet should be rewelded to the shell as soon as possible.
11. **Roof Support Structure:** After abrasive blast cleaning, the roof support structure should be carefully evaluated as metal loss repairs may be necessary at areas where the metal loss was not previously visible.

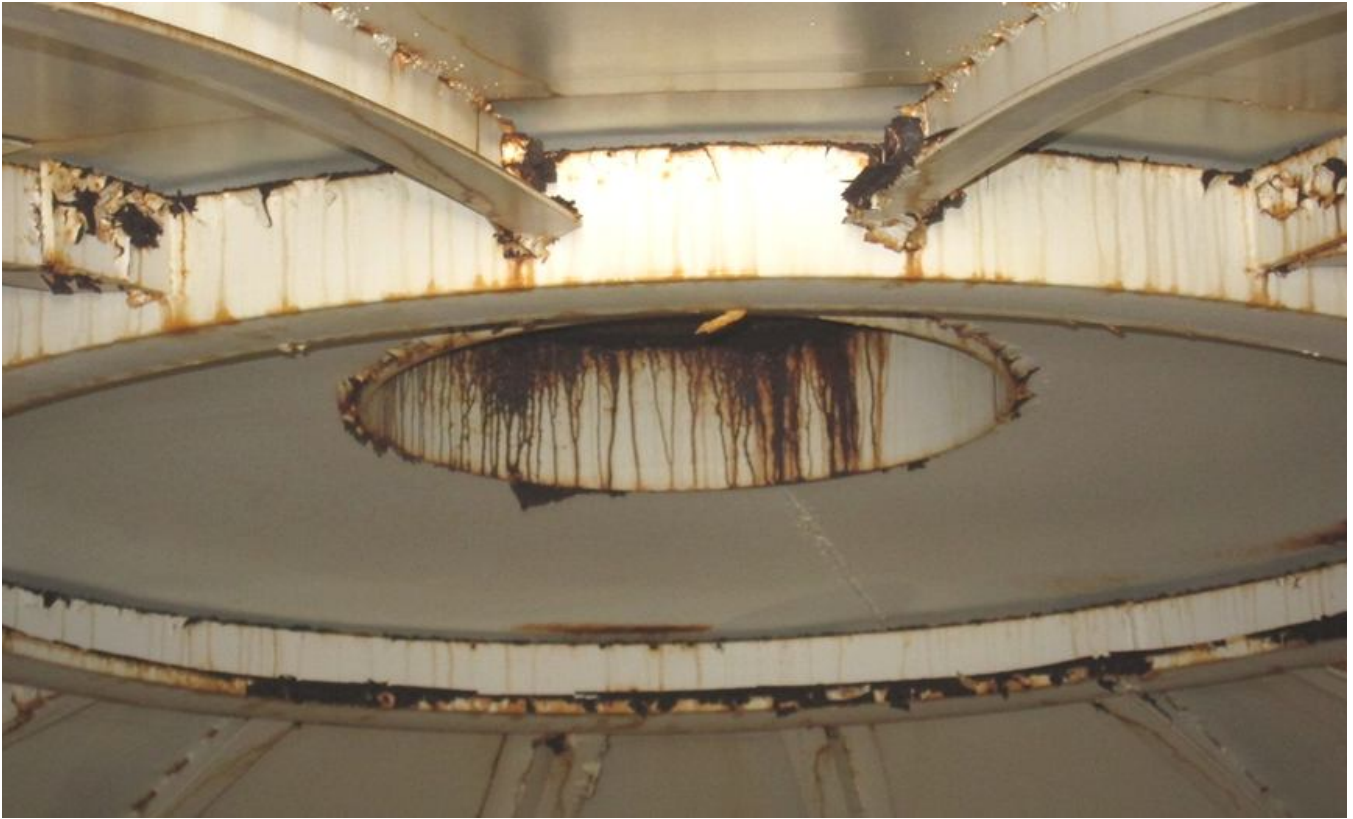
39. Corrosion and metal loss along roof stiffeners and around roof vent opening.

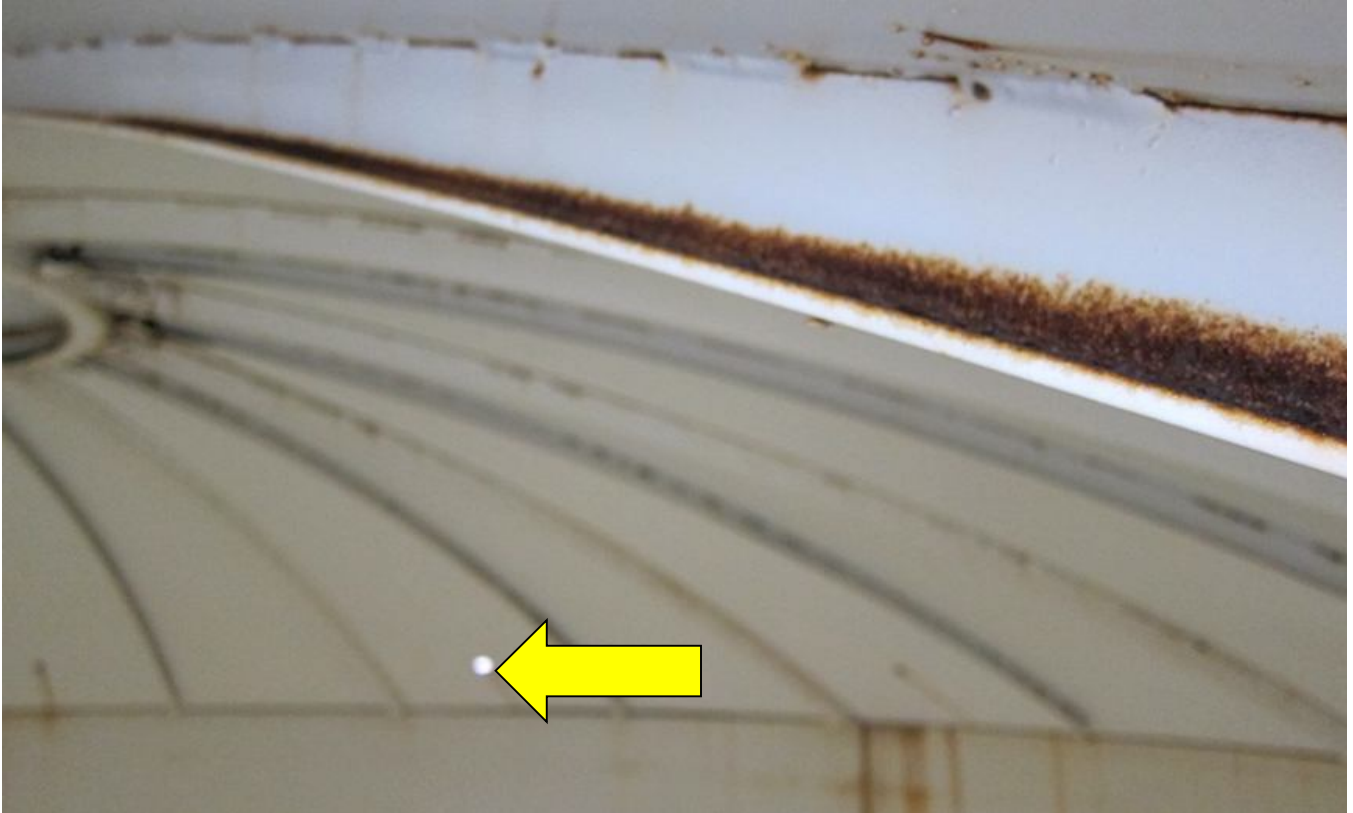
40. Corrosion along roof stiffener. Note daylight at coupling opening.

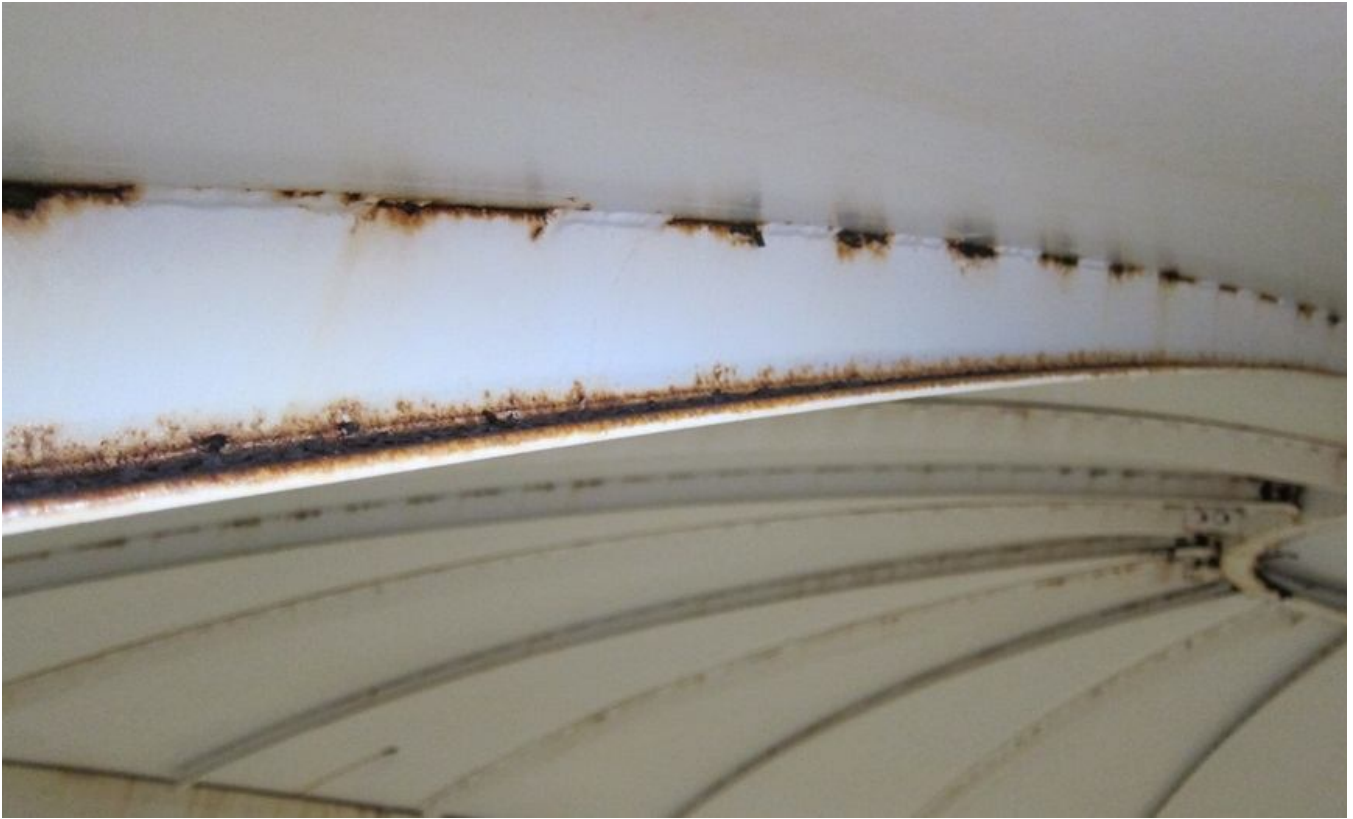
41. Corrosion along roof stiffener.

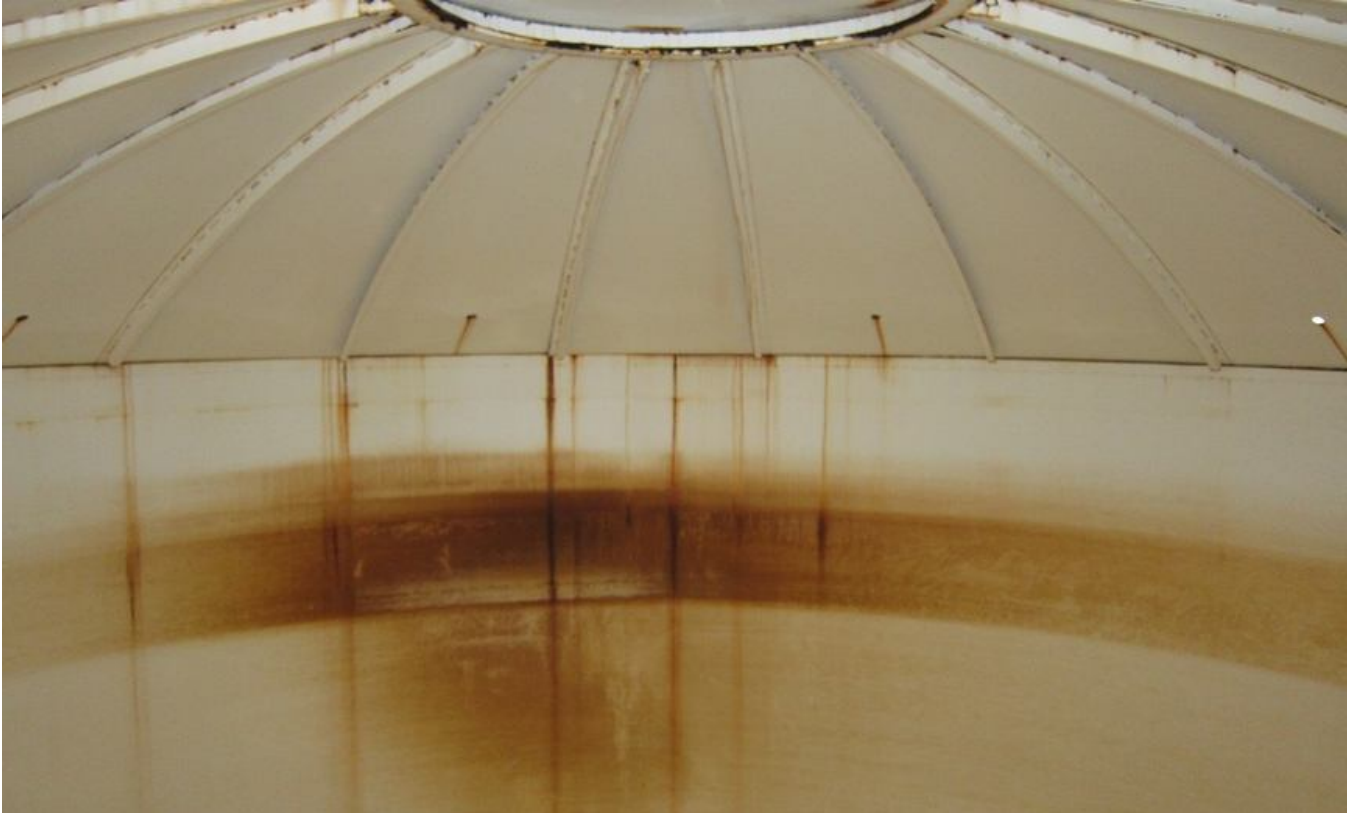
3. **Shell Condition:** The coating on most of the shell interior appeared to be in fair overall condition although corrosion had allowed metal loss to occur. Metal loss measurements taken during this evaluation indicated a typical pit depth of 1/16 in., and the deepest pit found measured 7/32 in. deep. The shell coating was discolored slightly due to mineral staining from the water. A top shell angle was located around the roof-to-shell connection, and widespread corrosion was located in this area. Rust staining had streaked down from the roof-to-shell connection and roof stiffener ends onto the upper shell surfaces. (See photos 42, 46-49)

42. Roof and rust staining on upper shell.

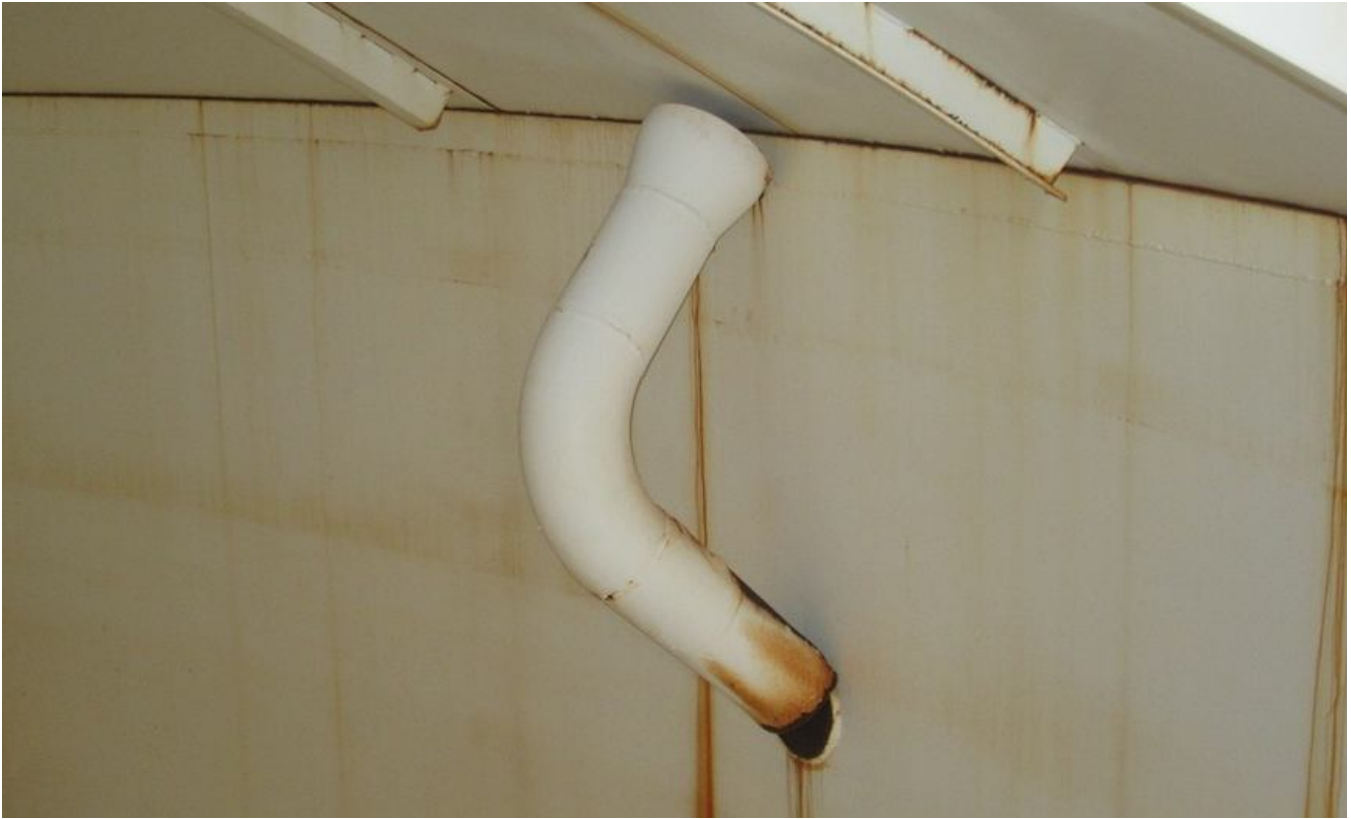
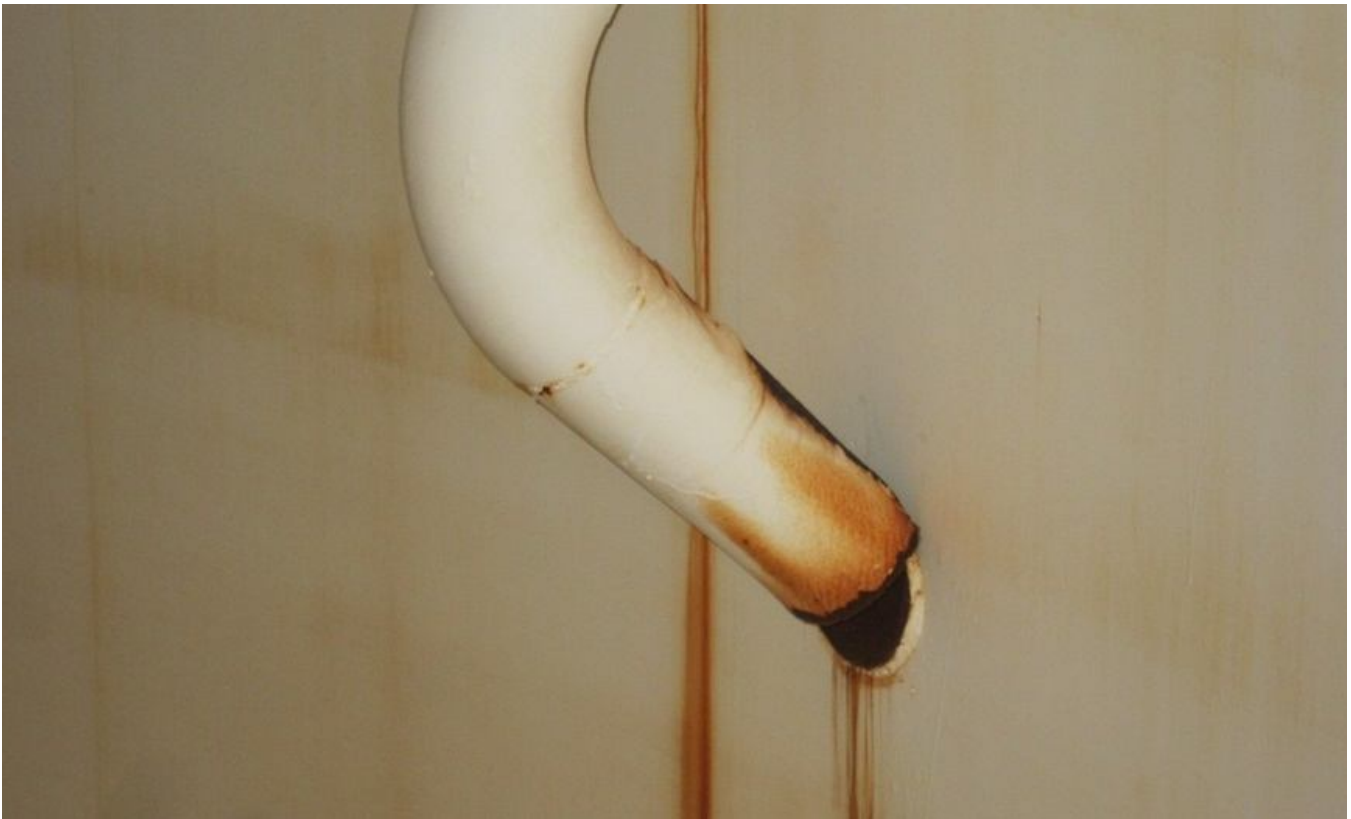
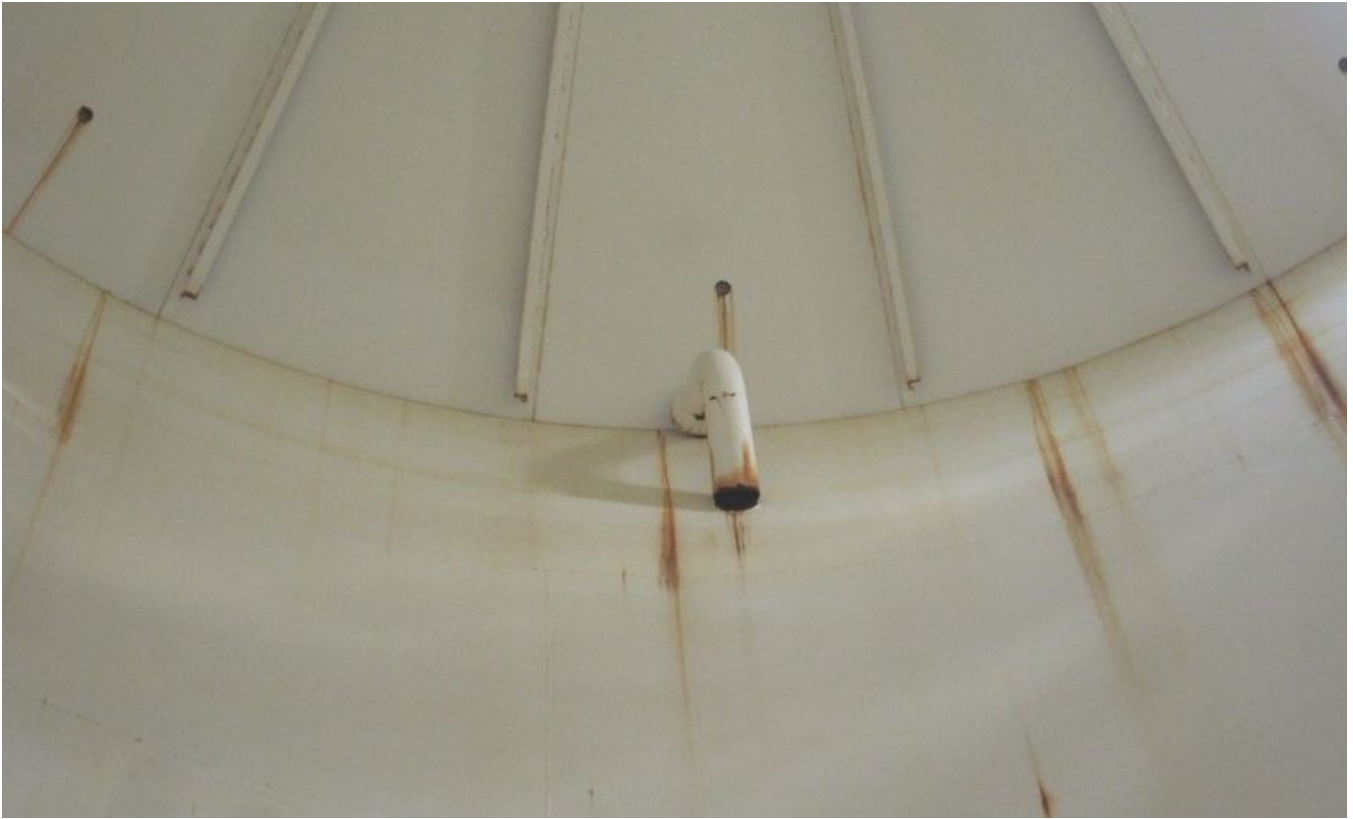
4. **Overflow Pipe:** There was an operational deficiency: the overflow pipe was not completely attached to the shell. The overflow included a funnel-type inlet. It appeared the location of the overflow inlet was such that the top capacity level was below the shell-to-roof connection. However, the overflow pipe was broken from the shell, and large gaps were located between the pipe and shell. Corrosion was observed on the pipe adjacent to its penetration and on the shell surfaces around the pipe opening. (See photos 43-45)

43. Overflow pipe no longer attached to shell.

44. Overflow pipe no longer attached to shell.

45. Overflow pipe no longer attached to shell.

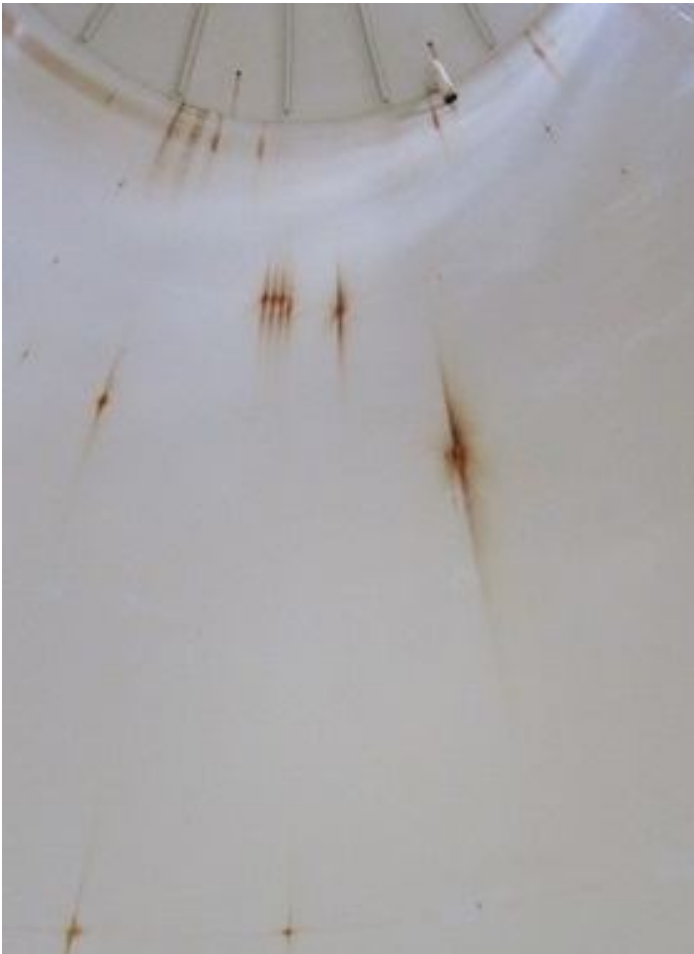
46. Corrosion on shell.

3. **Spot Cleaning and Spot Coating:** The areas of deep metal loss in the shell and floor should be repaired and spot cleaned to the equivalent of an SSPC-SP 10, Near-White Blast Cleaning. A two-component epoxy coating system should then be applied. This coating system should meet the

6. **Pit Welding and Pit Filling:** After initial cleaning, all significant pitting which is found should be welded, and all pitting with rough edges that would make the pitting difficult to coat properly should be filled with a solventless epoxy seam sealer. (It was estimated that approximately 25 square inches of pits will require welding, and approximately 2 gallons of seam sealer will be required for pit repair.) The existing hole and any other holes found in the floor should be covered with welded steel patch plates.

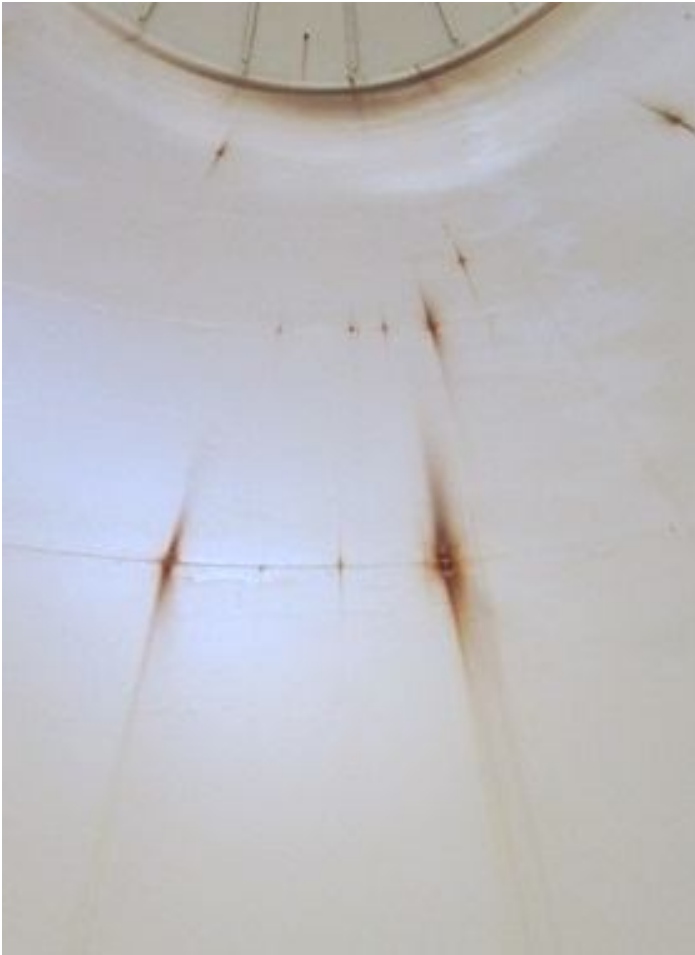
47. Corrosion along shell horizontal seams.

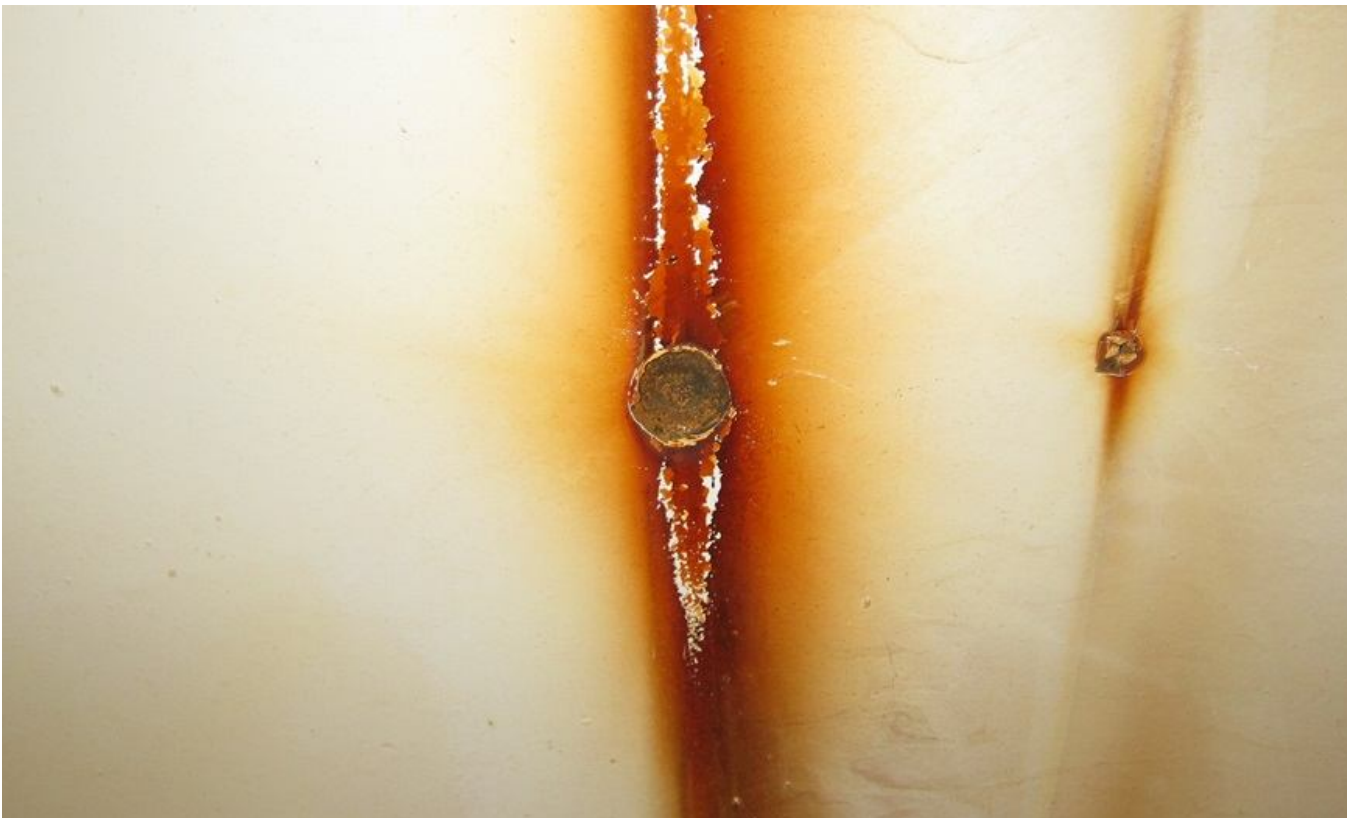
48. Corrosion and metal loss in shell.

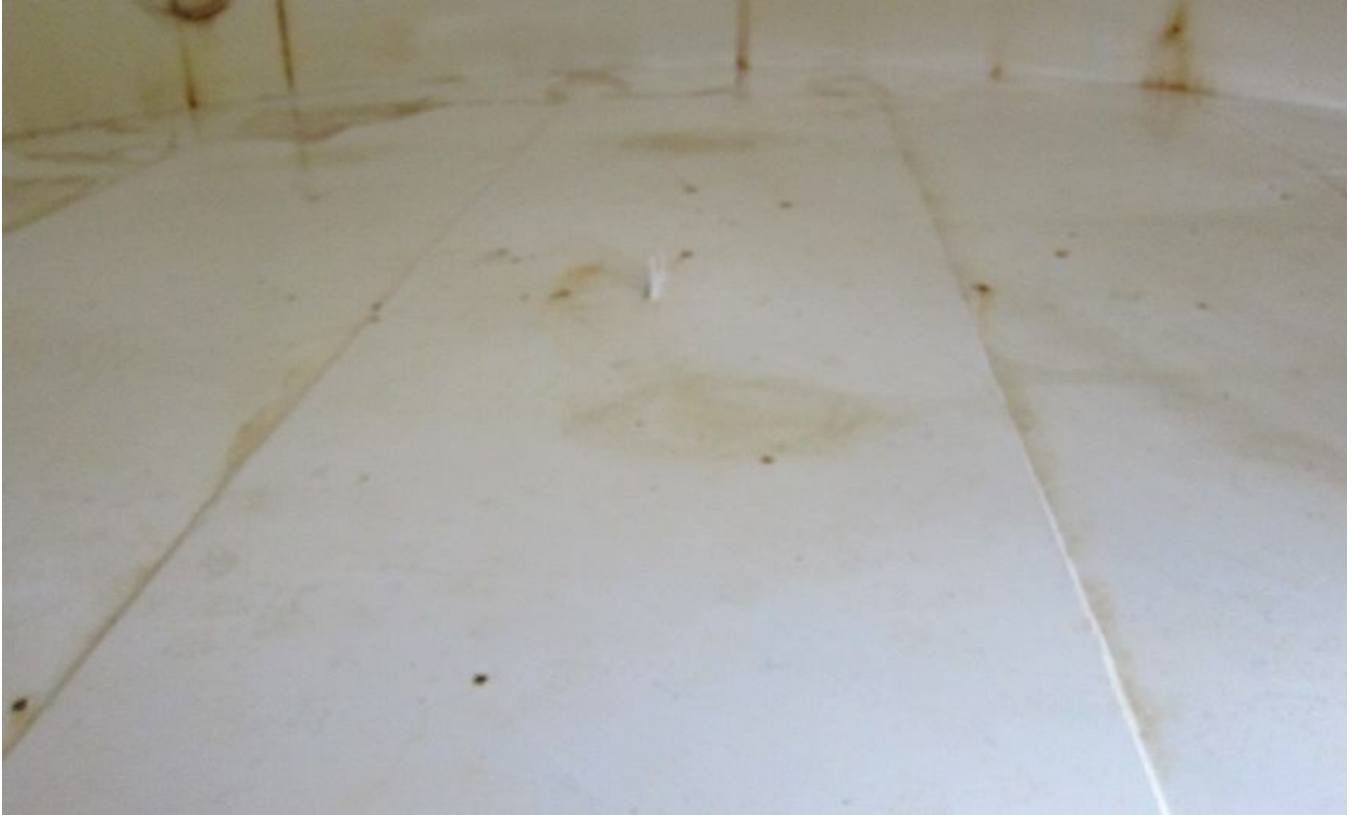
5. **Bottom Plate Condition:** There was an operational deficiency: holes were located in the floor. The coating on the tank bottom appeared to be in fair overall condition. Corrosion had allowed deep metal loss and a hole to occur in the floor. The metal loss typically measured 1/8 in. deep. A lug was located on the floor. The lug should not be used for rigging purposes. (See photos 50-53)

50. Lug on floor.

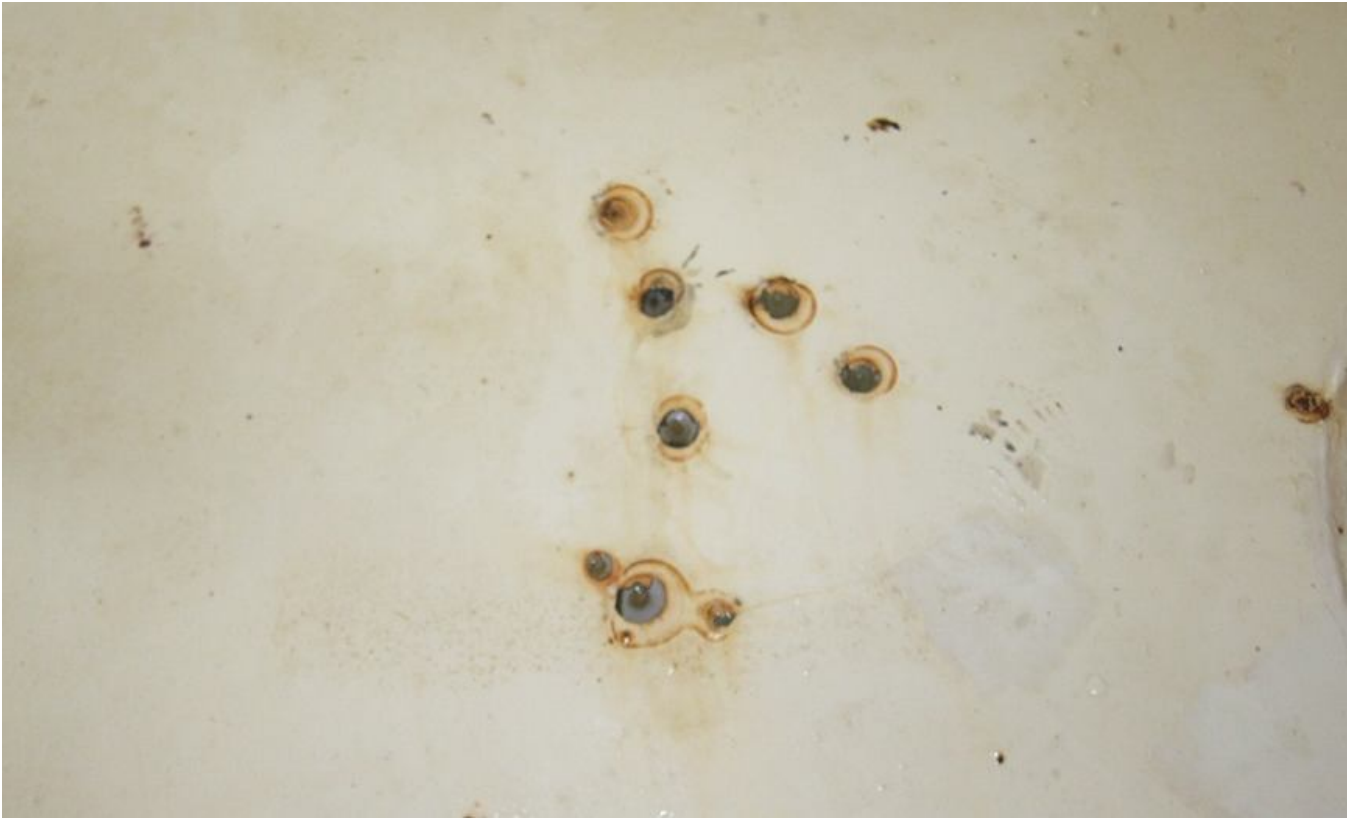
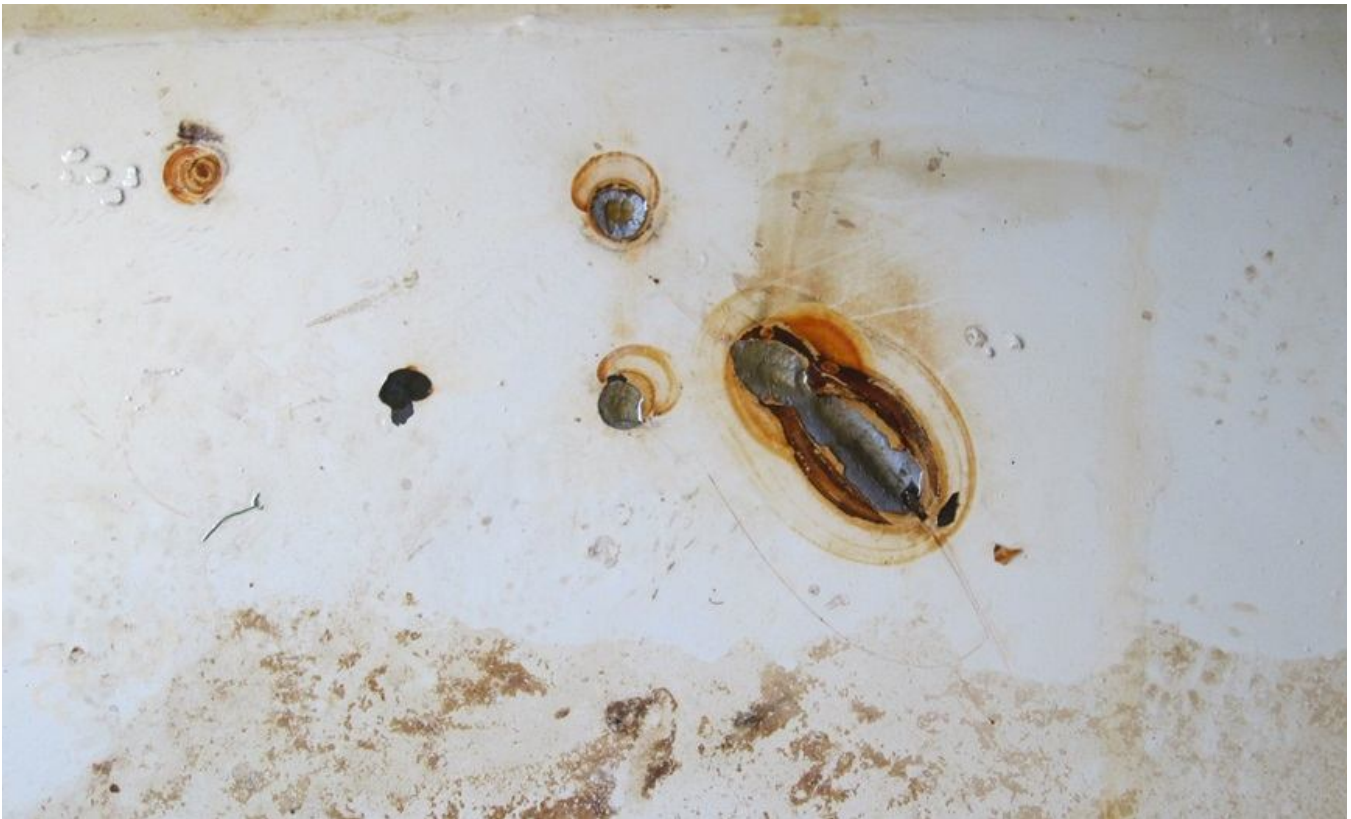
51. Metal loss in floor.

52. Metal loss in floor.

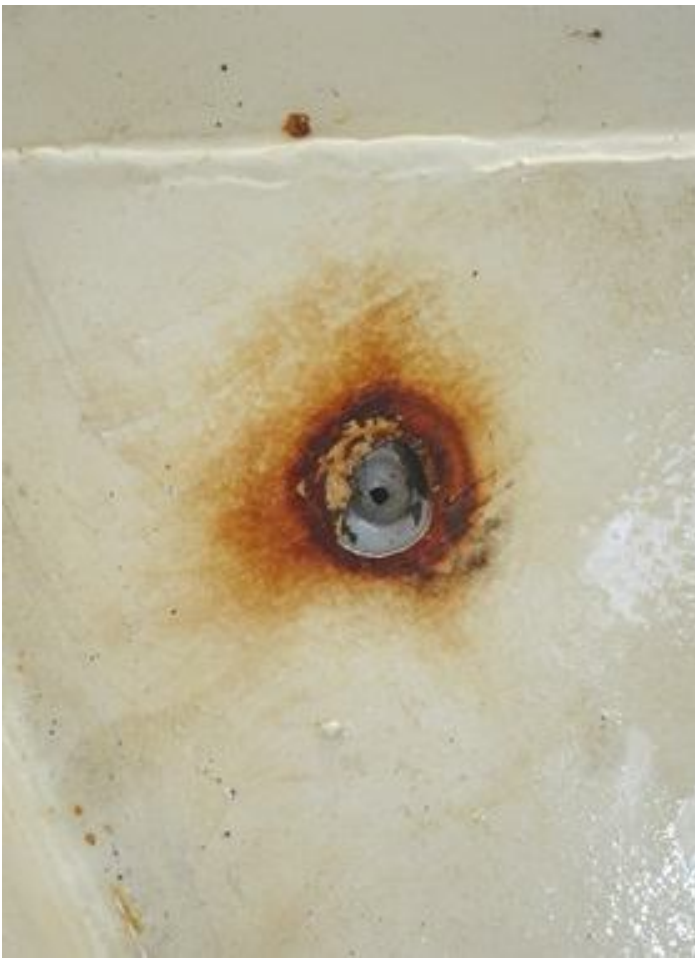
53. Hole in floor.
