**EVALUATION OF THE
350,000 GALLON STEEL STANDPIPE
“RICE HILL TANK”
BOSTON, NEW YORK
FOR
ERIE COUNTY WATER AUTHORITY
BUFFALO, NEW YORK**

October 16 and 17, 2016

16.081.L614.010

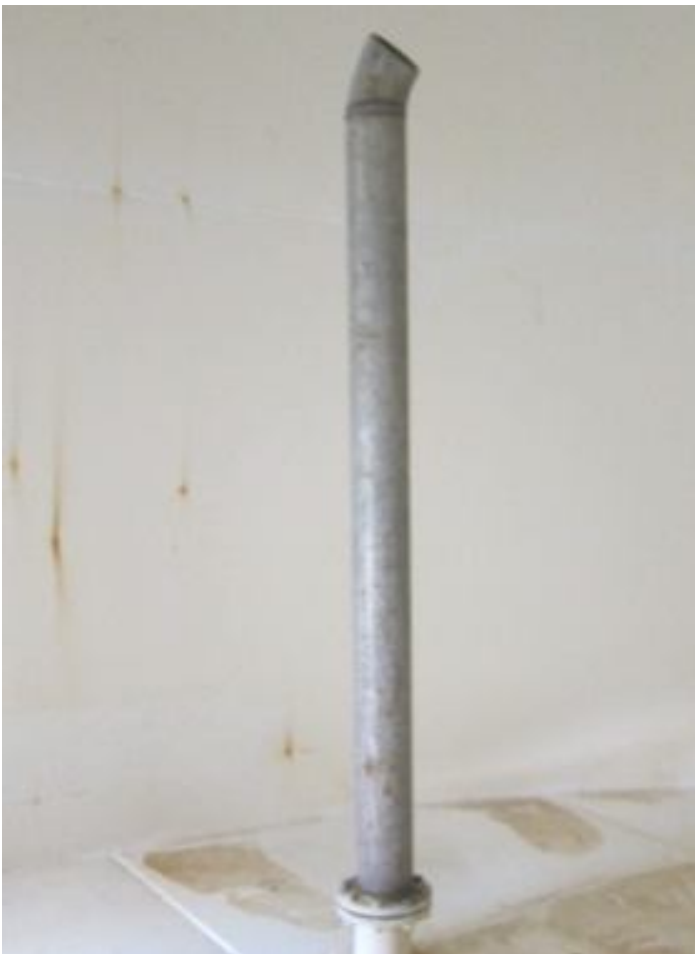
6. **Interior Piping:** The inlet pipe projected approximately 8 ft 5 in. above the floor. The outlet pipe projected above the floor. The inlet pipe appeared to have constructed of stainless steel. The outlet pipe ended with a flanged opening and was not equipped with a protective cover. A drain pipe was located in a sump in the floor. Corrosion was located in the sump. (See photos 54-56)

54. Inlet pipe.

12. **Inlet Pipe:** The inlet pipe appeared to be constructed of stainless steel, and this should be confirmed. If it is stainless steel, it is recommended the pipe be replaced with a plastic or carbon steel pipe to prevent accelerated rates of corrosion due to dissimilar metals.

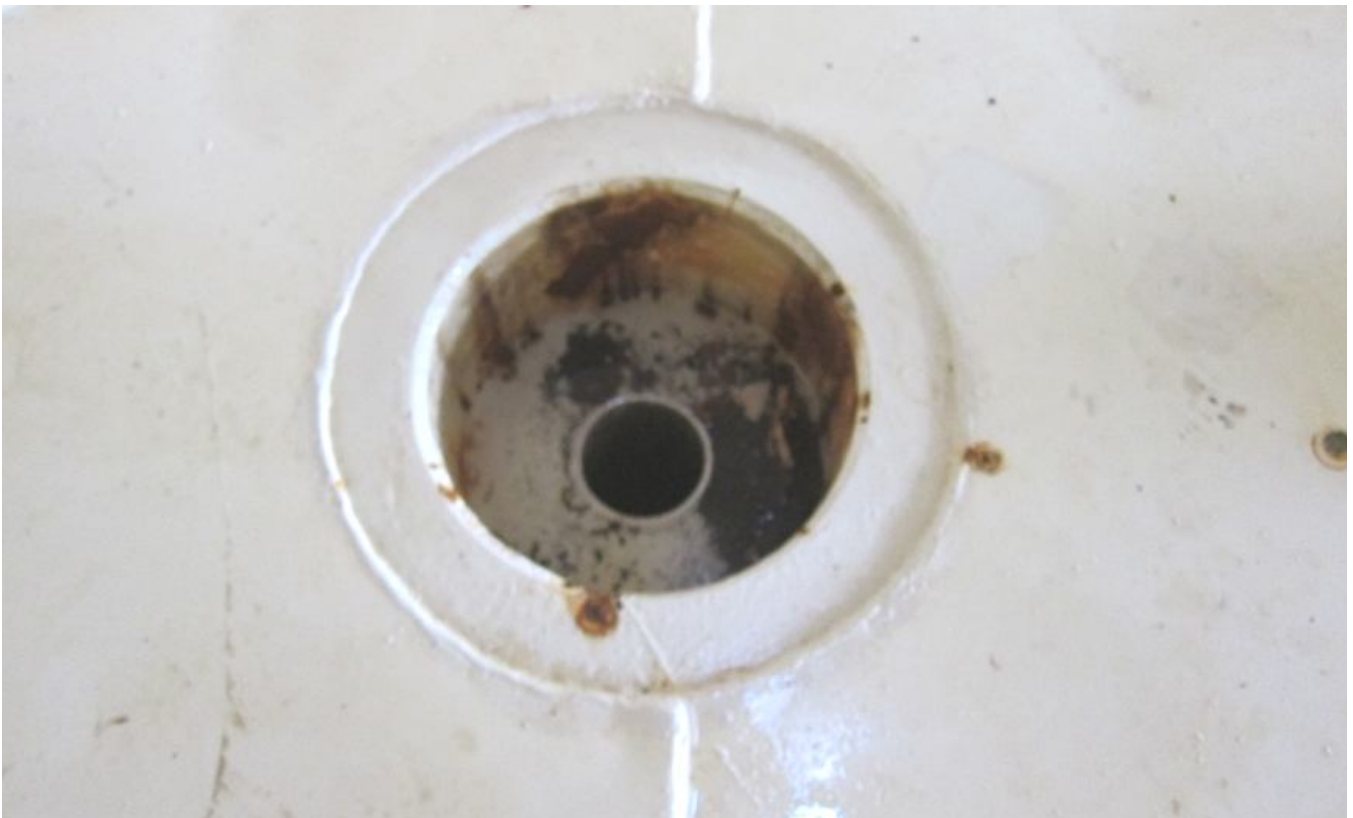
56. Drain pipe in sump.
