**EVALUATION OF THE
672,000 GALLON STEEL STANDPIPE
“WOHLHUETER TANK”
COLDEN, NEW YORK
FOR
ERIE COUNTY WATER AUTHORITY
BUFFALO, NEW YORK**

October 25, 2017

16.081.L614.015

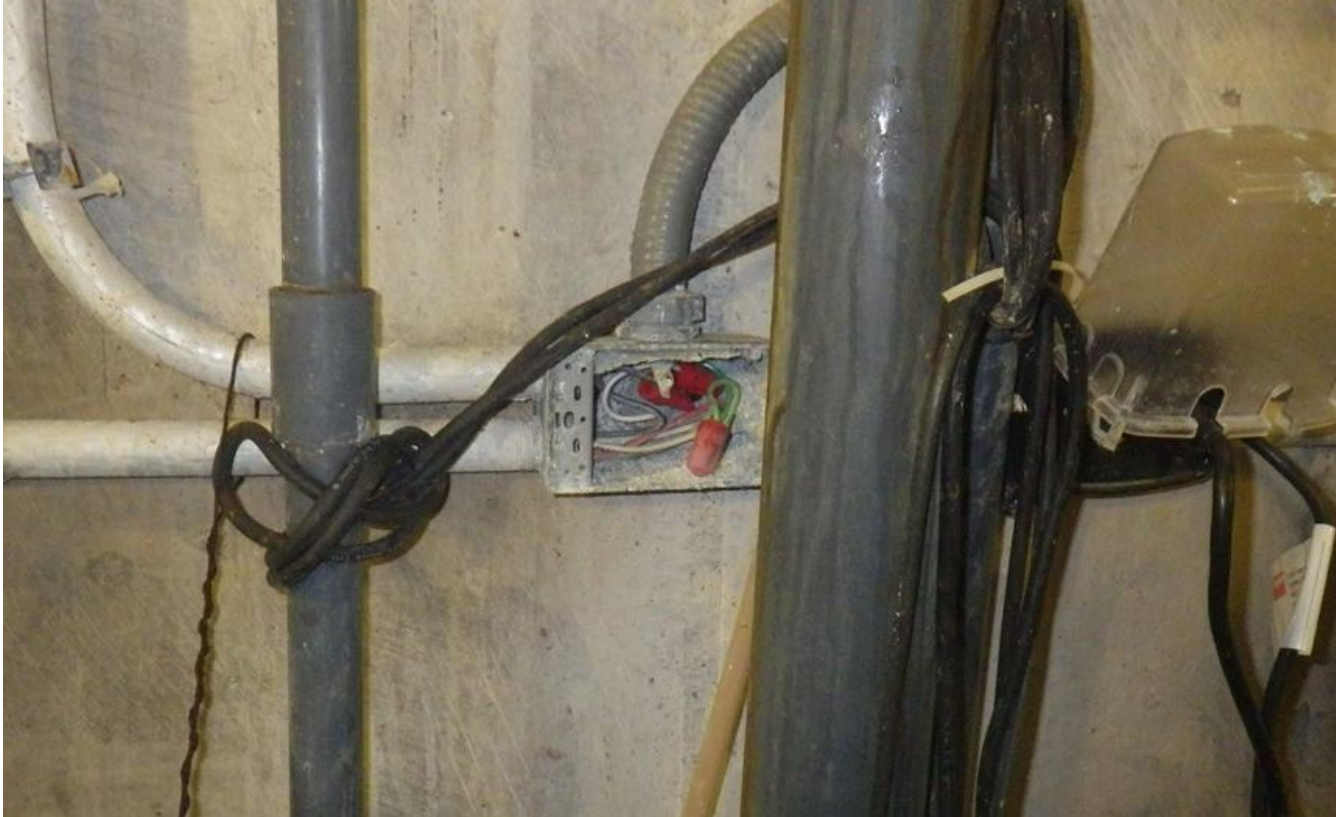
5. **Valve Vault:** There were safety and OSHA deficiencies noted: (1) the 5-1/2 in. minimum toe room did not meet the required 7 in. minimum, (2) one of the electrical receptacles was not equipped with ground fault interrupt circuits, and (3) an uncovered conduit junction box with exposed wiring was located in the valve vault. A valve vault was located beneath the pump building on the site. The vault access was equipped with an aluminum ladder. Minor spots of corrosion were observed on the piping in the valve vault at the time of the field evaluation. The vault was equipped with a sump and pump. Electrical equipment and four operational lights were located in the vault. A conduit junction in the vault was missing a cover. (See photos 7-10)

10. Conduit junction with missing cover.

6. **Valve Vault:** If compliance with OSHA dimensional and safety standards is desired, the access ladder should be modified to allow adequate toe room. The piping and valves located in the valve vault should be cleaned and painted in accordance with the interior coating recommendations at the time of the tank cleaning and coating. The exterior concrete surfaces should be cleaned to the equivalent of a brush-off blast cleaning and painted with a concrete sealer. Freeze protection should be provided for on all control piping and static water lines. The electrical outlet should be equipped with ground fault interrupt circuits, and the missing cover for the conduit junction replaced.

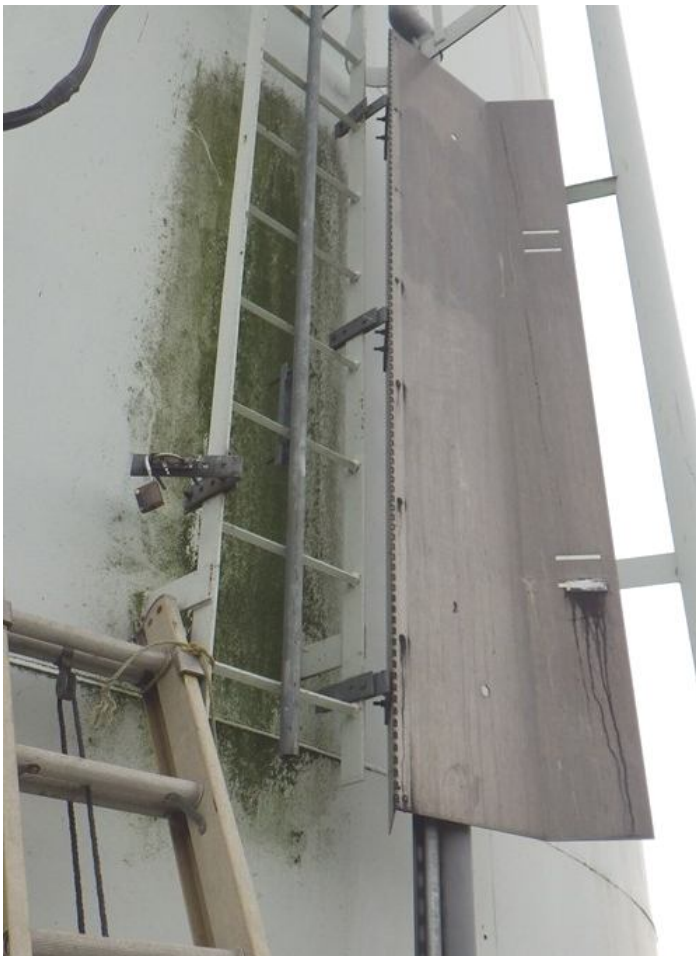
7. **Exterior Ladder:** **There was a safety and OSHA deficiency noted: the 26 in. depth of the ladder safety cage did not precisely meet the required 27 in. minimum.** The exterior ladder was welded to brackets which were welded to the shell. The ladder and brackets appeared to be in nearly their original structural condition at the time of this field evaluation. The ladder was equipped with a notched-tubular safe-climbing device and a safety cage which was constructed of welded flat bar members. Spots of corrosion were observed on the ladder safety cage, and a coaxial cable was clamped to the cage. The bottom of the ladder was equipped with a locked aluminum ladder gate-type vandal deterrent. The top bracket for the vandal deterrent was missing a bolt and was loose. No side plates were present along the ladder adjacent to the vandal deterrent. (See photos 19-31, 33)

30. Shell ladder with vandal deterrent.

16. **Vandal Deterrent:** The missing bolt for the bracket should be replaced and the existing vandal deterrent secured. The addition of side plates on both sides of the ladder at the existing vandal deterrent would offer the Owner further protection from unauthorized access to the ladder and tank.

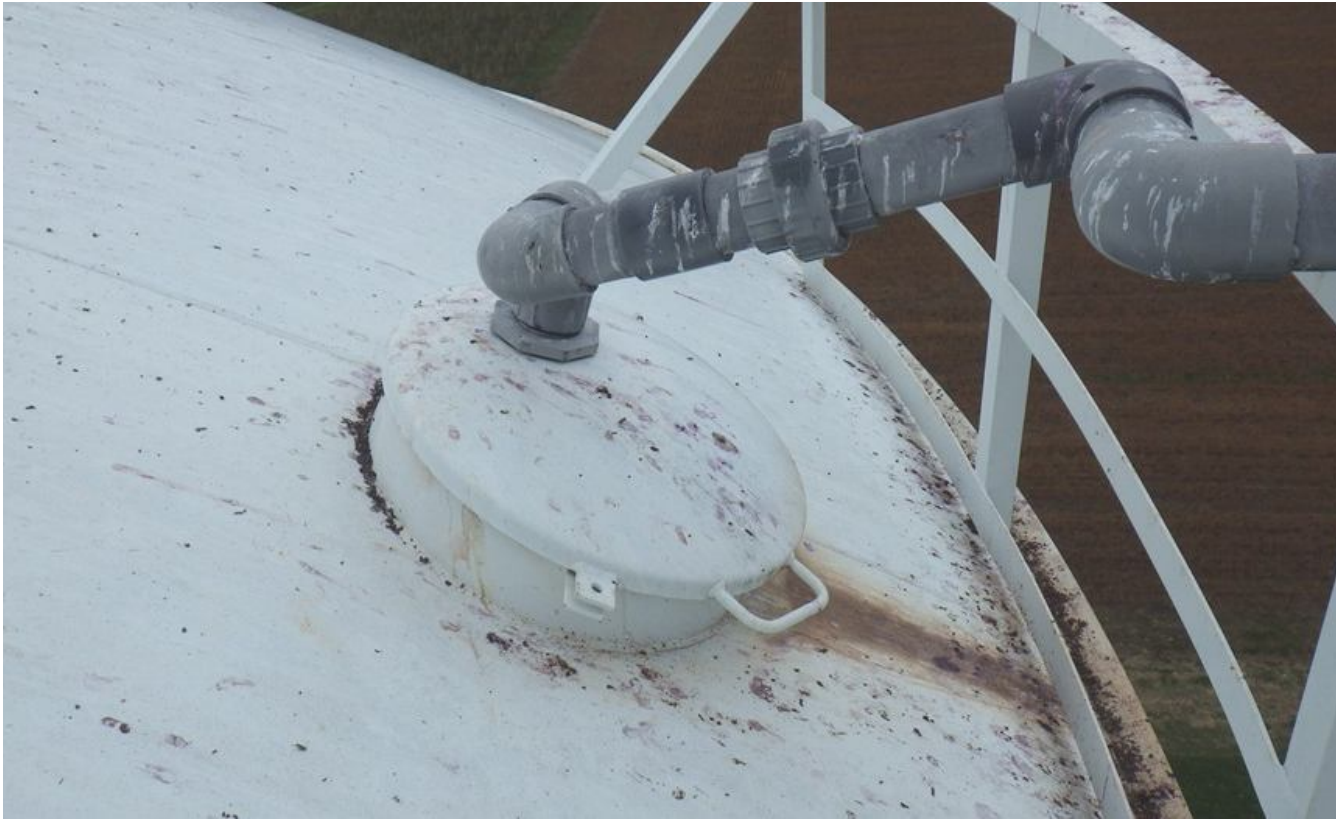
12. **Roof Manhole:** There were sanitary and AWWA deficiencies noted: (1) the cover overlap of 1-1/4 in. did not meet the required minimum of 2 in., and (2) the roof manhole was not locked. The roof was equipped with one manhole which had a hinged cover. The roof manhole was not locked prior to and after this evaluation. A 3 in. diameter PVC pipe penetrated the roof manhole cover which prevented personnel from accessing the manhole at the time of the field evaluation. (See photos 35-36)

35. Pipe attached to hinged roof manhole cover.

19. **Roof Manhole:** The existing roof manhole dimensions did not comply with current AWWA standards. Therefore, the roof manhole should be modified to include a 2 in. overlapping cover. The roof manhole should be locked. The cover for the existing roof manhole above the overflow weir box could not be opened due to the PVC pipe attached to the cover. As such a second roof manhole available for access is recommended.

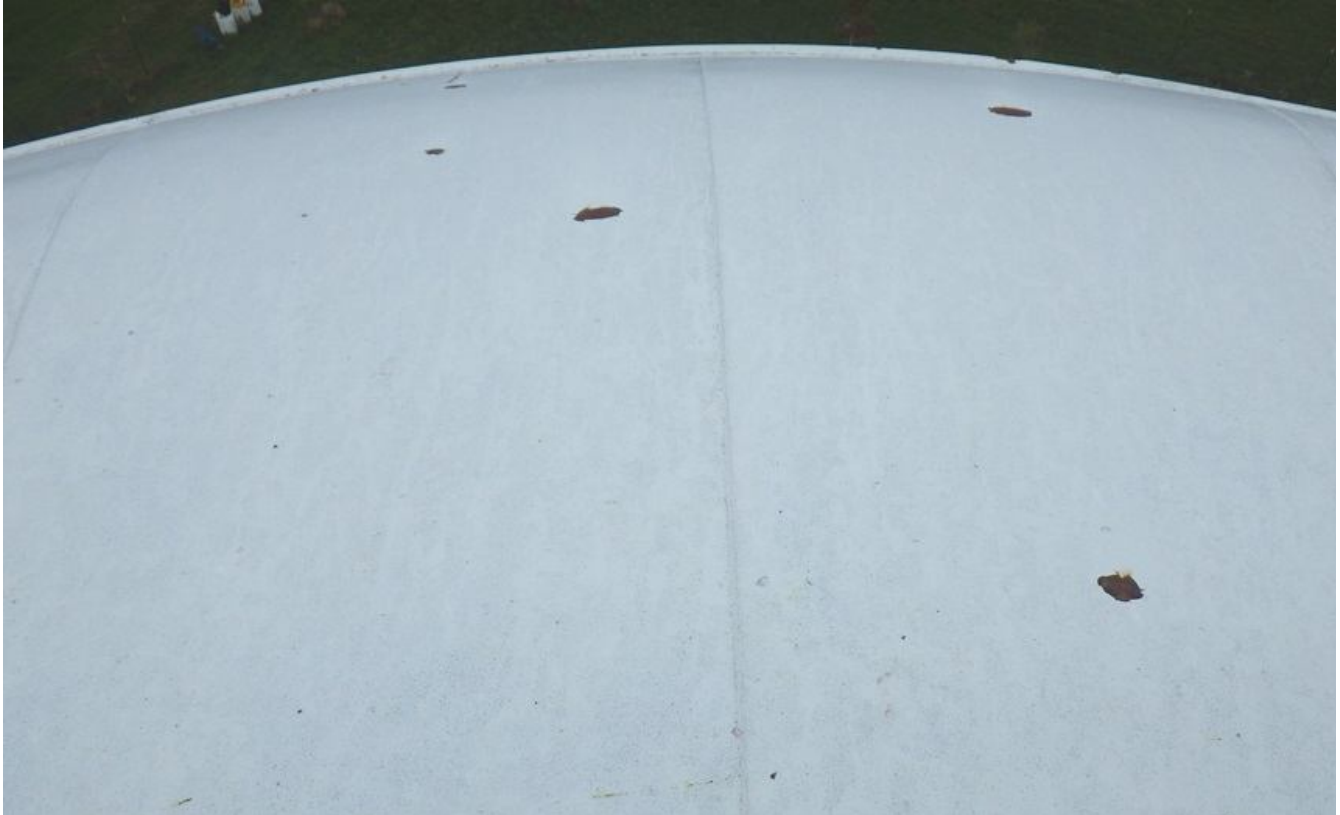
10. **Roof Condition:** The contour of the roof appeared adequate at the time of this evaluation. The roof coating appeared to be in fair to poor condition. Spots of peeled coating and rust were observed on the roof. The roof coating exhibited very poor adhesion to the steel. Two lugs were located on the roof cap on opposite sides of the roof vent. **It is the opinion of Tank Industry Consultants that the lugs should not be used for rigging purposes.** (See photos 37-39)

38. Coating failures and rust on exterior roof.
