**EVALUATION OF THE  
710,000 GALLON CONCRETE GROUND STORAGE TANK**

**“CRESTWOOD TANK”  
BOSTON, NEW YORK**

**ERIE COUNTY WATER AUTHORITY  
BUFFALO, NEW YORK**

**March 31, 2017**

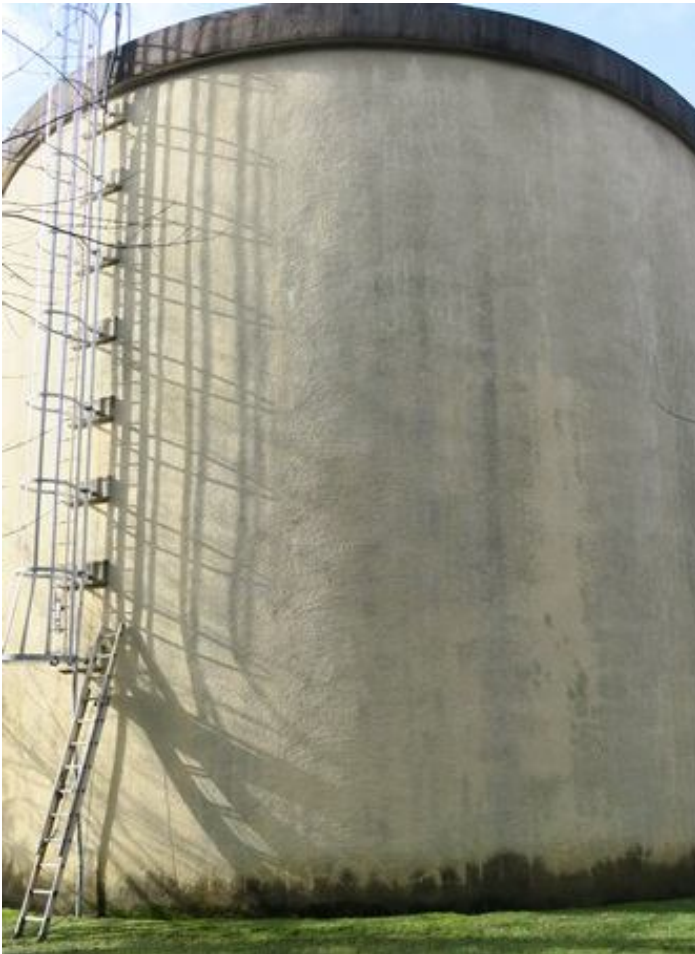
2. Tank.

2. **Site Conditions:** The tank site was covered with grass. The site was graded such that water was standing around the base of the tank. The tank site was not fenced. A control building was located on the site northwest of the tank. (See photos 1-2, 5)

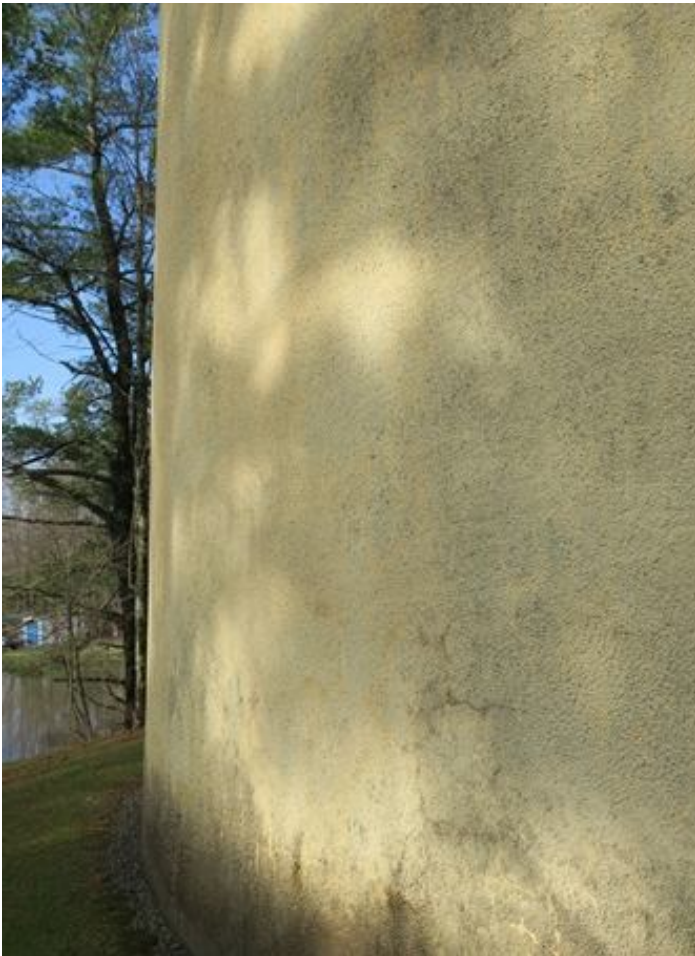
10. Shell exterior.

2. **Shell Condition:** The concrete shell exterior appeared to be in fair to good overall condition with numerous cracks observed. The cracks measured less than 2 ft long, and efflorescence was observed at most of the cracks. The largest cracks were located in the surfaces beneath the shell manholes and overflow pipe projection. A significant amount of mildew and moss were also observed on the lower part of the shell. The tank nameplate was attached to the west side of the shell. (See photos 10-17, 22-23)

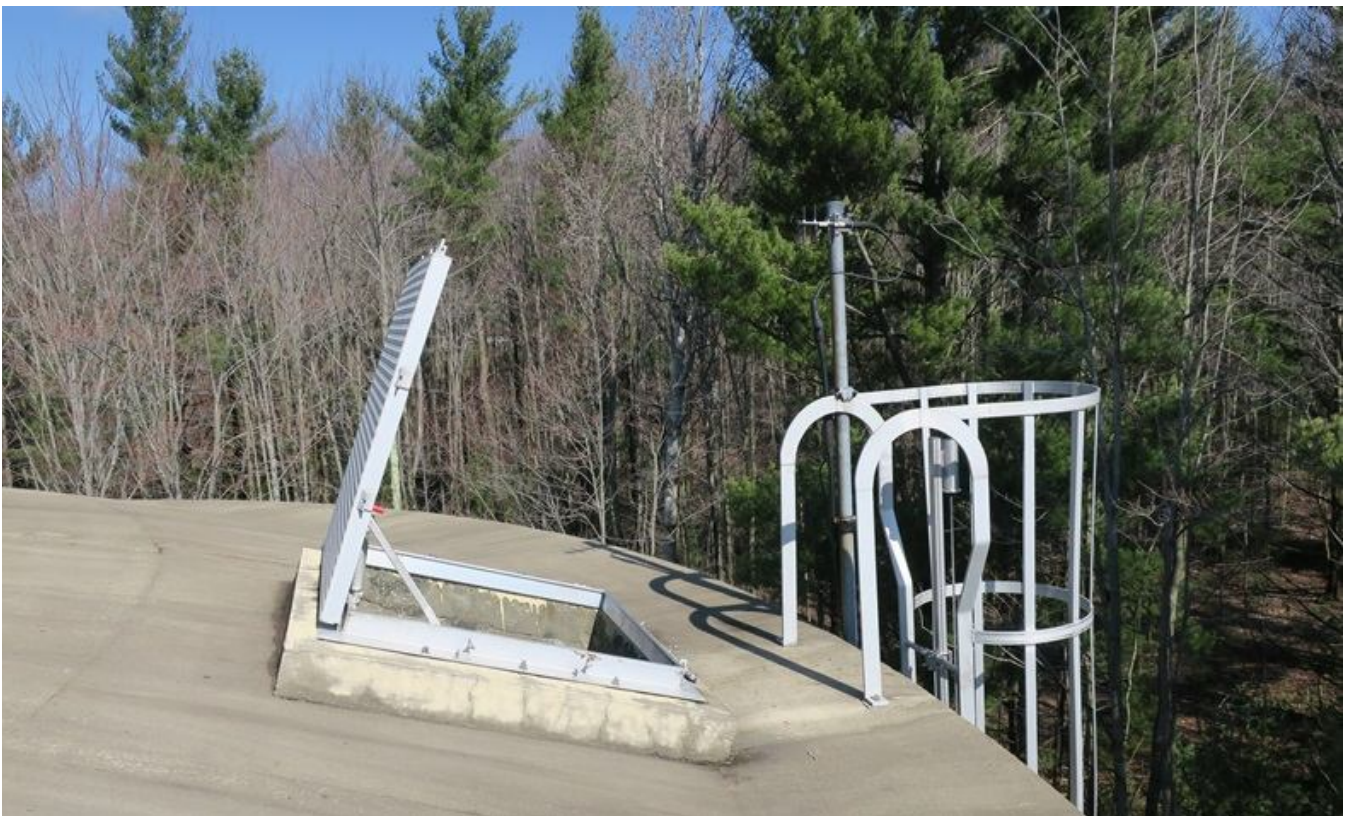
5. **Exterior Ladder:** **There were safety-related and ANSI/OSHA deficiencies noted: (1) the antenna and conduit attached to the ladder could interfere with the climber's use of the side rails, (2) the 26-1/4 in. extension of the safe-climbing device above the roof did not meet the industry recommended 54 in. minimum, (3) the bottom bracket of the safe-climbing device was loose and a nut was missing, and (4) the 25-1/2 in. depth of the ladder safety cage did not meet the minimum required 27 in. minimum.** A ladder provided access from near grade to the roof. The ladder was equipped with a cable-type safe-climbing device and a safety cage. The ladder was equipped with bolted brackets, and the ladder and brackets appeared to be in nearly their original structural condition at the time of the field evaluation. A conduit extended up the ladder brackets to an antenna located at the roof's edge. The conduit was bent just above grade level, and the conduit could interfere with the climber's use of the ladder side rail. The base of the ladder was equipped with a vandal deterrent. The ladder deterrent was locked prior to and after the field evaluation. The top of the ladder was equipped with terminals at the roof. (See photos 18-21, 24-25)

8. **Roof Manhole:** The roof was equipped with one hinged cover manhole. The manhole was locked prior to and after the field evaluation. The manhole surfaces appeared to be in adequate condition at the time of the field evaluation. (See photos 24, 26)

24. Roof manhole, roof access, and antenna.

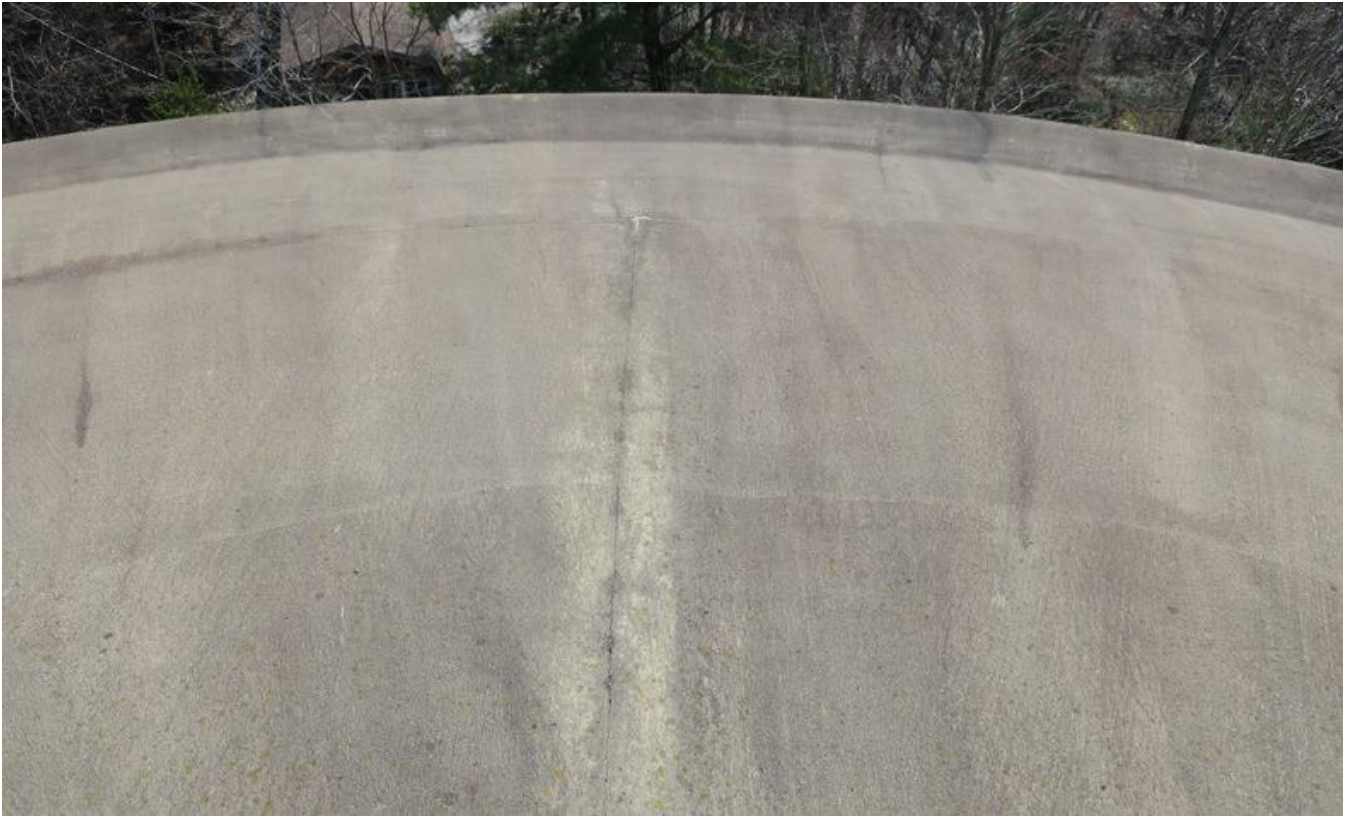
29. Roof exterior.

7. **Roof Condition:** The concrete roof exterior appeared to be in fair condition at the time of the field evaluation. Several hairline cracks were observed, and surface voids were located near the edge of the west side of the roof. An area of spalling was also located on the west side of the roof near the edge. Efflorescence was observed at some of the hairline cracks. (See photos 27-33)

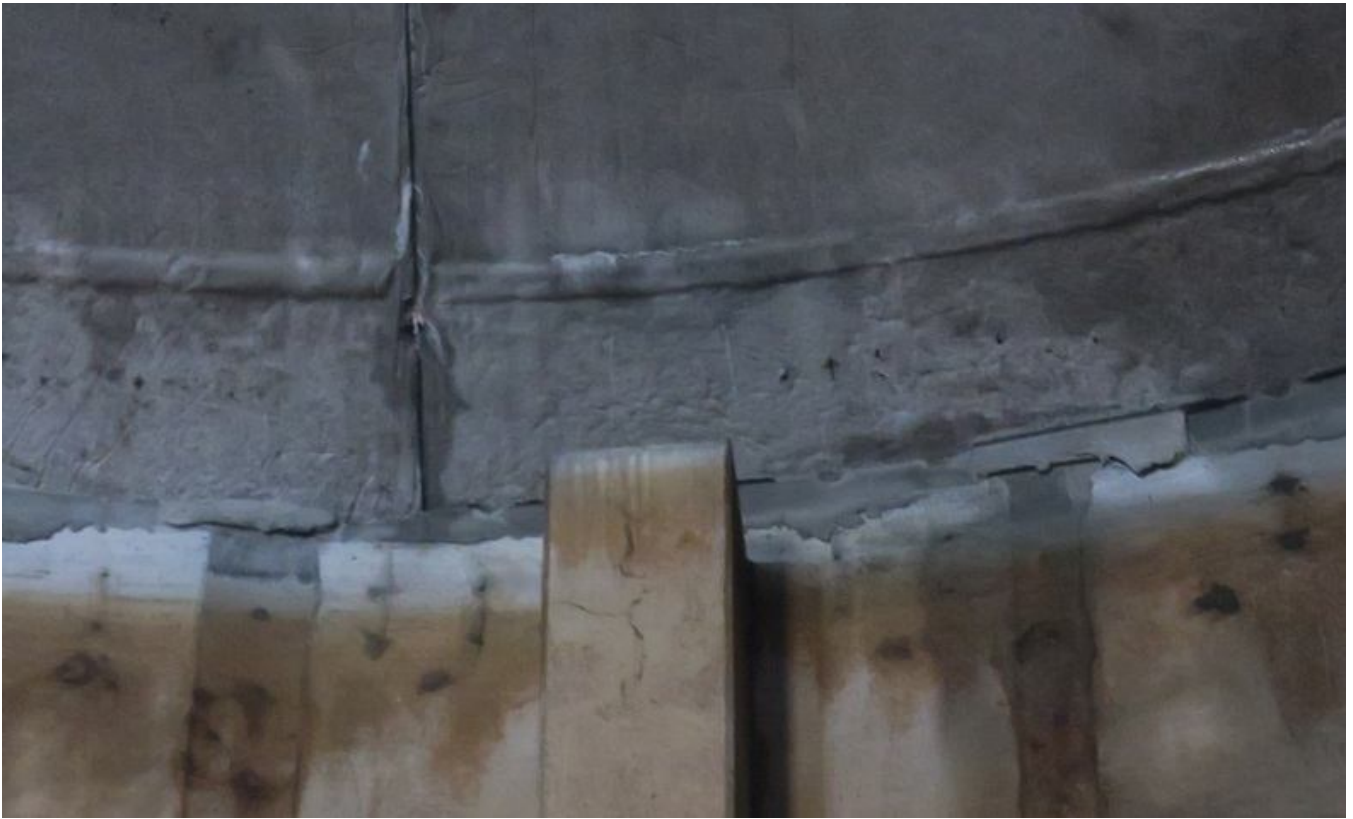
43. Concrete encasing overflow inlet.

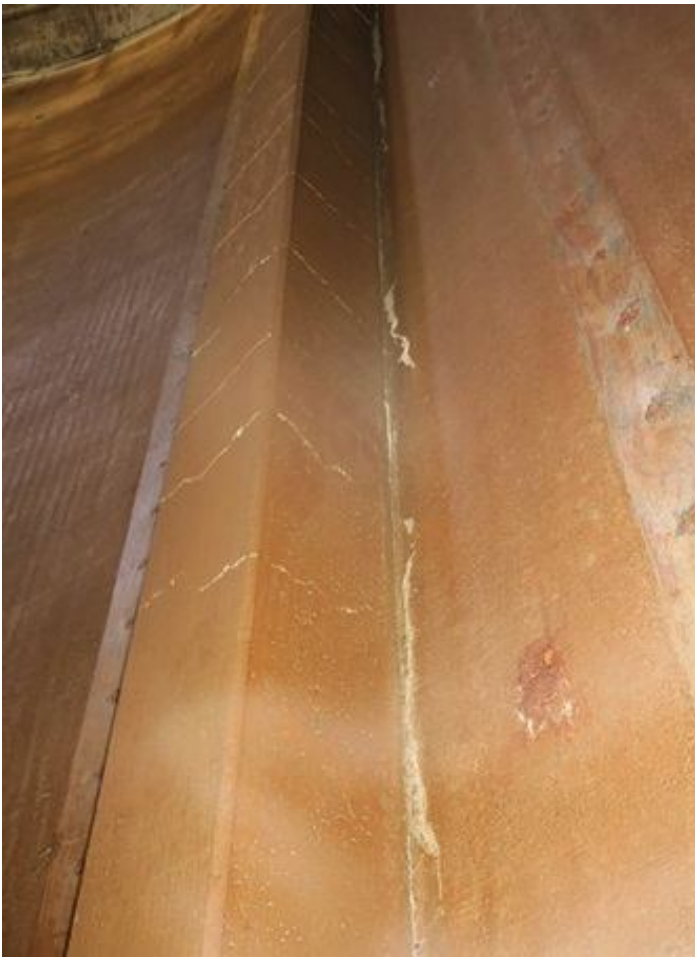
44. Concrete encasing overflow pipe.

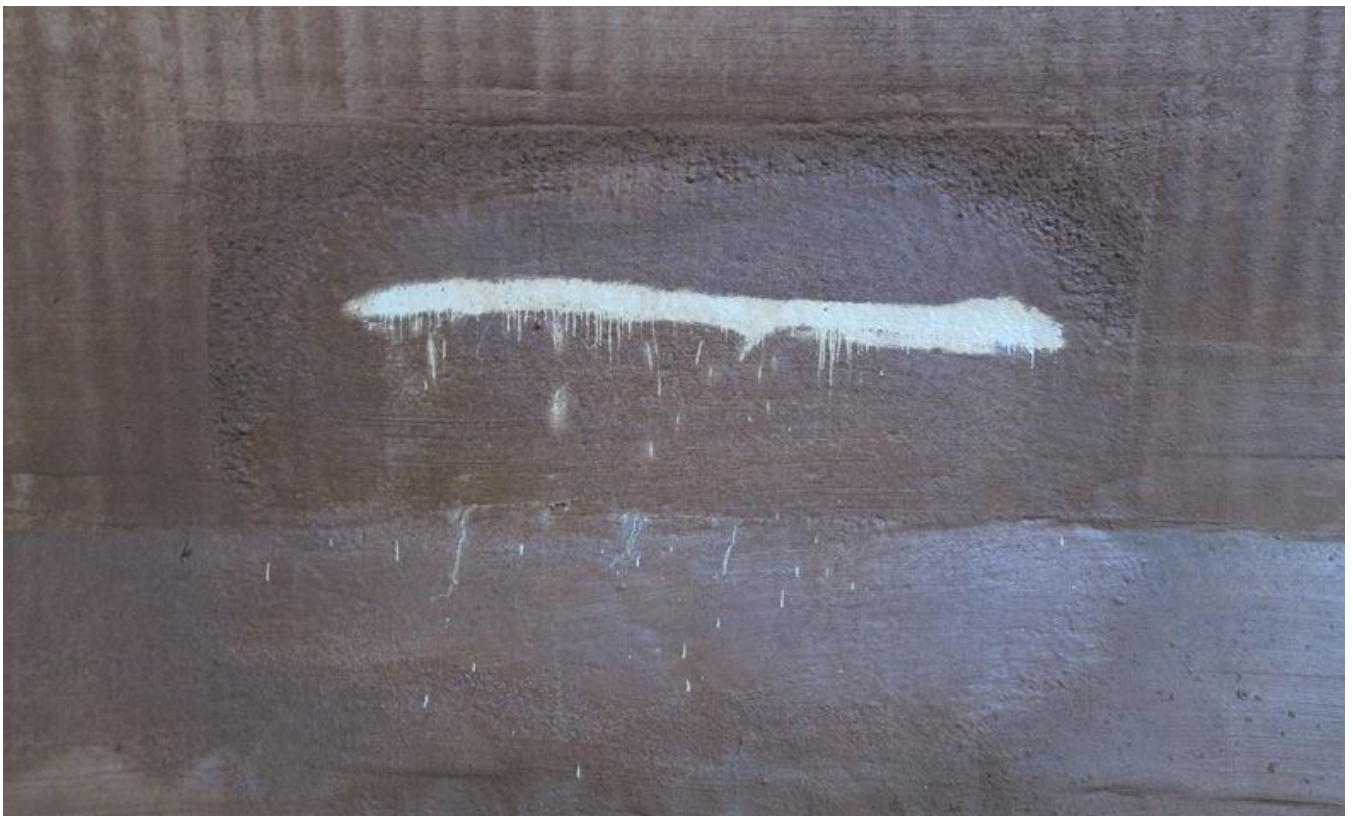
52. Sealant on lower shell.
